Risk Assessment and Risk Management Plan

Brazos Island Harbor (BIH) Brownsville Entrance Channel November 5, 2008

Addendum
Risk Assessment and Risk Management Plan

Brazos Island Harbor (BIH)
Brownsville Entrance Channel
November 13, 2008

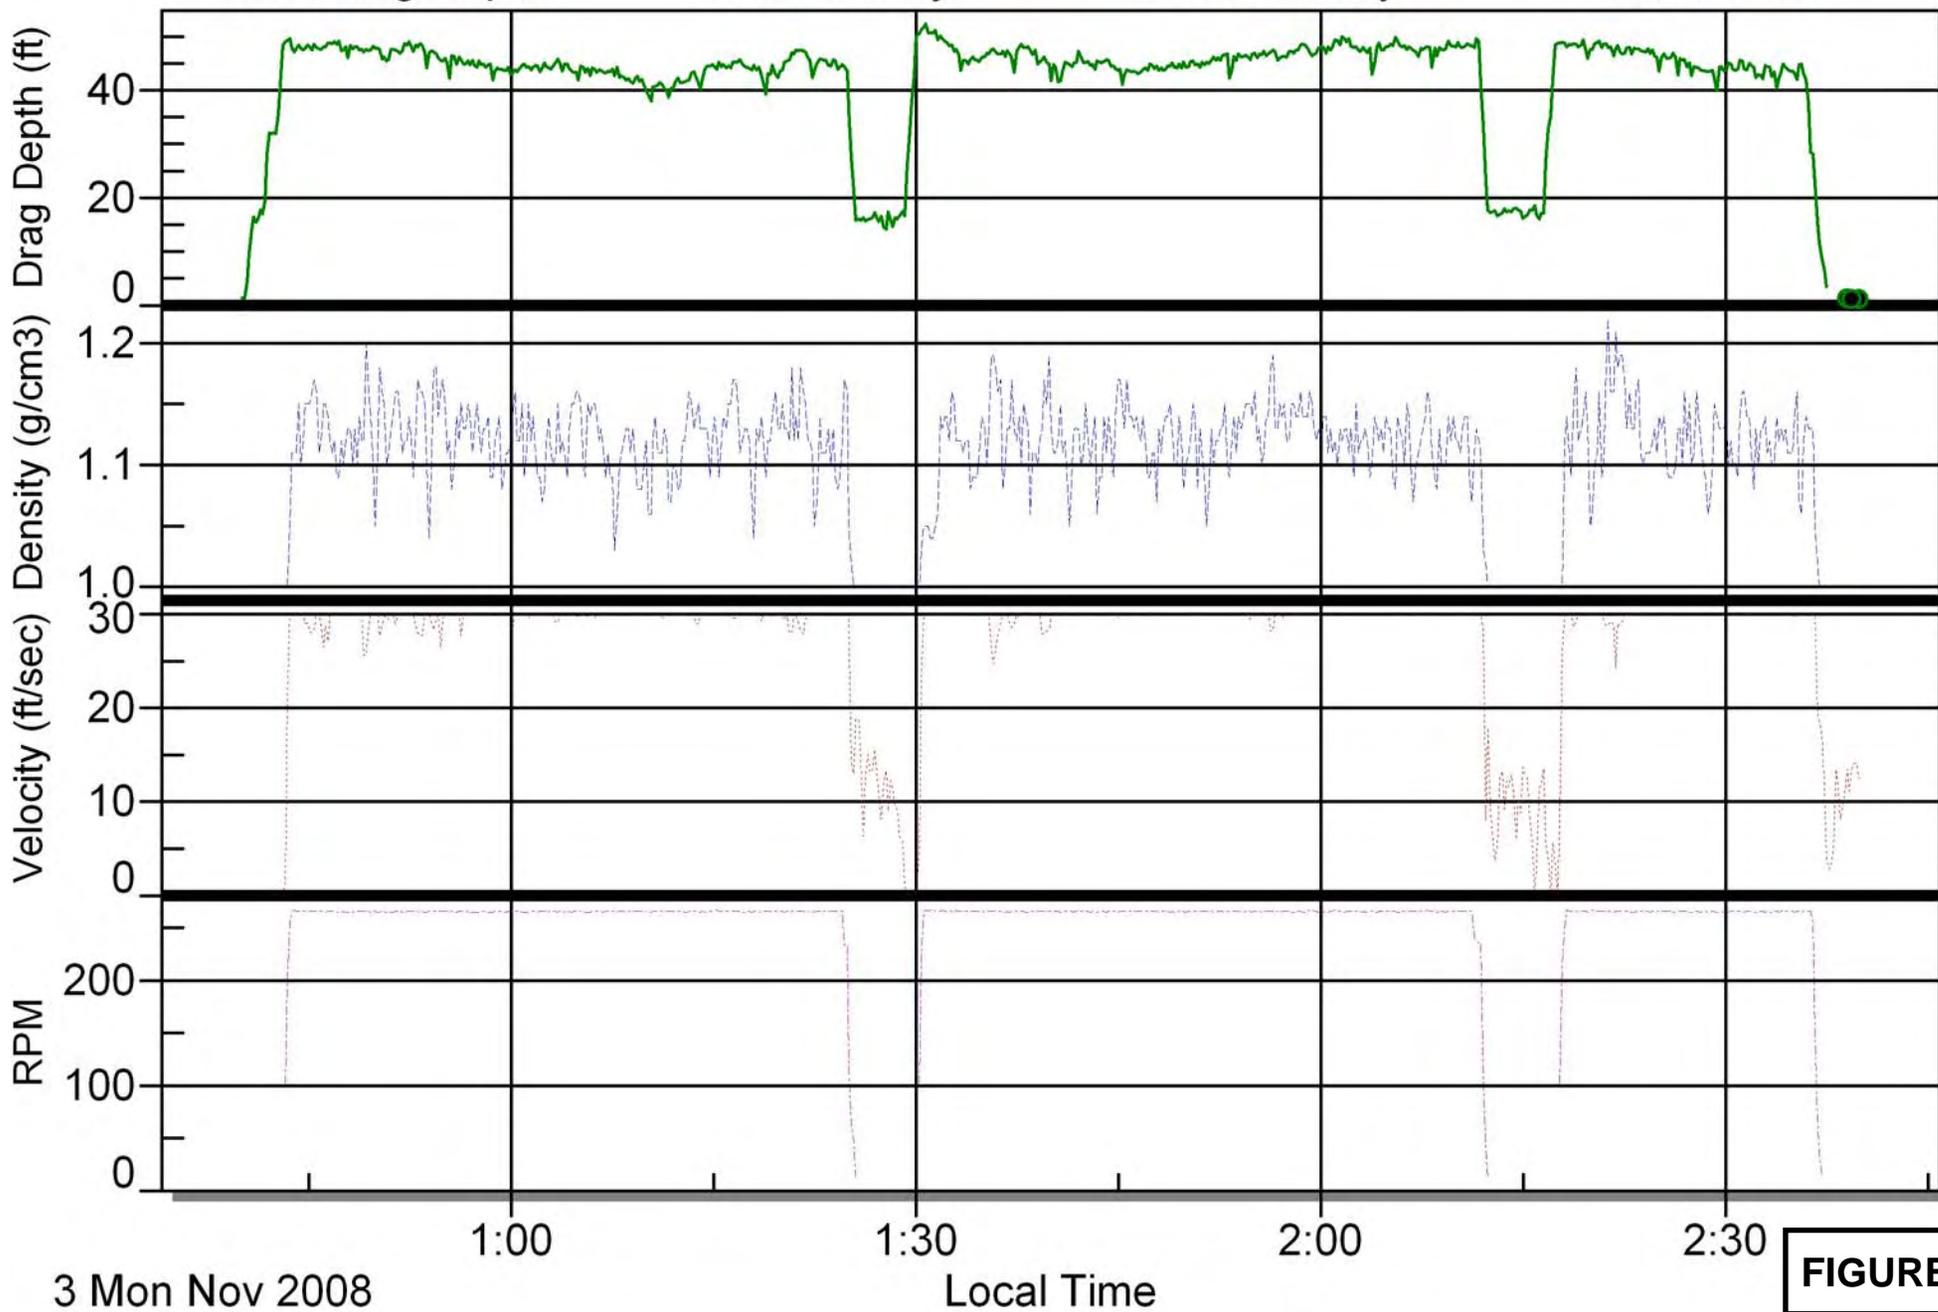
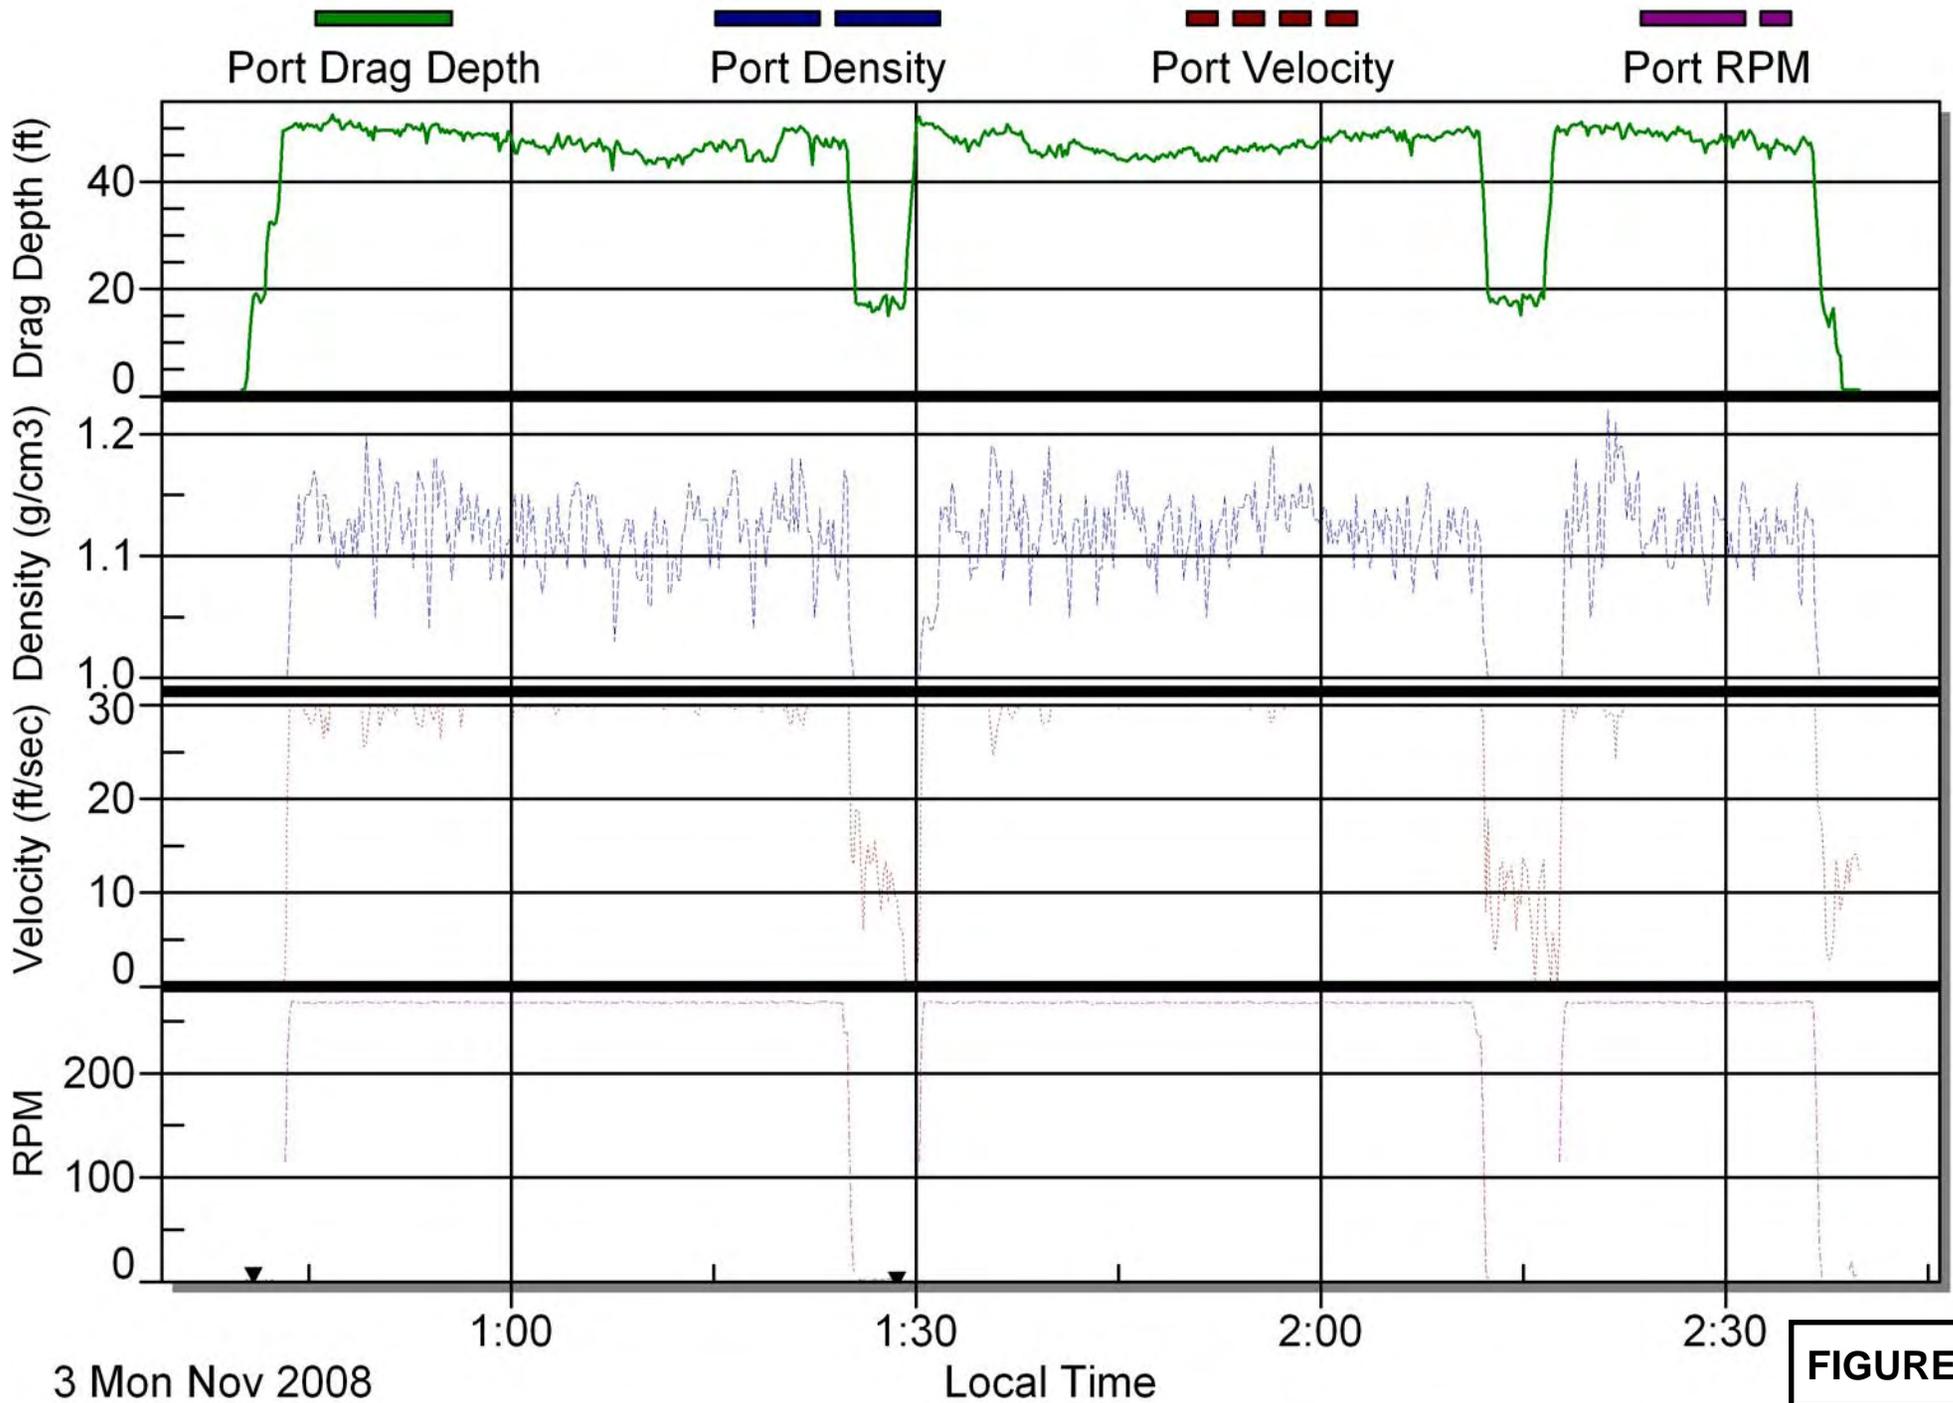
This take occurred on November 3 in Load No. 283. The water temperature was about 24.4°C. Winds were out of the southeast at an estimated 9.0 knots; seas were relatively calm with wave heights of about 2.0 ft. The take was reported to have occurred between 00:43 and 02:36. The dredge was working along the entire length of channel outside the jetties, with emphasis on the northern half of the channel but not along the side slopes. Before-dredging channel surveys show a lot of variability in depth, possibly indicating the presence of depressions and humps. So, channel topography may be a factor in this take; the draghead was constantly being buffeted and the turtle may have been in close proximity when this occurred, or it could have been lurking

in a depression or a prior dredge track when the draghead passed over. There is no way to determine if this was the case, nor is there a way to avoid this situation.

Generally, it appears that the dredge was operated satisfactorily. Figures 1 and 2 are plots of some of the operating parameters extracted from Silent Inspector (SI) data. These plots indicate that the pumps were operated properly with regard to draghead depth. The draghead depths displayed a lot of variation reflective of the irregular bottom contours. Pump rpm remained constant during dredging, but there was variability in the slurry density. However, there is no evidence in the SI plots to suggest that any corrective action would be appropriate. It is possible that as the dragheads bounced along the channel bottom, they lost contact with the sediment. These events are transient and uncontrollable; it is impossible to detect whether the turtle was entrained during such an event.

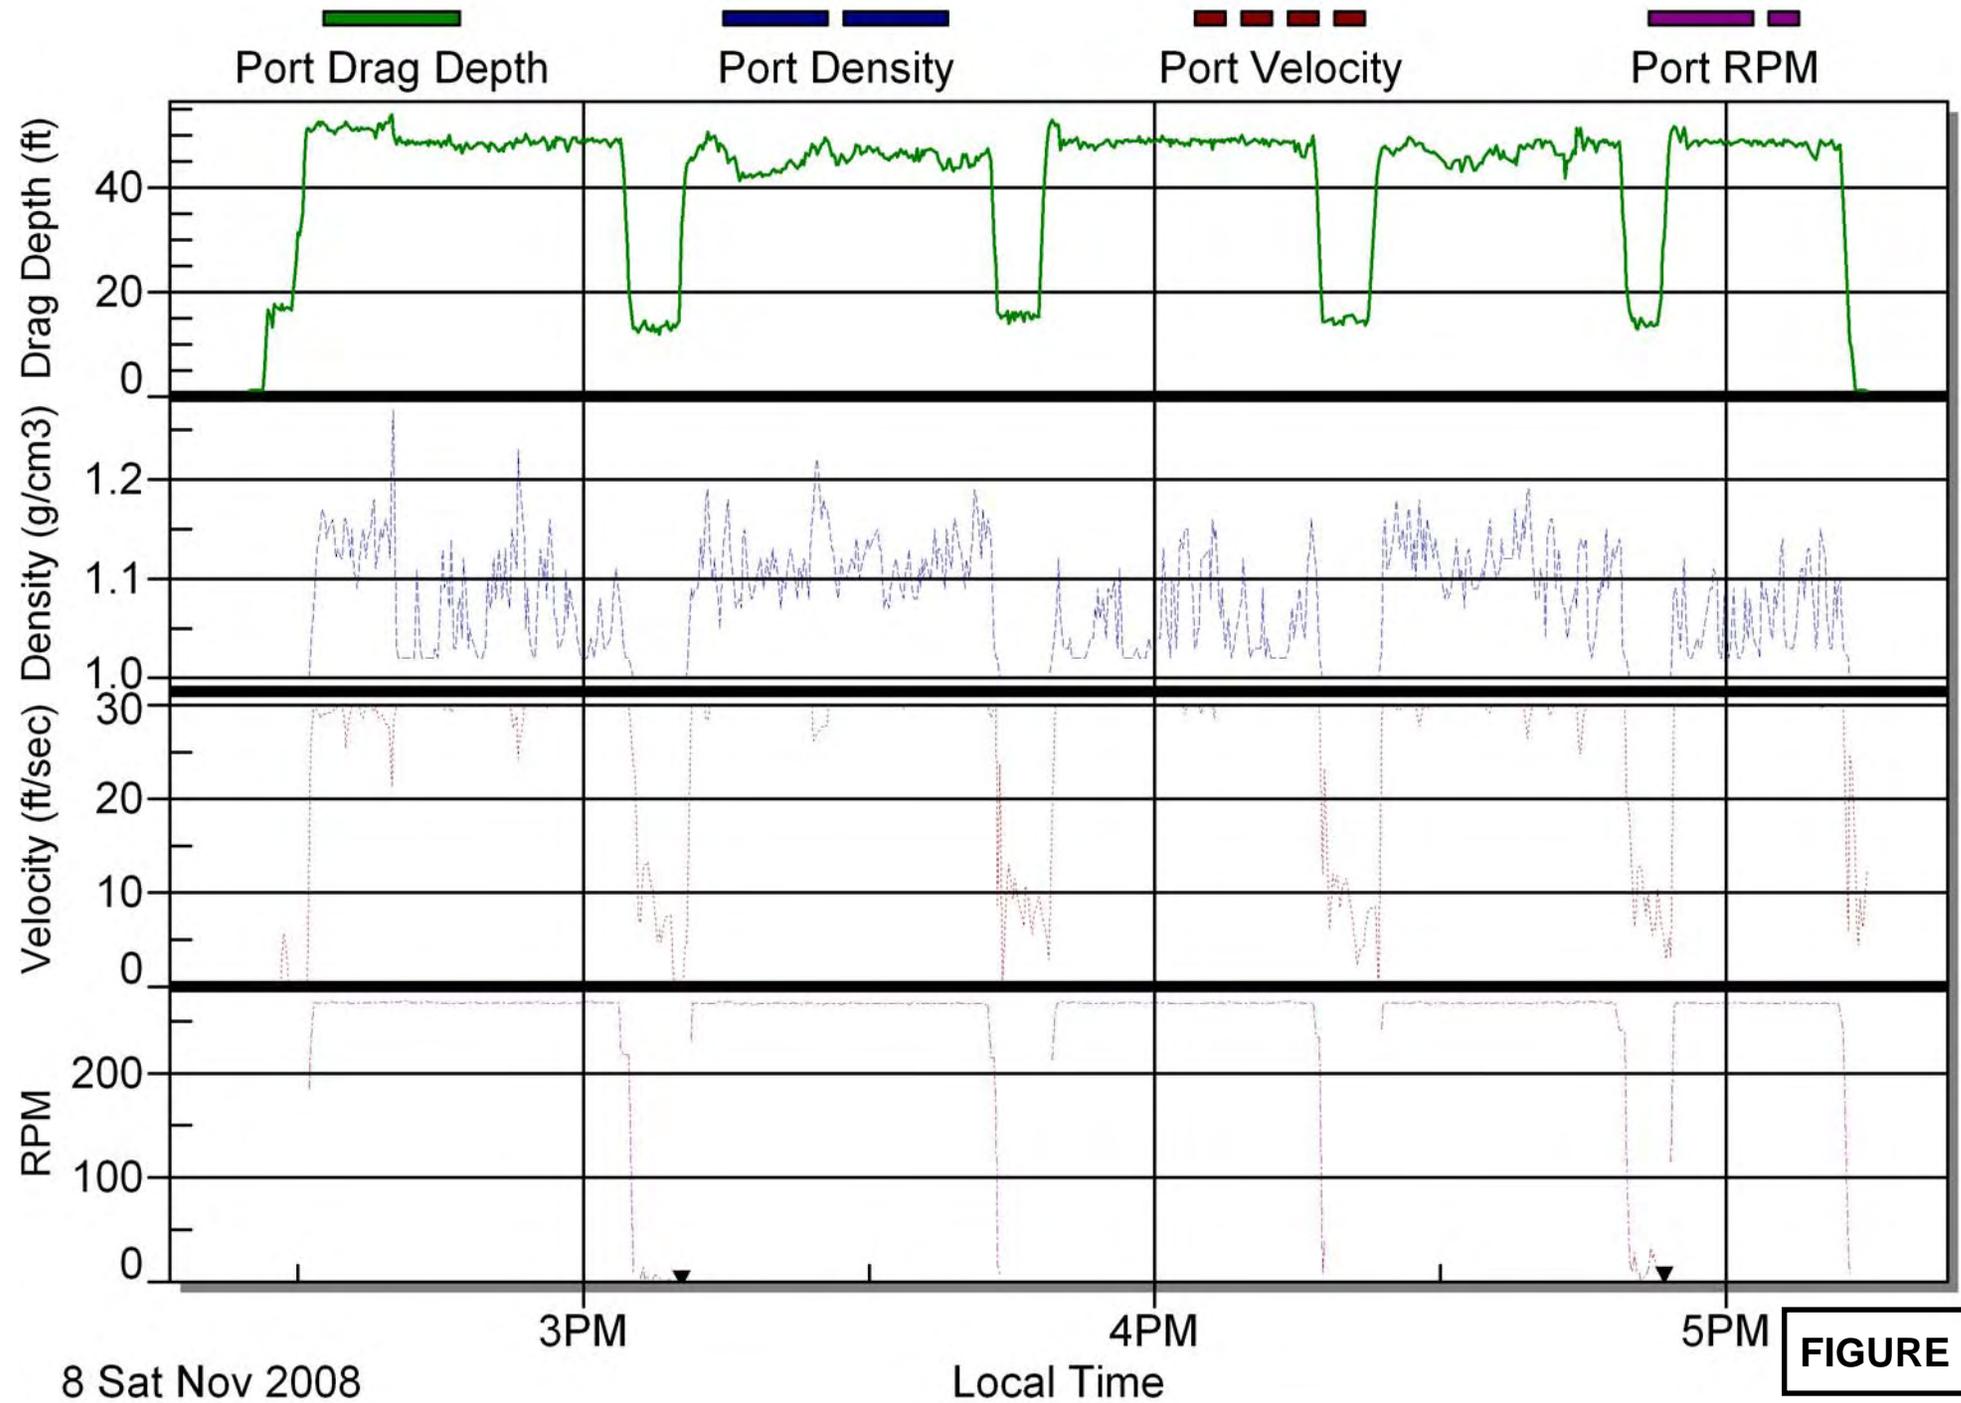
FIGURE 1

This take was a loggerhead that occurred on 8 November in Load No. 326 via the port draghead. The water temperature was about 25.6°C. Winds were estimated to be about 11.0 knots resulting in wave heights of about 3 to 4 feet. This take was reported to have occurred between 14:32 and 17:12. The dredge was working along the entire length of channel outside the jetties, with emphasis on the northern half of the channel. Some of the tracks appear to be along the northern slope, as well.

Generally, it appears that the dredge was operated satisfactorily. Figure 1 shows plots of some of the operating parameters extracted from Silent Inspector (SI) data. These plots indicate that the

pumps were operated properly with regard to draghead depth. The draghead depths displayed a lot of variation reflective of the irregular bottom contours. Pump rpm remained constant during dredging, but there was variability in the slurry density. However, there is no evidence in the SI plots to suggest that any corrective action would be appropriate. The bouncing of dragheads previously reported could account for the variations. These events are transient and uncontrollable; it is impossible to detect whether the turtle was entrained during such an event.

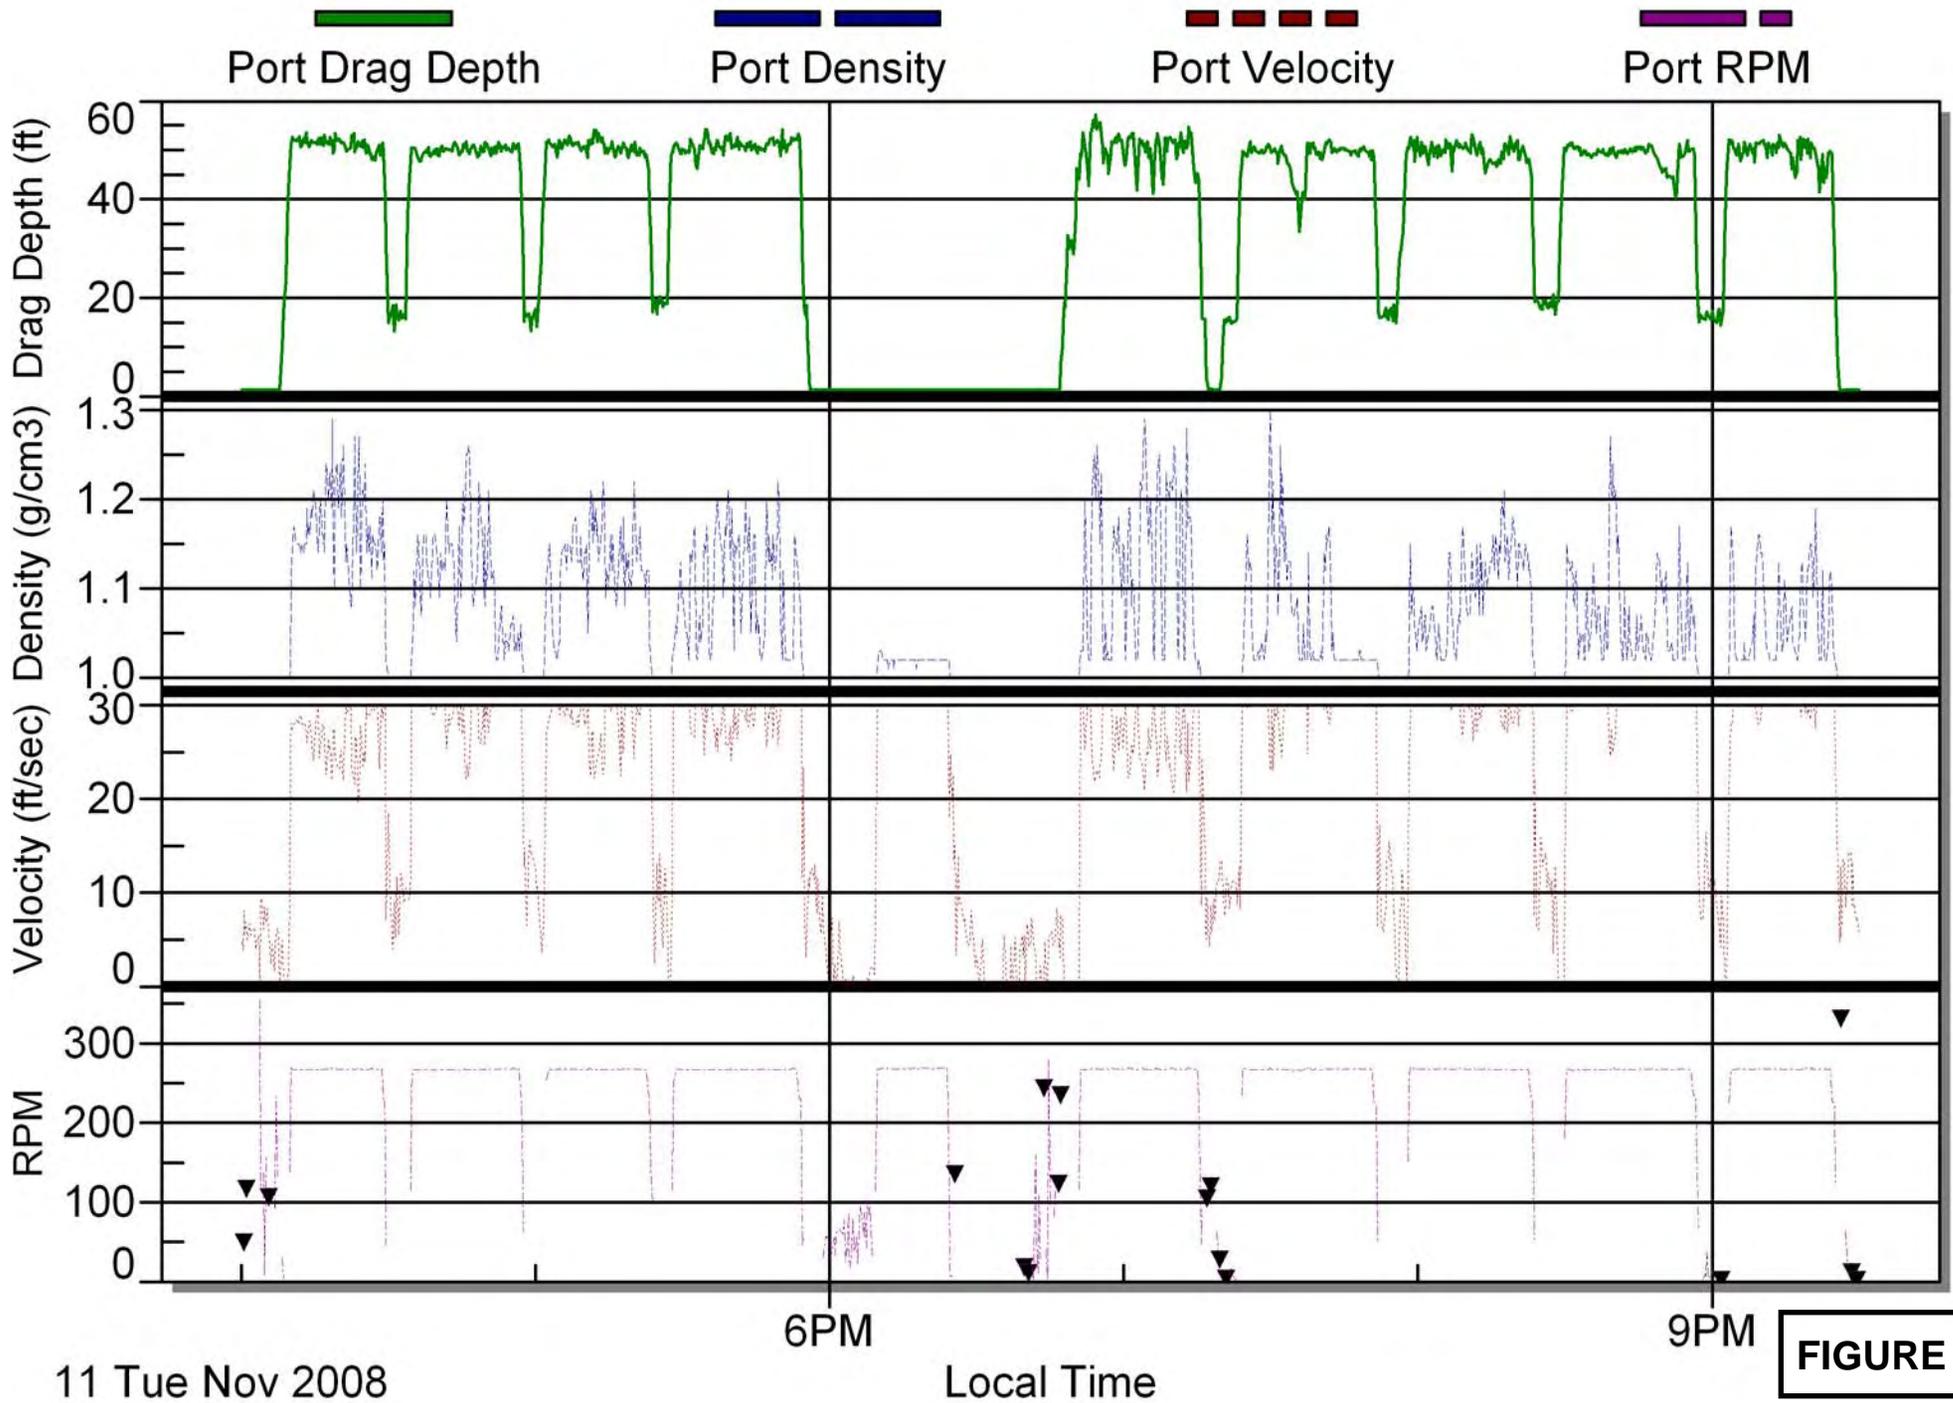
FIGURE 2

This take was another loggerhead that occurred on 11 November in Load No. 337 via the port draghead. There is some uncertainty as to what the load number actually was due to mis-numbering of loads. The water temperature was about 26.1°C. Winds were estimated to be about 12.0 knots resulting in wave heights of about 3 to 5 feet. There is also some discrepancy in the actual timing; on the observer reports, this take was reported to have occurred between 16:04 and 17:54. But a different report puts the time between 18:00 and 21:00. The dredge was working along the entire length of channel outside the jetties, with emphasis on the southern half of the channel. Some of the tracks appear to be along the southern slope, as well.

It appears that the dredge was operated satisfactorily. Figure 2 shows plots of some of the operating parameters extracted from SI data. Because of the confusion related to timing, plots of the two loads between 16:04 and 21:26 were obtained. These plots indicate that the pumps were operated properly with regard to draghead depth. There was one occurrence shortly after 6:00 PM, when the draghead was not at the channel bottom while the pump appeared to be engaged, probably to clear the line. The draghead was, however at or near the water surface, so it is unlikely that this is when the take occurred. The draghead depths displayed a lot of variation reflective of the irregular bottom contours. There were two events when the draghead seemed to abruptly raised off of the bottom. These occurred shortly after 7:30 PM and again just before 9:00 PM. These events were of relatively short duration and may be instances when the draghead rode up the side slope. Pump rpm remained constant during dredging, but there was variability in the slurry density. However, there is no evidence in the SI plots to suggest that any corrective action would be appropriate. The bouncing of dragheads previously reported, together with the fact that the dredge was essentially conducting some cleanup operation could account for the variations. Recent surveys indicate the presence of trenches and other depressions that resulted from previous dredging activities. It is possible that this turtle may have been in a low spot and was thus vulnerable to a draghead passing overhead. This take may be attributable to this circumstance, but it is impossible to determine whether the turtle was entrained during such an event.

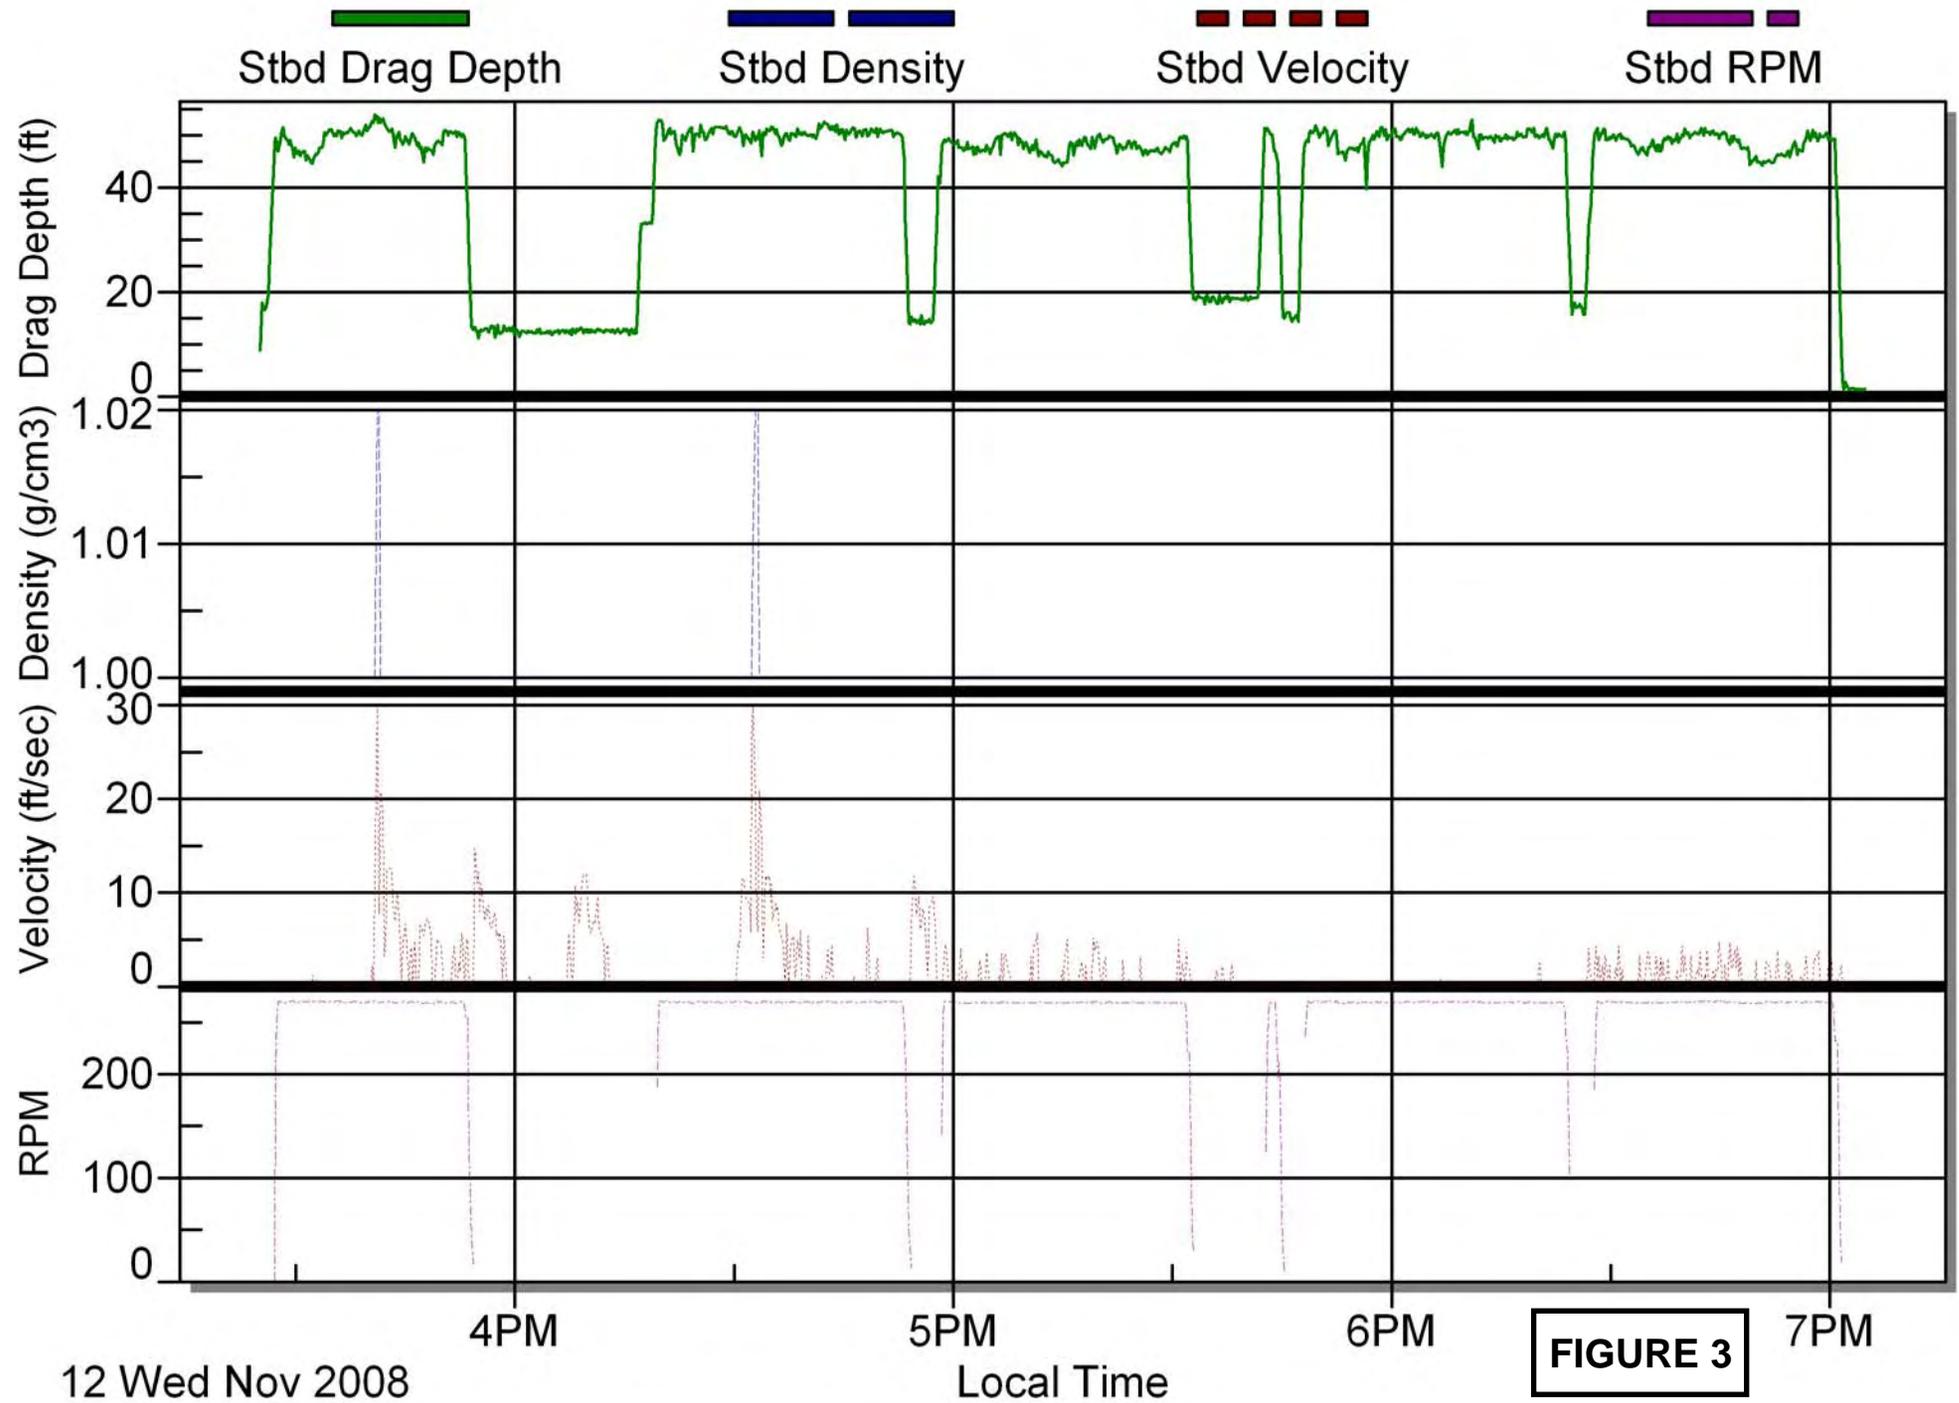
This take was a green that occurred on 12 November in Load No. 343 through the starboard draghead. Even though this was the first dredge entrainment of a green turtle during this task, they are known to be abundant in the region because of the lush seagrass pastures in the adjacent Laguna Madre. Mechanical problems have rendered the port draghead useless, so only starboard will be used for the duration of this dredging. The water temperature was about 26.1°C. Winds were estimated to be about 11.0 knots resulting in wave heights of about 1 to 2 feet. The dredge was working along the entire length of channel outside the jetties, the prime emphasis seemed to be along the northern half of the channel, but significant activity was also undertaken along the southern half. Some of the tracks are not straight suggesting an effort to hit selected areas, some dredging appears to be along the side slopes, as well.

Generally, it appears that the dredge was operated satisfactorily. Figure 3 shows plots of some of the operating parameters extracted from SI data. These plots indicate that the pumps were operated properly with regard to draghead depth. The draghead depths displayed a lot of variation reflective of the irregular bottom contours. There were two events when the draghead seemed to abruptly raised off of the bottom. These occurred shortly before and after 6:00 PM and again just before 9:00 PM. These events were of very short duration and may be instances when the draghead rode up the side slope. Pump rpm remained constant during dredging. The plot of the slurry density displayed only two spikes, suggesting some difficulty with the sensor. This may be an artifact of using only one draghead. However, there is no evidence in the SI plots to suggest that any corrective action would be appropriate. The bouncing of dragheads together with cleanup operation could account for the variability in draghead depth, and could have contributed to this take. But, it is impossible to determine a definitive cause.
