**ENDANGERED SPECIES OBSERVER PROGRAM**

**INCIDENT REPORT OF SEA TURTLE TAKE BY DREDGING ACTIVITY**

**Dredge Wheeler  
accidental  
uninjured  
sea turtle  
take 09-14-95**

**Port Aransas  
Texas**

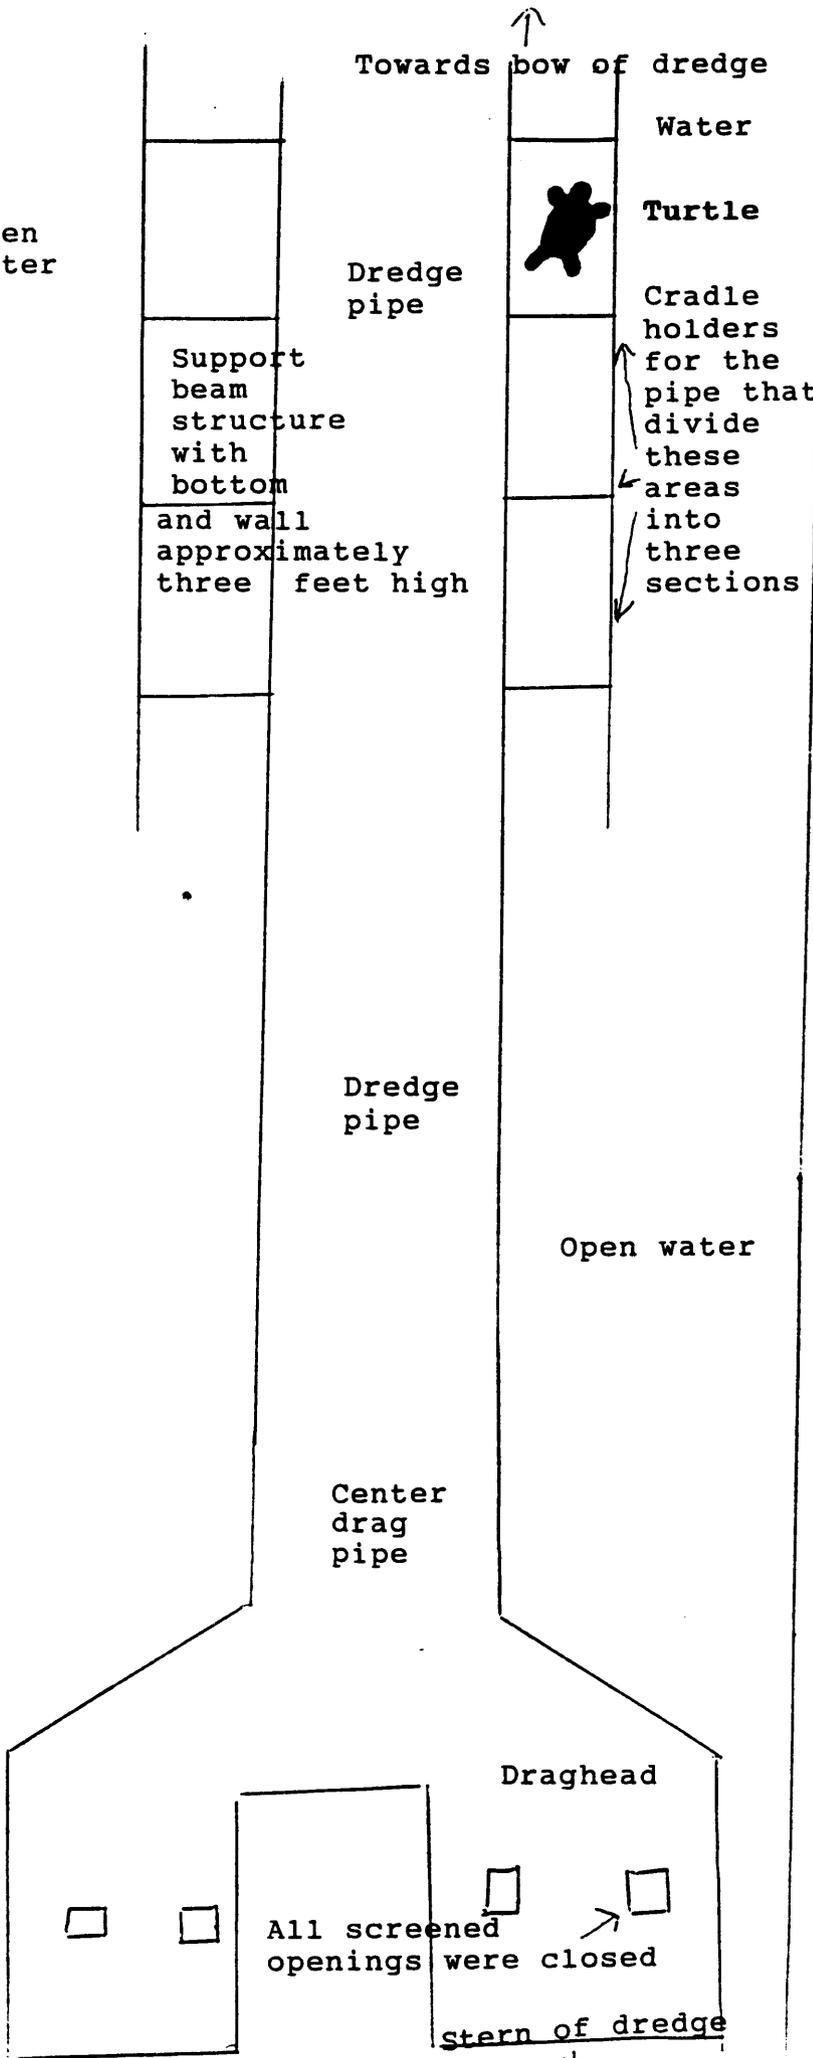
Comments This appears to be a freak accident that the turtle was caught in this supporting beam. After the digging cycle the center draghead is brought up out of the water. The turtle must have been swimming in the area and got caught in this structure as the draghead pipe was being brought up. The pipe was lowered and the turtle swam away.

Turtle was temporarily caught in the support beam structure as the drag was being brought up to go to the dump

The pipe had to be lowered so the turtle could swim over the wall and into the water

Support beam structure with bottom and wall approximately three feet high
