ENDANGERED SPECIES OBSERVER PROGRAM

Project: Cape Henry Channel / Chesapeake BayINCIDENT REPORT OF SEA TURTLE TAKE BY DREDGING ACTIVITYDate 06 / 01 / 02Time(24hr) 2112Species of Turtle Taken Chelonia mydasDredging Site (channel, port, etc.) Cape Henry Channel / Chesapeake BayLocation of Take: Latitude 36 59.91 N Longitude 76 01.29 W (^{stations}
₁₅₀₊₀₀)Vessel Name and Company Bayport / MansonType of Dredging Activity maintenance dredgingLoad # 891 Times: Start 1758 End 2112 Dump 2324-2236Sampling Method (overflow, inflow,etc.) inflowSamples Recovered From Port side fore inflow screenCondition of Screening goodDraghead Deflector? Yes No Condition of Deflector goodWeather Conditions clear / seas - 1 ft / winds SE 5-10 knots Tide 1.7 ebbWater Temperature: Surface 72 °F Column 71 °F C or F (circle one)Condition of Specimen(s) Sampled entire turtle was recovered except for a few small portions of the carapace; fresh take; some blood observed and all internal organs exposed but intact; no bleeding or odor observed *See comments and diagram.

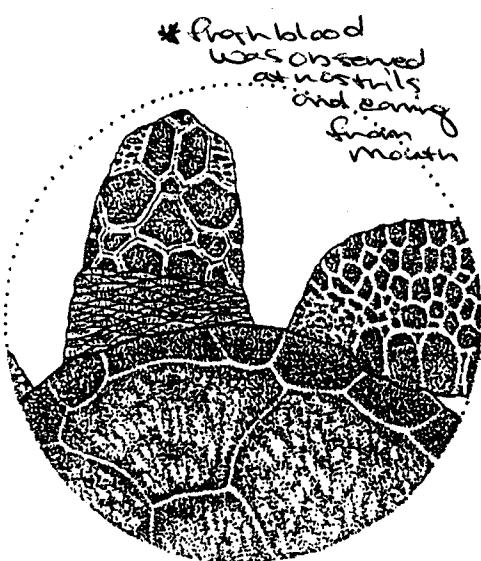
Head Width 5 cm~~* straight~~~~* straight~~Plastron Length 24 cmWidth 22 cmCarapace S. L. Length 27 cmS.L. Width 24 cmCarapace O.C. Length —O.C. Width —Turtle Tagged? Yes No Tag # N/A Tag Date 1-1-1Comments turtle was a fresh take; blood observed; no odor orbleeding; turtle suffered from a large crack that spanned from the notch of the carapace, along the vertebral scutes,to almost the tip of the carapace; several lateral cracks ranged across costal scutes; small portion of carapace missingfrom vertebral scutes (3-5)Observer's Name Holly Farnbach

Shade areas of turtle that are missing. Sketch cracks and lacerations.

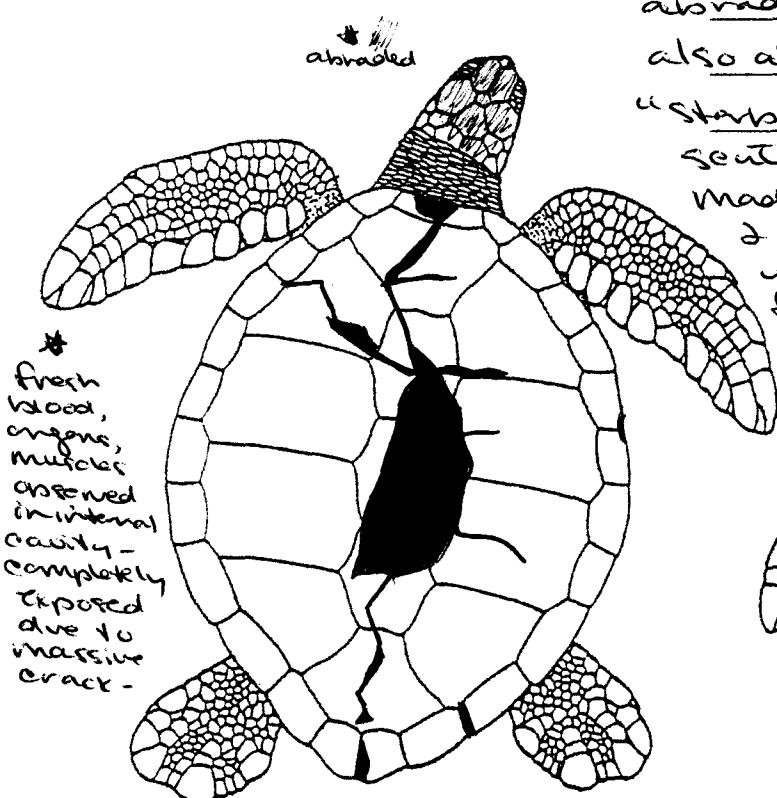
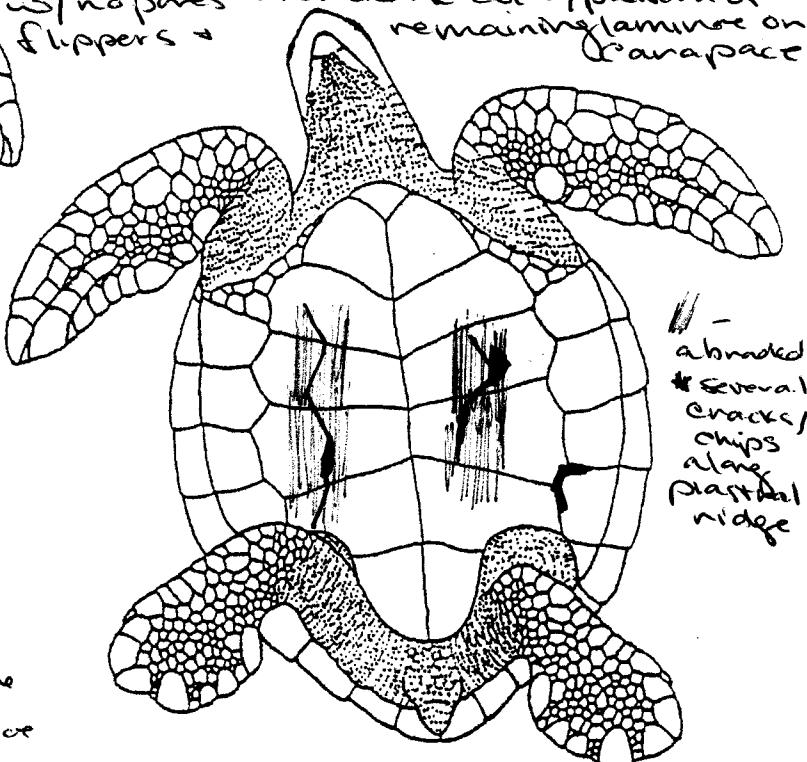
Diagrams by Tom McFarland

Comments: Fresh lake - turtle was recovered almost completely intact; large crack present from carapace notch, almost to the tip; crack ranged along the ventral scutes and several lateral cracks / chips were observed on costal scutes; small portion of carapace missing from ventral scutes (3-5); internal organs completely exposed but still intact; prefrontal scales (2) and other scales in the head region were abraded; the laminae of the carapace was also almost completely abraded but the "starburst" pattern was apparent on several scutes; positive species identification was made from the presence of 4 costal scutes, 2 prefrontal scales, 4 inframarginal scutes w/ no pores and dark color/pattern of remaining laminae on carapace

* the shaded (lightly) regions on the plastron and head indicate abraded regions - almost the entire carapace was abraded and most of the laminae was missing - cracks and several chips from the plastron were observed - some bruising observed.
