DAILY REPORT

Project Name: Myrtle Beach Renourishment USACE District: Charleston, SC
 Dredge Name: Myrtle Island Dredge Firm: G.L.D.D.
 Contract # W91ZHN-07-R-0053 Maintenance / New Work X

ENDANGERED SPECIES OBSERVER PROGRAM
SEA TURTLE INCIDENTAL TAKE DATA FORM

PROJECT NAME: Myrtle Beach Renourishment DREDGE NAME: M/V Padre Island

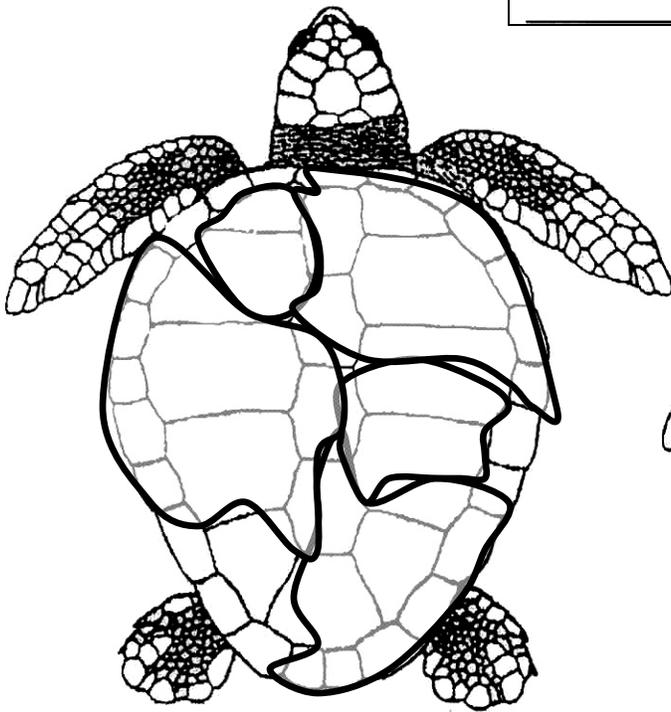
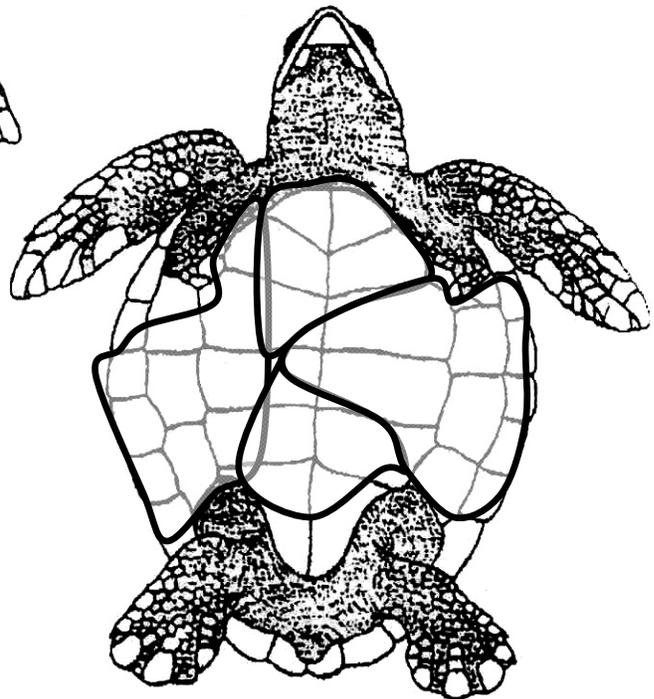
Loggerhead (*Caretta caretta*)

Condition of specimen: Entire turtle recovered in the starboard draghead. Turtle was folded in half, with many cracks in dorsal and ventral carapace. Body cavity ruptured, with some loss of internal organs.

Entire turtle recovered minus a few internal organs.

Back carapace was completely crushed in multiple points. Turtle was actually folded in half in the draghead.

See diagram for cracks.
