**ENDANGERED SPECIES OBSERVER PROGRAM**

Project: Egmont Channel, Tampa Bay

**INCIDENT REPORT OF SEA TURTLE TAKE BY DREDGING ACTIVITY**

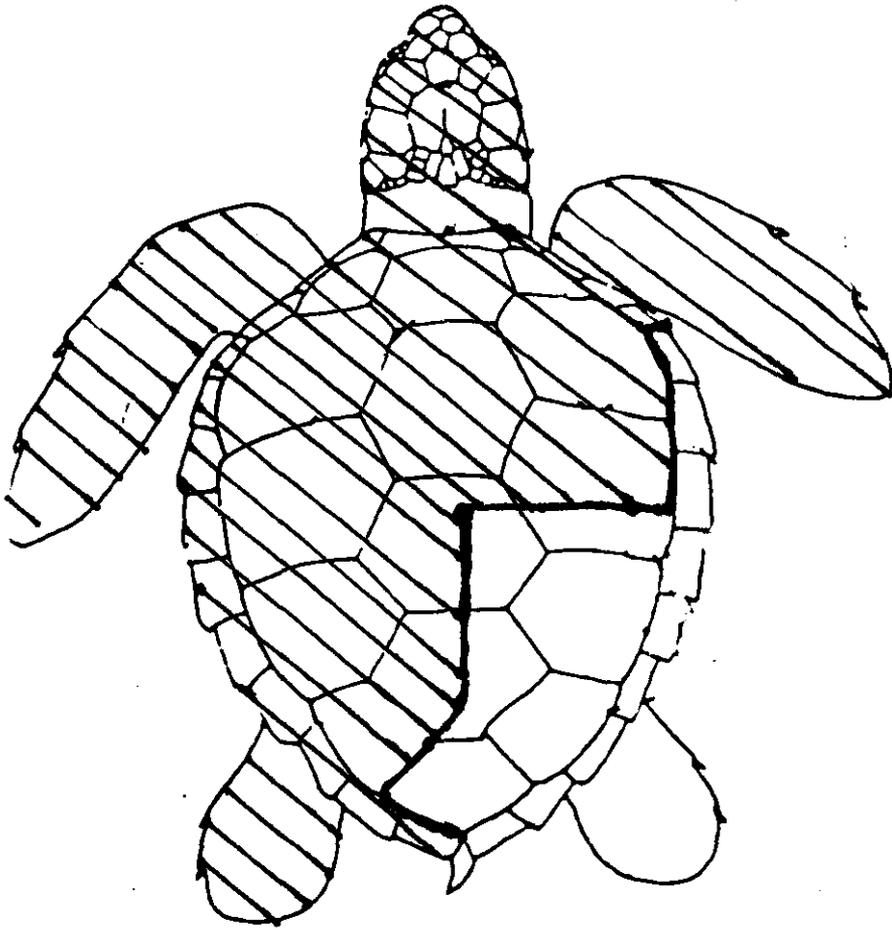
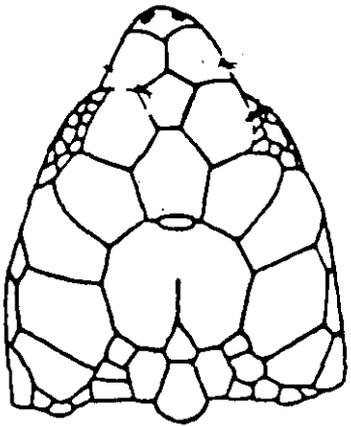
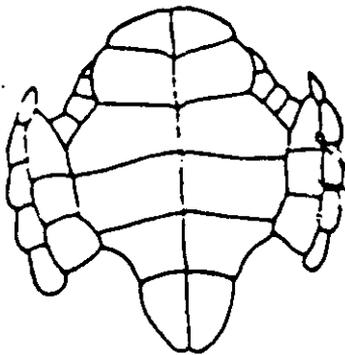
Dredge Stuyvesant  
03-16-97  
Egmont Channel, Tampa Bay  
Loggerhead (*Caretta caretta*)

Date 03 / 16 / 97 Time(24hr) 0530  
Species of Turtle Taken Caretta caretta, loggerhead  
Dredging Site (channel, port, etc.) Tampa Bay, Egmont Channel, Buoys 11-12, 9-10.  
Location of Take: Latitude 27°37'00"N Longitude 82°51'04"W  
Vessel Name and Company Dredge Stuyvesant, Stuyvesant dredging company  
Type of Dredging Activity Hopper, maintenance.  
Load # 58 Times: Start 0345 End 0530 Dump 0645  
Sampling Method (overflow, inflow, etc.) 100% overflow, one large mid skimmer screened.  
Samples Recovered From Port side of the mid skimmer.  
Condition of Screening Good  
Draghead Deflector? Yes  No   
Condition of Deflector Good  
Weather Conditions Skies clear, Winds NE 15 knots, Seas 2'-4' Tide Flood  
Water Temperature: Surface 73° Column \_\_\_\_\_ C or  (circle one)  
Condition of Specimen(s) Sampled Fresh dead, sampled right rear flipper and  
partial carapace, about 25% of the turtle. The turtle had no foul

odor, ventral skin had no signs of postmortem color changes.

Comments No bow thruster was used during the load. The turtle was  
frozen in case the dredge picks up anymore pieces in the next  
couple of days. The turtle was photographed and measured. The  
right rear flipper was 24 cm in length and 12.5 wide and had  
two claws. Total length of piece was 44cm and 30 cm wide.
