ENDANGERED SPECIES OBSERVER PROGRAM

Project: Mayport, Florida

INCIDENT REPORT OF SEA TURTLE TAKE BY DREDGING ACTIVITY

Date 10/15/01

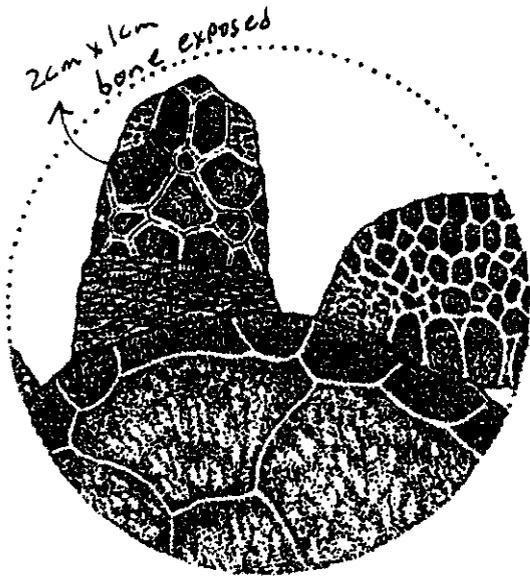
Chelonia mydas (green turtle)

Comments The plastron has a severe laceration and fracture of 5.5cm. The head has an abrasion 2cm by 1cm, which went to the bone. Parts of the marginal scutes are fractured and missing. The left eye has a laceration. Severe internal injuries apparent.

Comments: 10/15/01 Severe laceration and fracture to the plastron 5.5cm
The head has an abrasion of 2cm by 1cm which goes to the bone. Parts of
The marginal scutes are fractured and missing. Severe internal injuries are
apparent.
