**ENDANGERED SPECIES OBSERVER PROGRAM**

Project: Brunswick Bar Channel

**INCIDENT REPORT OF SEA TURTLE TAKE BY DREDGING ACTIVITY**

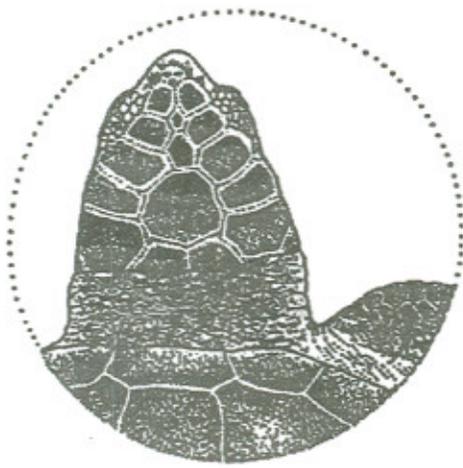
(IN 2  
PIECES)  
↓

TURTLE CUT IN HALF WIDTH-WISE  
≈ 1/2 SCUTES BEHIND FRONT FLIPPERS  
CARAPACE CRACKED LENGTH-WISE  
WITH LARGE CENTER PIECE  
MISSING.

CENTRAL INTERNAL ORGANS GONE  
BUT THOSE IMMEDIATE TO INTACT  
PIECES STILL PRESENT. MISC.  
INTERNAL PARTS FOUND WITHIN  
SCREENING BOX.

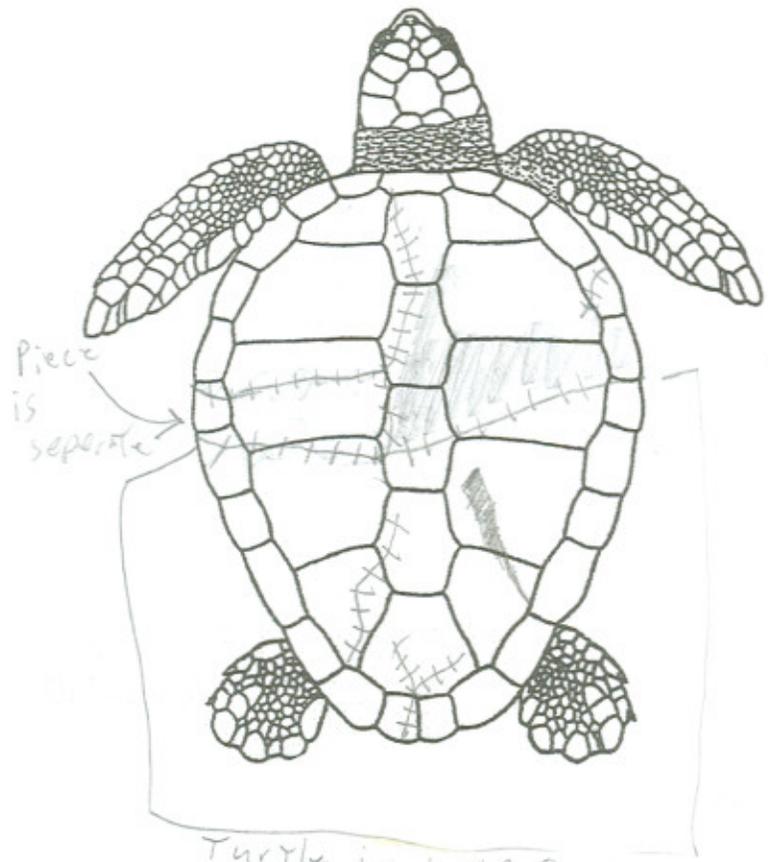
CRACKS  
+++

Turtle in half from  
these points

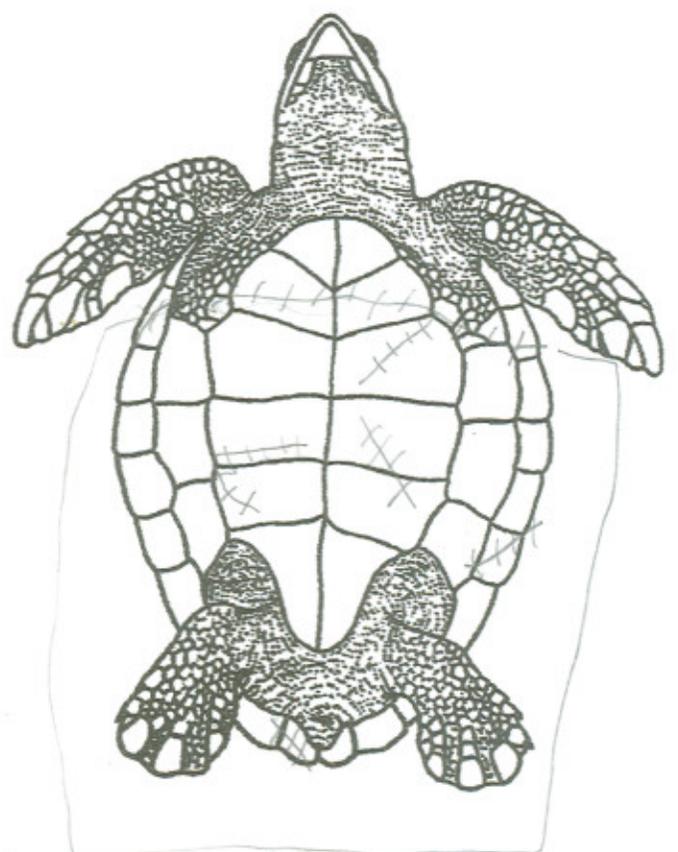
In half from these points
