## ENDANGERED SPECIES OBSERVER PROGRAM

Dredge *OUACHITA* - Brownsville, TX  
USACE, Galveston District

Dredge Ouschita  
Braço Santiago Pass  
Sampled live  
Chelonia mydas  
02-23-95  
Load 144 0520

INCIDENT REPORT OF SEA TURTLE MORTALITY AND DREDGING ACTIVITY

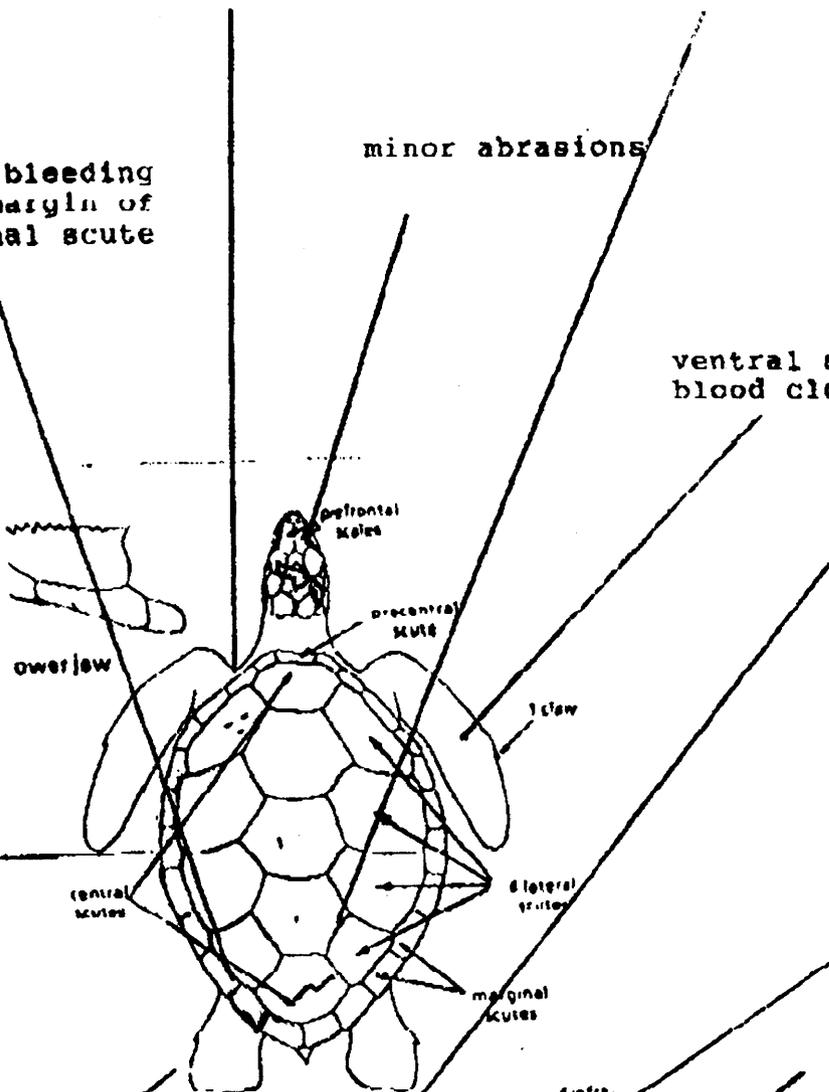
Fig. 27

cracked 5th central scute,  
bleeding

minor abrasions  
lateral scute

light bleeding  
from margin of  
marginal scute

minor abrasions

ventral side large  
blood clot

8th marginal scute  
from posterior scute  
cracked

pectoral and  
abdominal scutes  
cracked

6&7 marginal scute from  
from posterior scute has  
minor abrasions and the  
6th scute minor bleeding

light bleeding  
from inframarginal  
scute margin

note  
ventral  
skin  
notably  
pink in  
color
