INCIDENT REPORT OF SEA TURTLE TAKE BY DREDGING ACTIVITY

Date 12 MAY 03 Time (24 hr) 2302
 Species of Turtle Taken Caretta caretta
 Dredging Site (channel, port, etc.) Aransas PASS, TX
 Location of Take: Latitude 27° 49.115 N Longitude 97° 00.581 W
 Vessel Name and Company A+Chalupa, B+B Dredging
 Type of Dredging Activity hopper dredging
 Load # 289 Times: Start 2125 End 2302 Dump _____
 Sampling Method (overflow, inflow, etc.) inflow, screening
 Samples Recovered From draghead
 Condition of Screening good
 Draghead Deflector? Yes No _____
 Condition of Deflector: good
 Weather Conditions: partly cloudy, hazy, wind ^{10+20 knots} Tide _____
 Water Temperature: Surface 81°F Column _____ °C or (circle one)
 Condition of specimen(s) sampled when turtle was brought up in draghead. Turtle was still alive and breathing. Flippers were intact. No visible tags. Carapace was cracked.
 Measurements (metric if possible): metric
 Give estimate of entire carapace dimensions, as well as fragments samples:

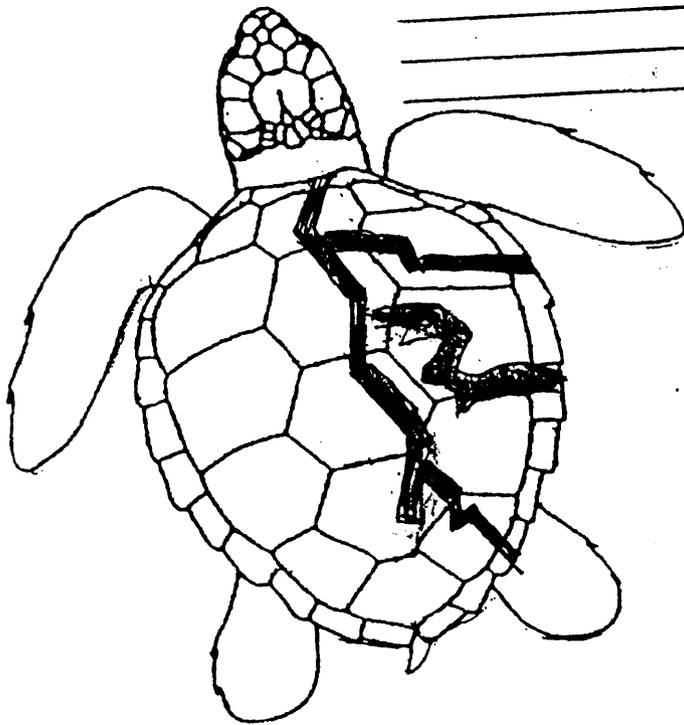
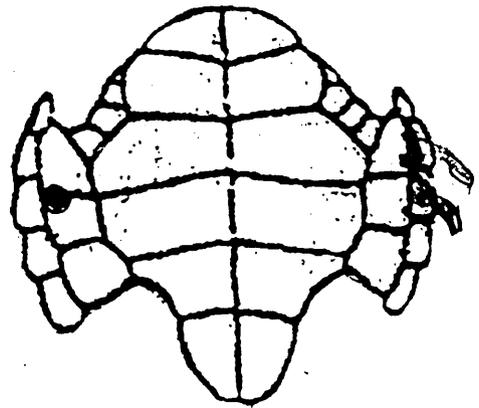
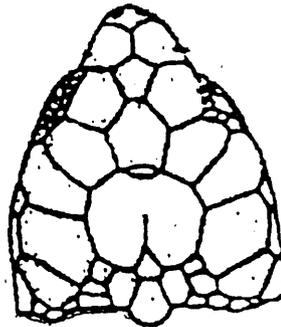
Head Width 11 cm
 Plastron Length 52.5 cm Width 41
 Carapace *S.L. Length 59.0 cm S.L. Width _____
 Carapace **O.C. Length 62.0 cm O.C. Width _____
 Turtle Tagged? Yes _____ No Tag# _____ Date 1/1
 Comments: Carapace had 3 cracks. in ~~the~~ Plastron left side @ 3rd coastal scute hole ^{is present}. Right side of plastron ~~was~~ piece hanging off. Insides of turtle were sucked out. ~ 10 mins after removing turtle ~~and~~ from draghead it died.
 Observer's Name Erwin Smith

Blacken/shade parts which are missing.
 Sketch any visible cracks and lacerations.

Comments first crack on right
side of carapace was 12 cm in length
Middle crack was 23 cm in length
from middle ~~of~~ carapace to 3rd costal
sawte. 3rd crack was 12 cm
Crack from middle head to middle
of carapace 40 cm long.
4th scute was hanging from side.
