3.9 Seafloor Video Results from Cell LU

3.9.4 Monitoring Results

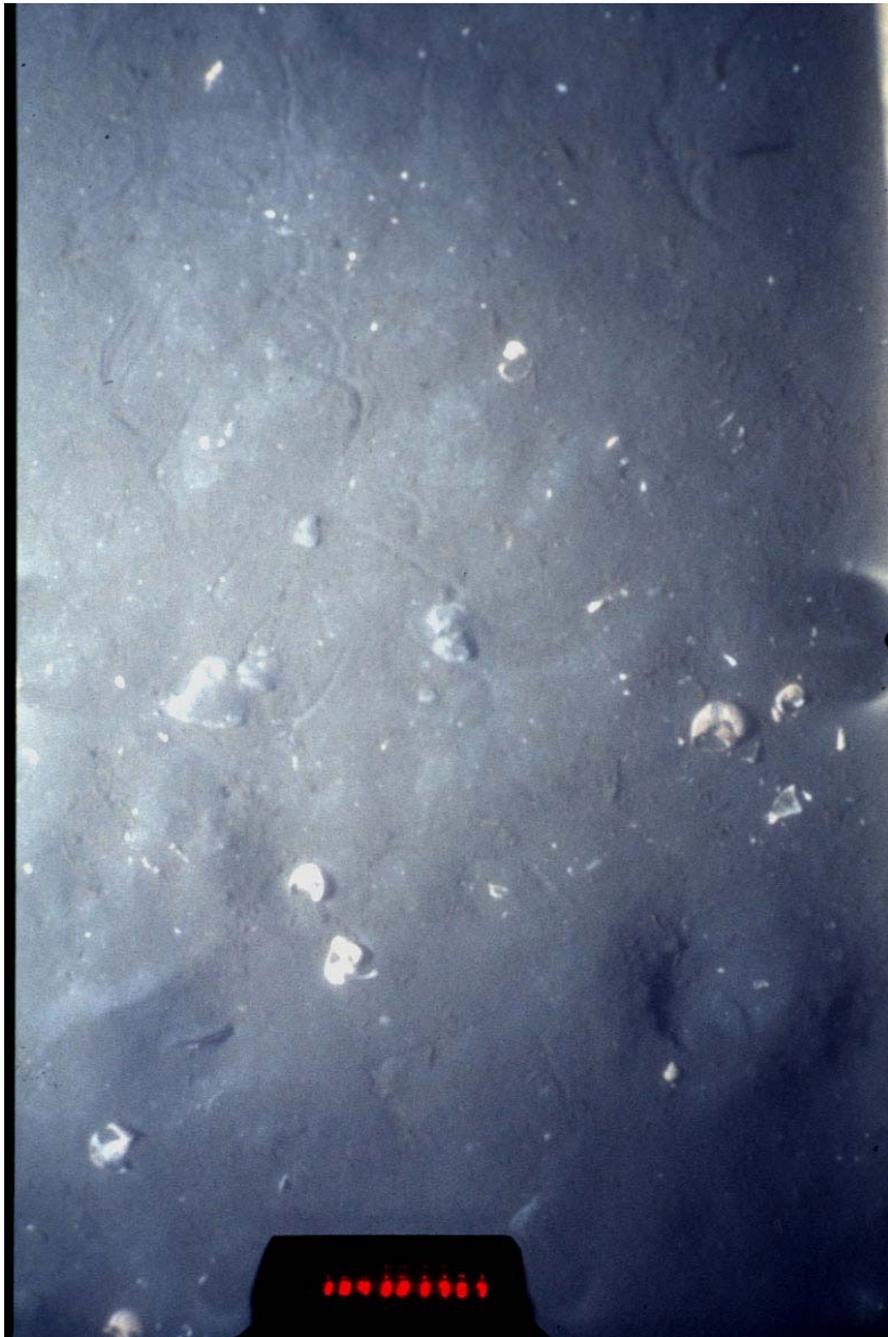
Figure 3.8-8. Evidence of epifaunal activity. This image from Cell LU Station I08, taken during the Post 1 survey, shows evidence of recent epifaunal activity on the cap material surface in the form of tracks.

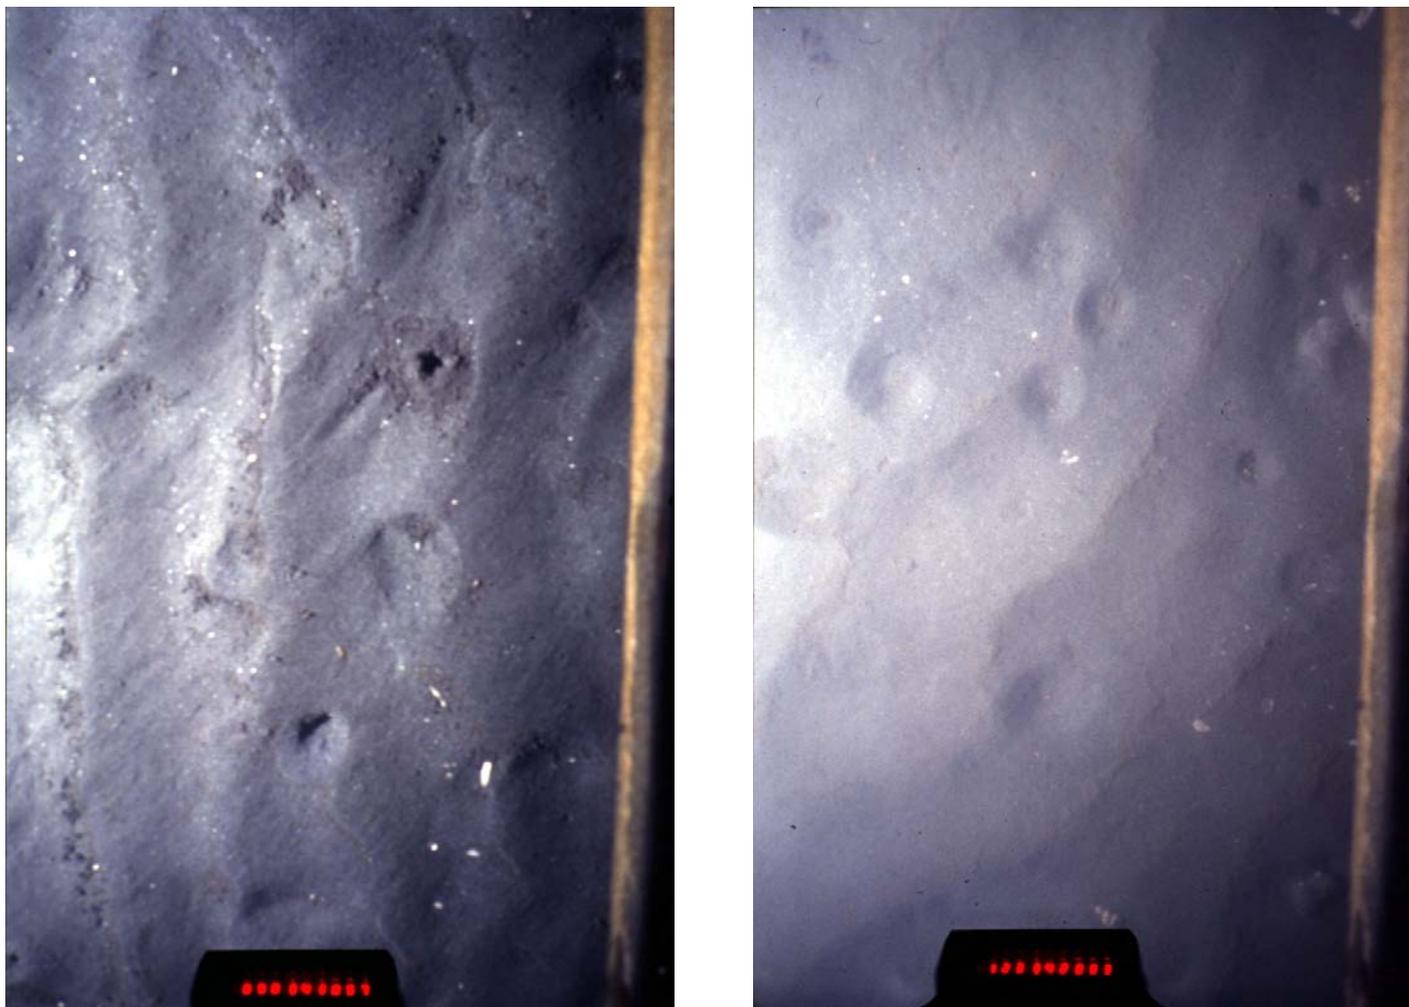
Figure 3.8-13. Physical processes. The uniform sand waves in these images from Station I11 and I30, taken during the Cell LU Post 25 survey, suggest a slight re-working of the cap material surface due to physical processes such as currents.

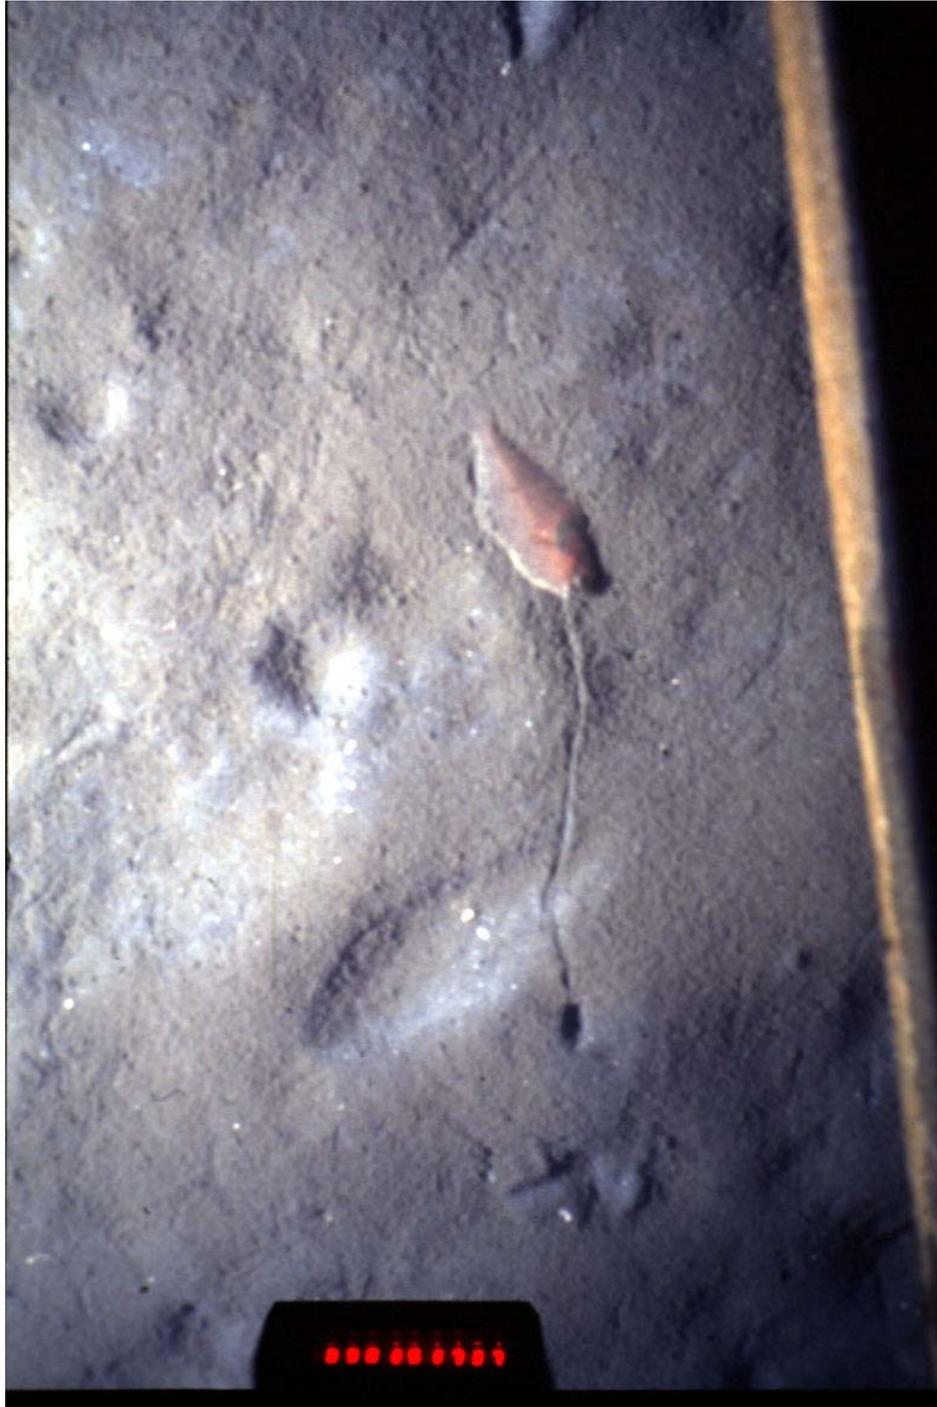
Figure 3.8-16. Epifaunal activity. The track leading to this recently re-excavated burrow at Cell LU, Station I14, provides insight into the foraging activities of this fish. The image was acquired during the Post 45 PVC survey.

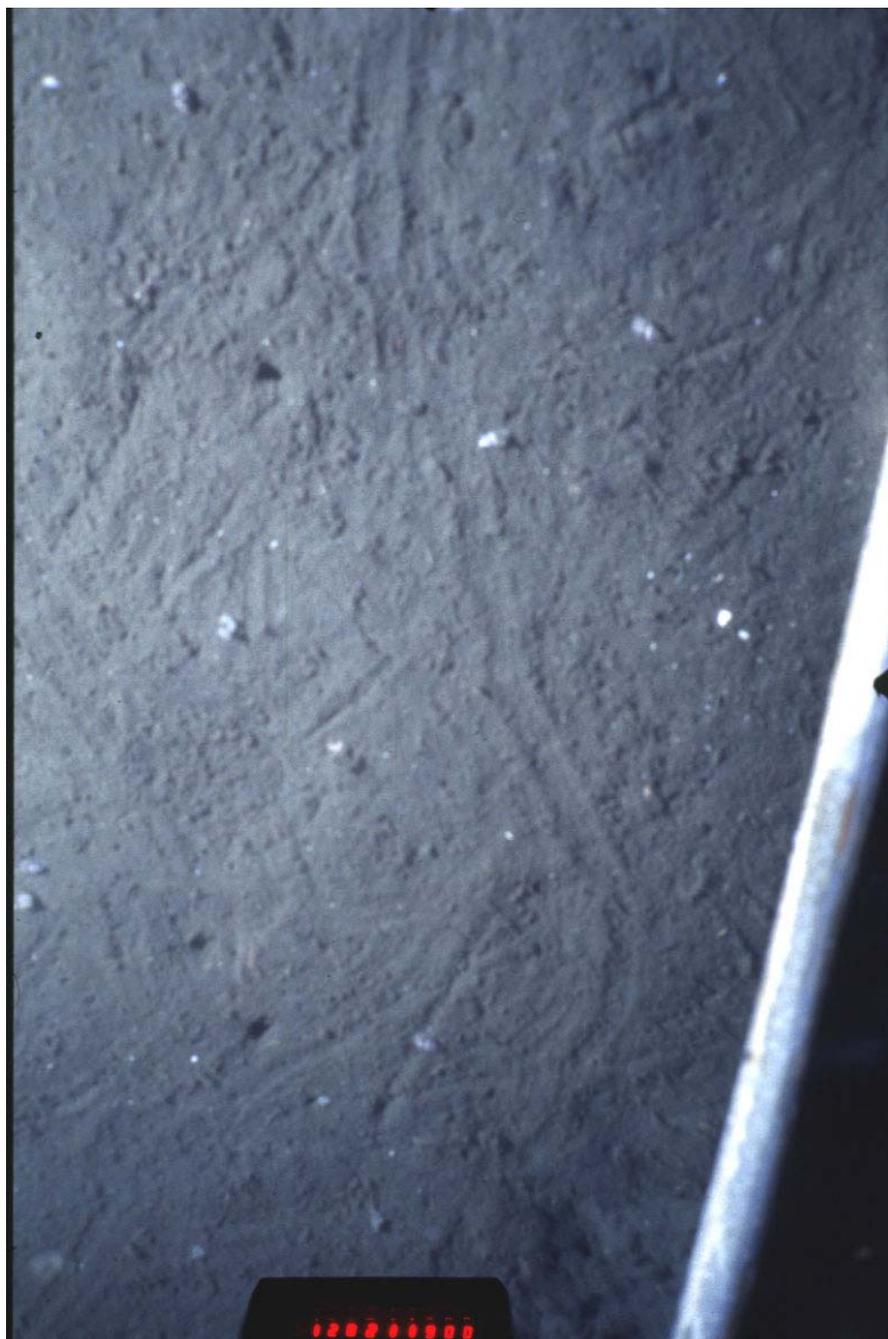
Figure 4.8-2. Evidence of Biological Activity in Cell SU. This plan view image acquired during the baseline survey in Cell SU at outside station O05 provides direct evidence of epifaunal and infaunal activity. The image shows numerous epifaunal organism tracks coupled with white spiraled organisms dotted across the surface. The image also shows small biological burrows. These burrows are estimated to measure approximately 0.5 to 1.5 cm in diameter.

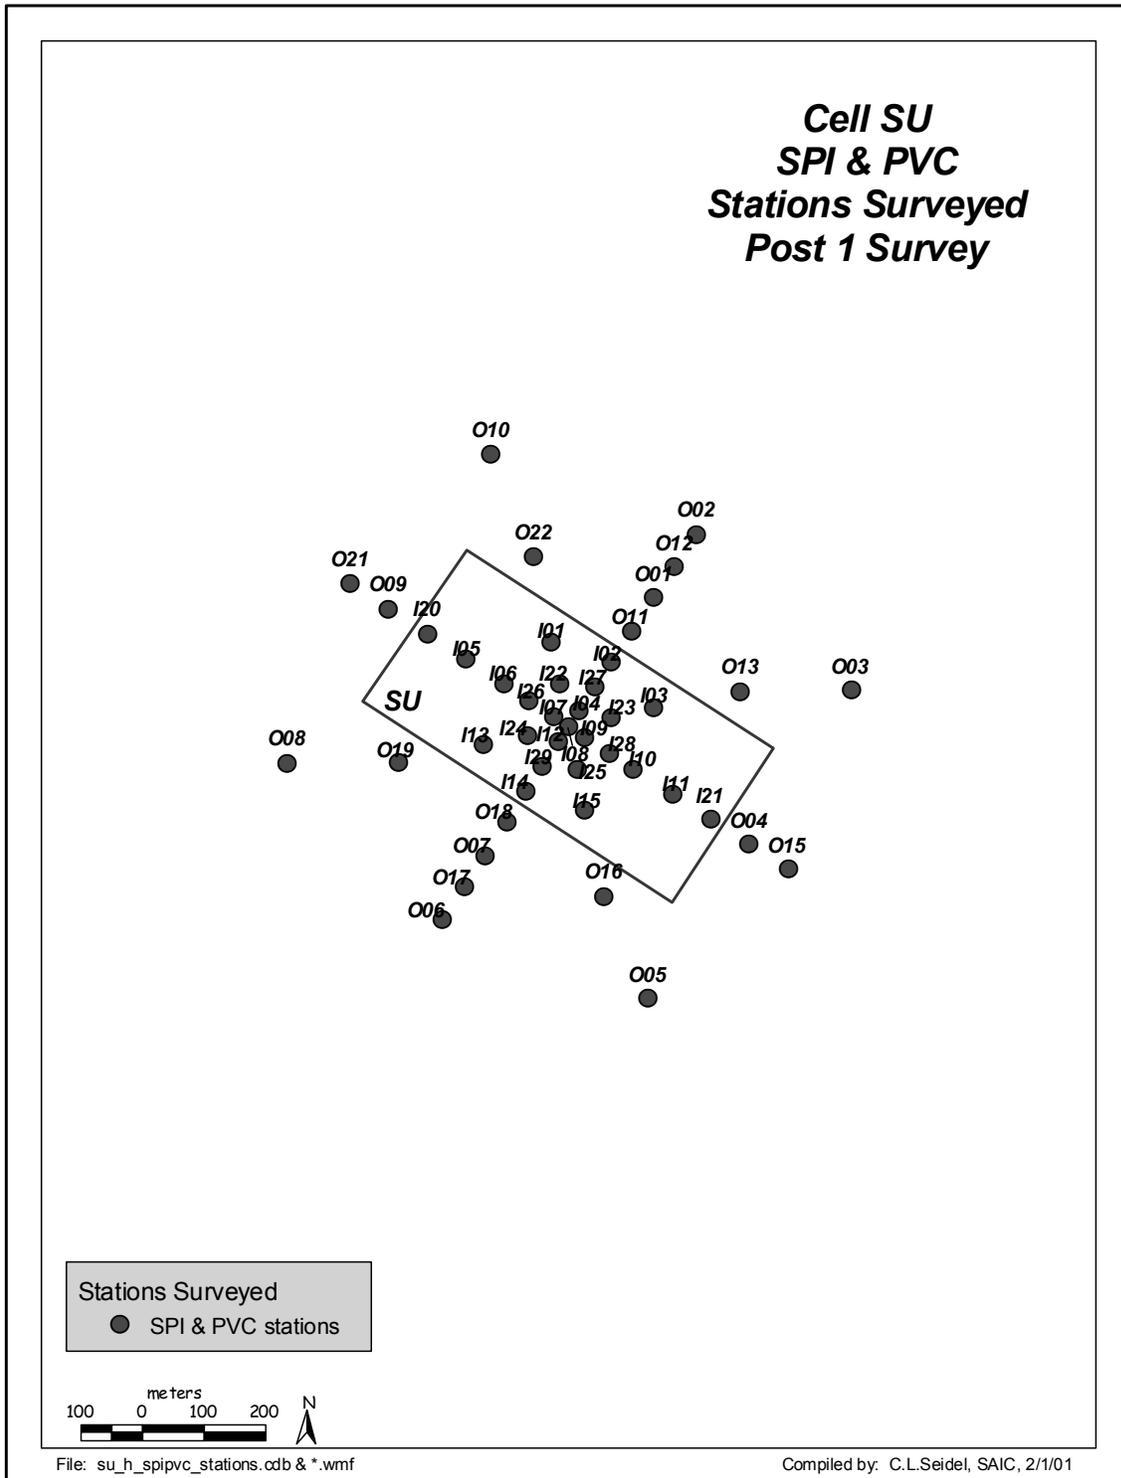
Figure 4.8-3. Cell SU SPI and PVC Stations surveyed – Post 1 survey.

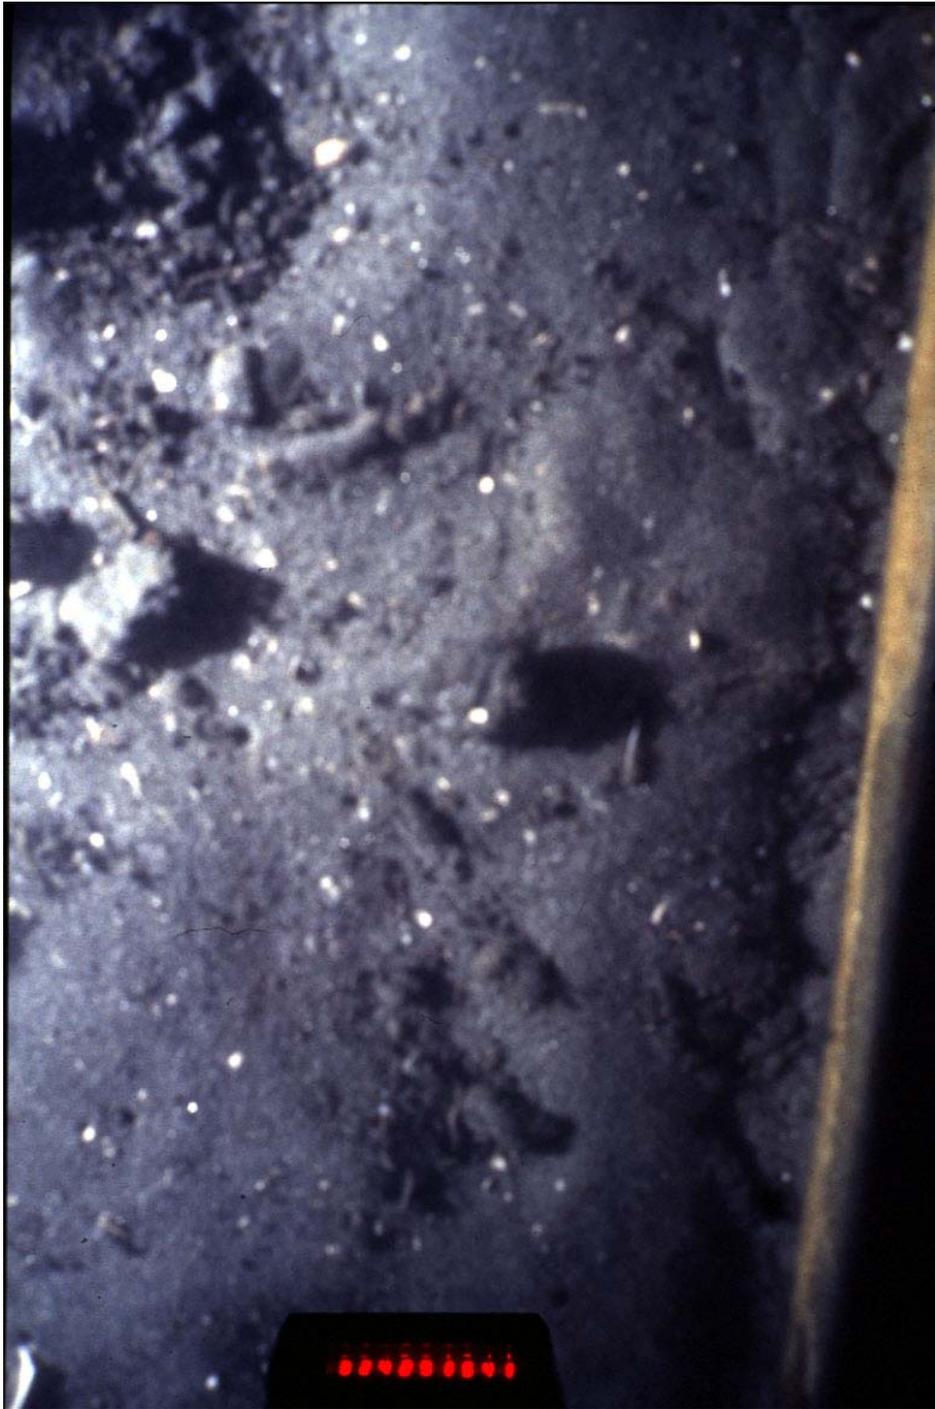
Figure 4.8-9. Atypical sediments in Cell SU. This plan view image acquired at Cell SU outside Station O07 shows atypical surface sediments compared to the fine-grained gray sediments that characterize the cell. Sediments similar to that shown here were also seen at inside Stations I44 and 45.

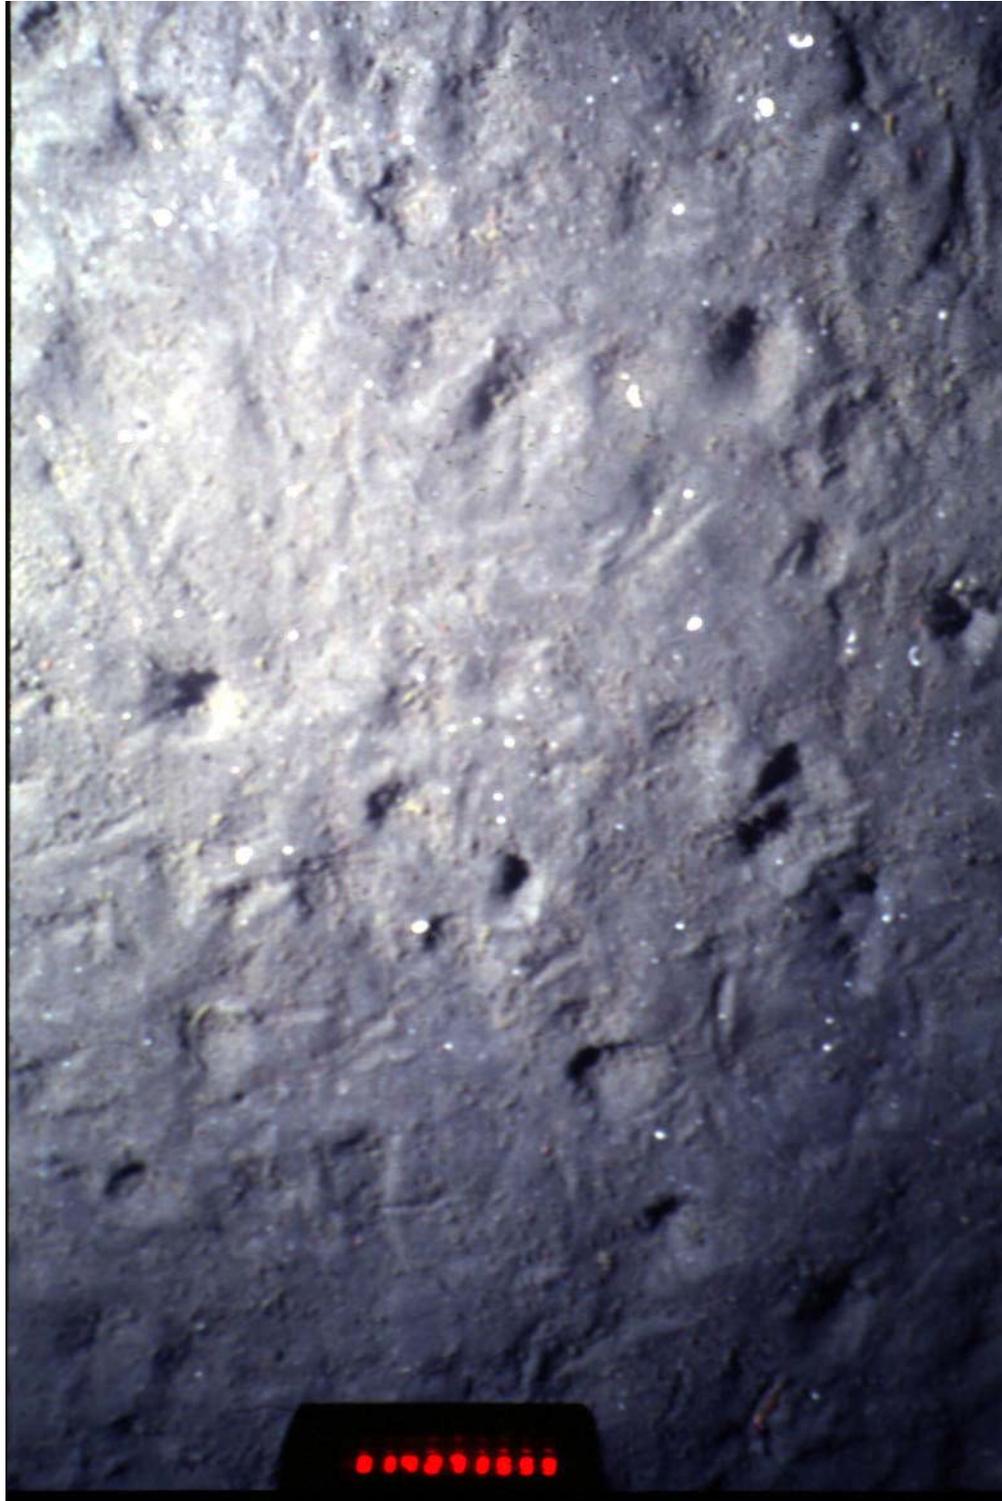
Figure 4.8-13. Re-excavated burrows. The image taken outside Station O71 during the Post 21 survey shows the re-excitation of biological burrows. Denoted by the well-constructed and more pronounced burrow walls.
