**SEA TURTLE
PROTECTION
MEASURES INCLUDING
NEST RELOCATION
AND NEST SUCCESS
EVALUATION FOR THE
NEW PASS
MAINTENANCE
DREDGE AND BEACH
DISPOSAL PROJECT**

A Final Report

Mote Marine Laboratory
1600 Ken Thompson Parkway
Sarasota, FL 34236

Mote Marine Laboratory Technical Report Number 542.

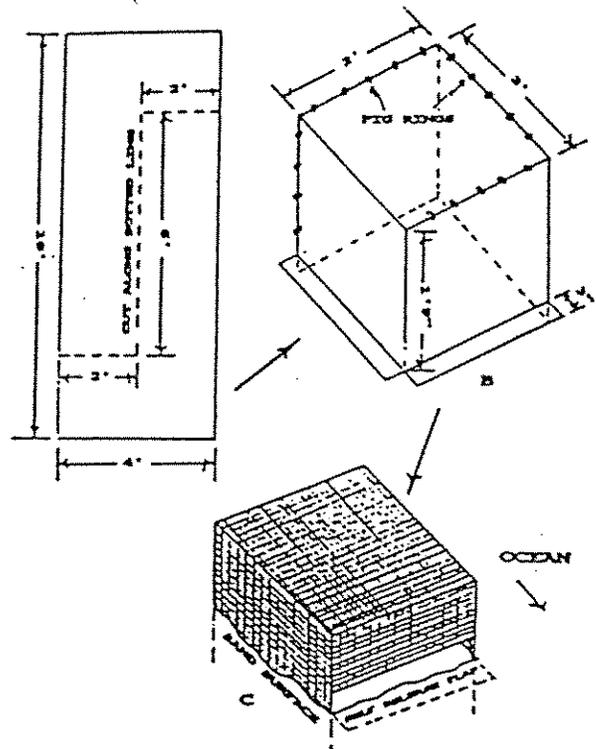
Figure 13. Example of a cage that can be either self-releasing or restraining. The cage is constructed of 1/2" galvanized hardware cloth. It becomes self-releasing if a 3" flap is cut along the entire bottom edge of the seaward side of the cage. This flap is folded outward and downward into a trench dug in front of the cage. The flap is then buried under no more than one inch of sand, leaving a 2" tall space through which hatchlings can escape. Restrained hatchlings are collected through a 6" x 6" flap cut in the top of the screened and secured by wire ties. Cage design courtesy of Ecological Associates, Inc.

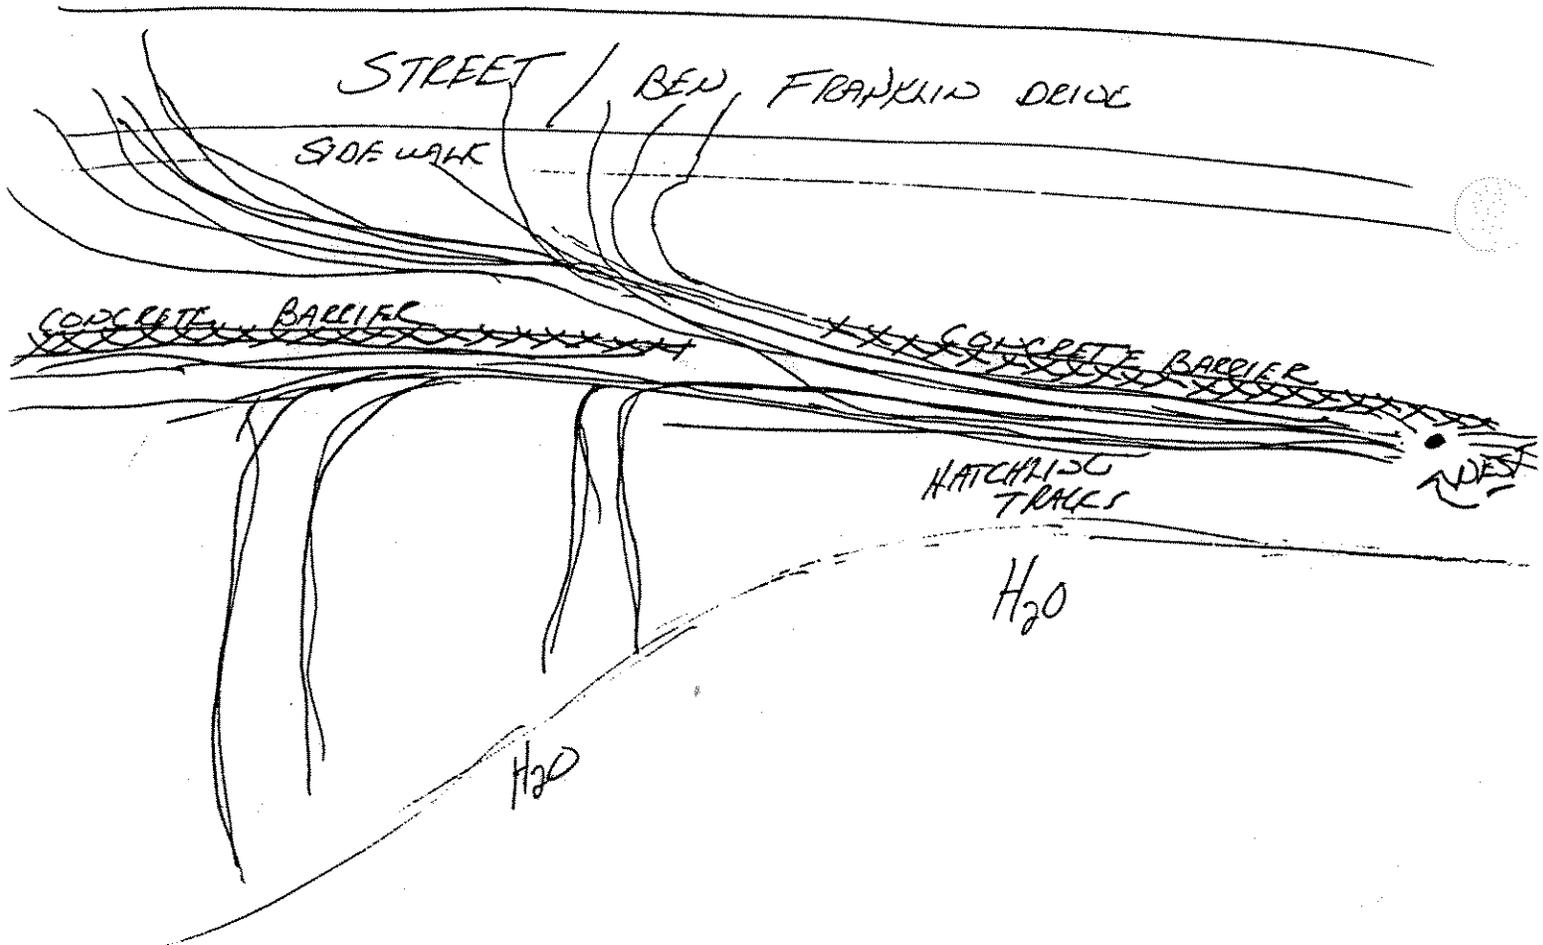
(Sketch on back)

Additional comments please elaborate and use back if necessary: THIS WAS AN UNMARKED NEST ORIGINALLY RECORDED AS A FC. HATCHLINGS EMERGED - ALL HEADS N + S RATHER THAN TO THE WATER. APPROXIMATELY 10-15 TRACES TO H.O. FACTOR DUNE BEACH.
Coordinate
Signature of Observer: _____ Date: 8/11/97

STREET / BEN FRANKLIN DRIVE

SIDE WALK

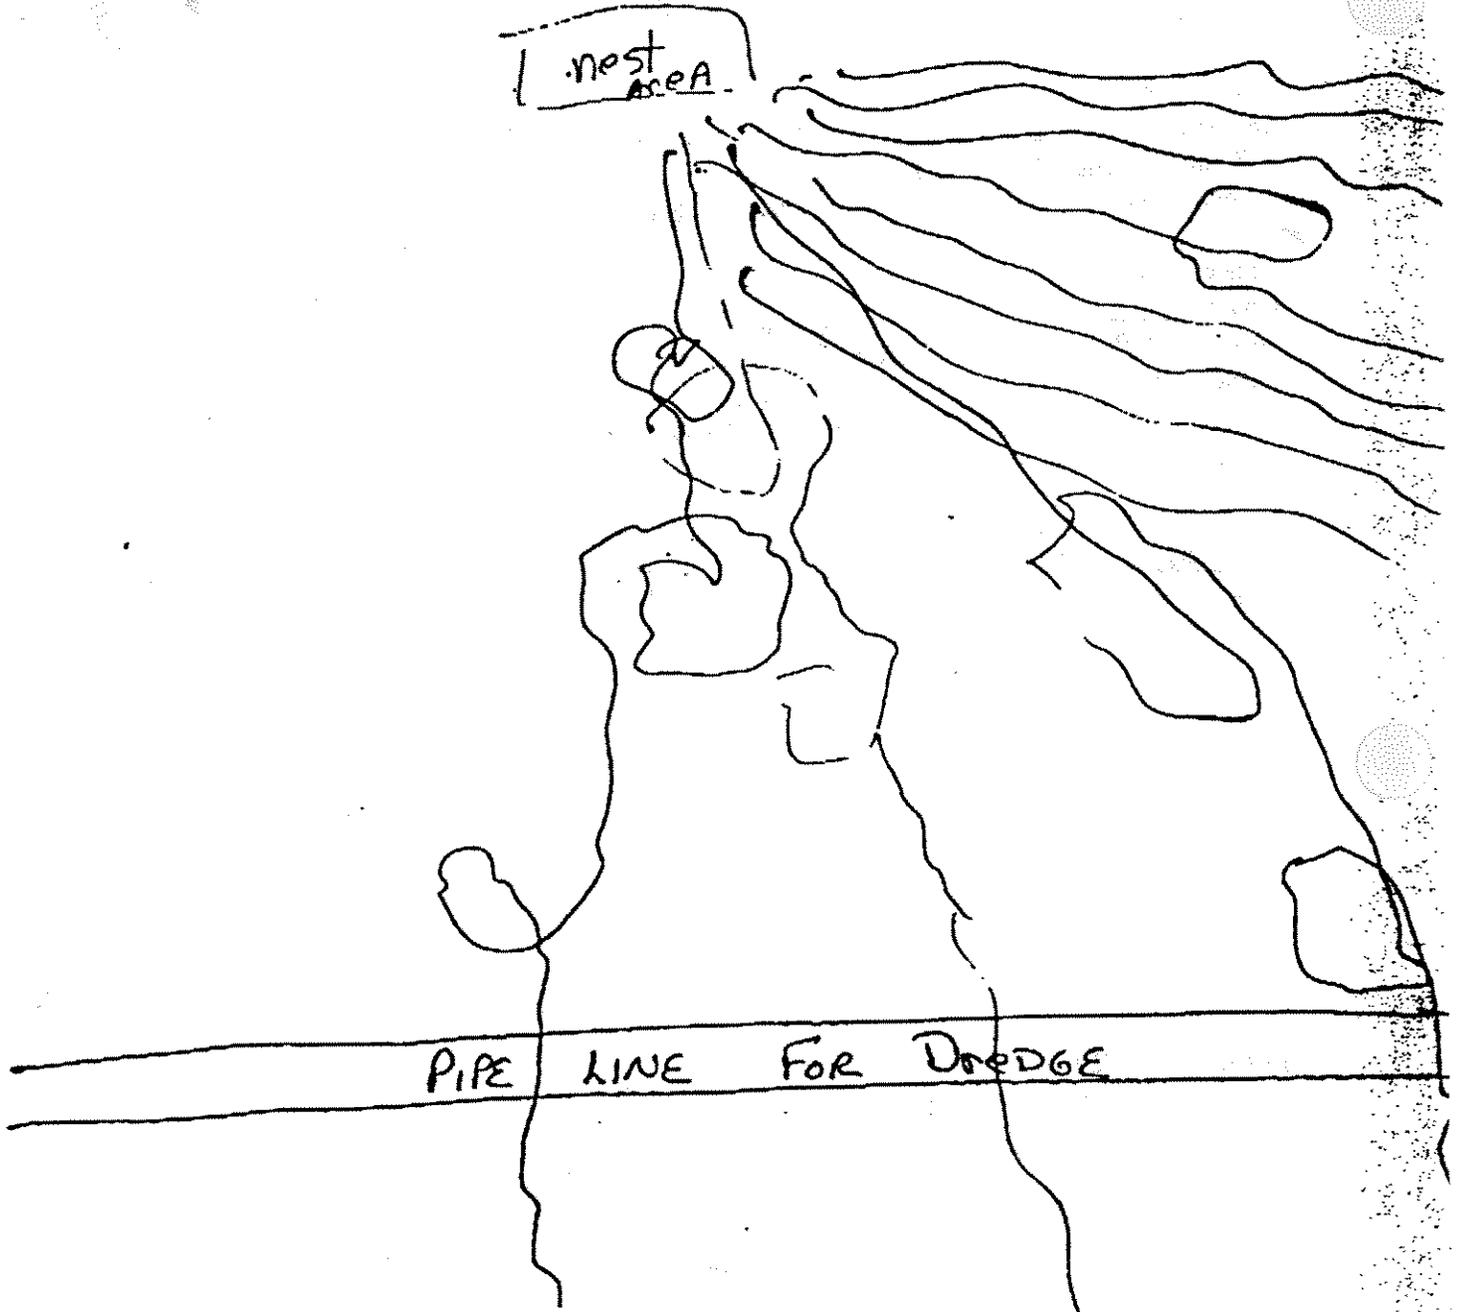
FC #20

Hatchlings wandered around on beach
 headed S toward bright lights on Dredge
 but eventually all made it to water - followed
 all crawls & checked beach carefully -
 no turtles found - appeared to crawl under

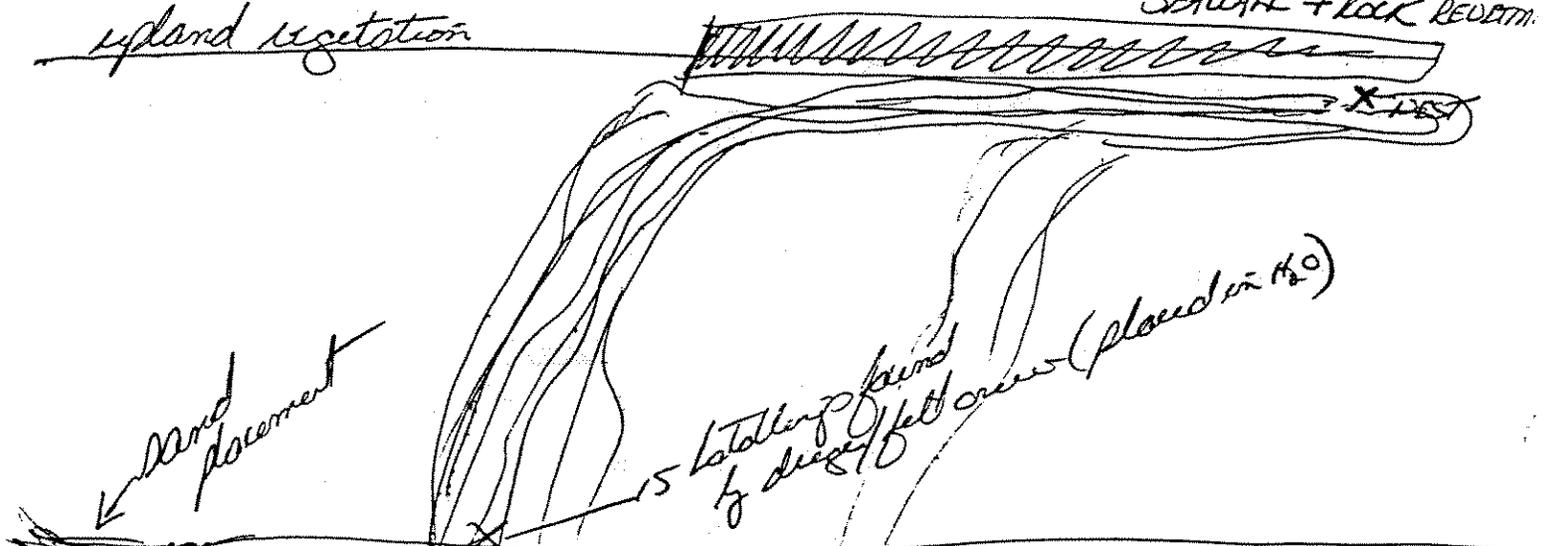
upland vegetation

SEAWALL + ROCK REDEM.

DREDGE PIPELINE

dredge equipment
including bulldozers
& more
