REPORT: POSSIBLE DREDGE / WHALE COLLISION
Brunswick Harbor Entrance Channel
24 February 2005

Christopher K. Slay
Coastwise Consulting
173 Virginia Avenue
Athens, GA 30601

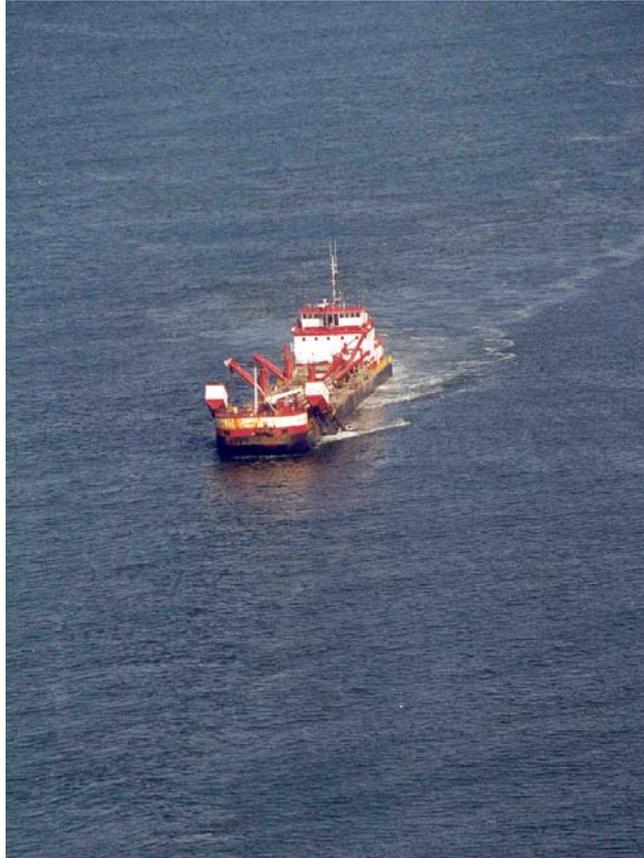
Dredge Bayport, similar to the RN Weeks

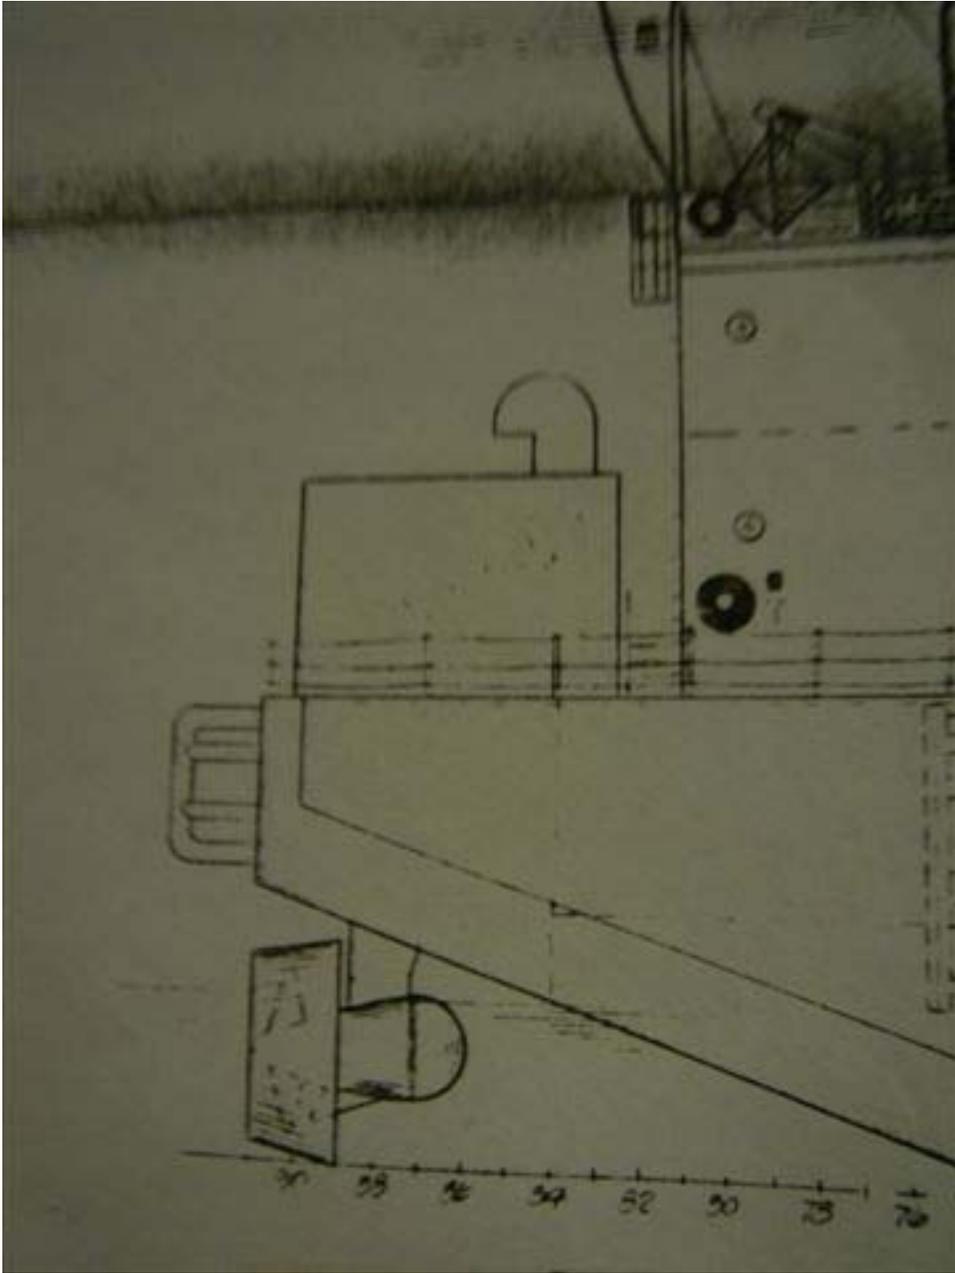
Kort Nozzle Surrounding Propeller on the “Z-Drive” of the *RN Weeks*

The superstructure of the Weeks is situated at the stern and the mate felt that shudder originated from the area of the "Z-drive" propulsion system. If indeed that hit the whale, the Kort nozzle enshrouding the propeller would most likely be the point of contact. (see Attachment).
