**SECOND POST-NOURISHMENT MONITORING SURVEY
OF NEARSHORE HARD BOTTOM HABITATS
SOUTH OF FORT PIERCE INLET
FORT PIERCE, FLORIDA**

26 July 2002

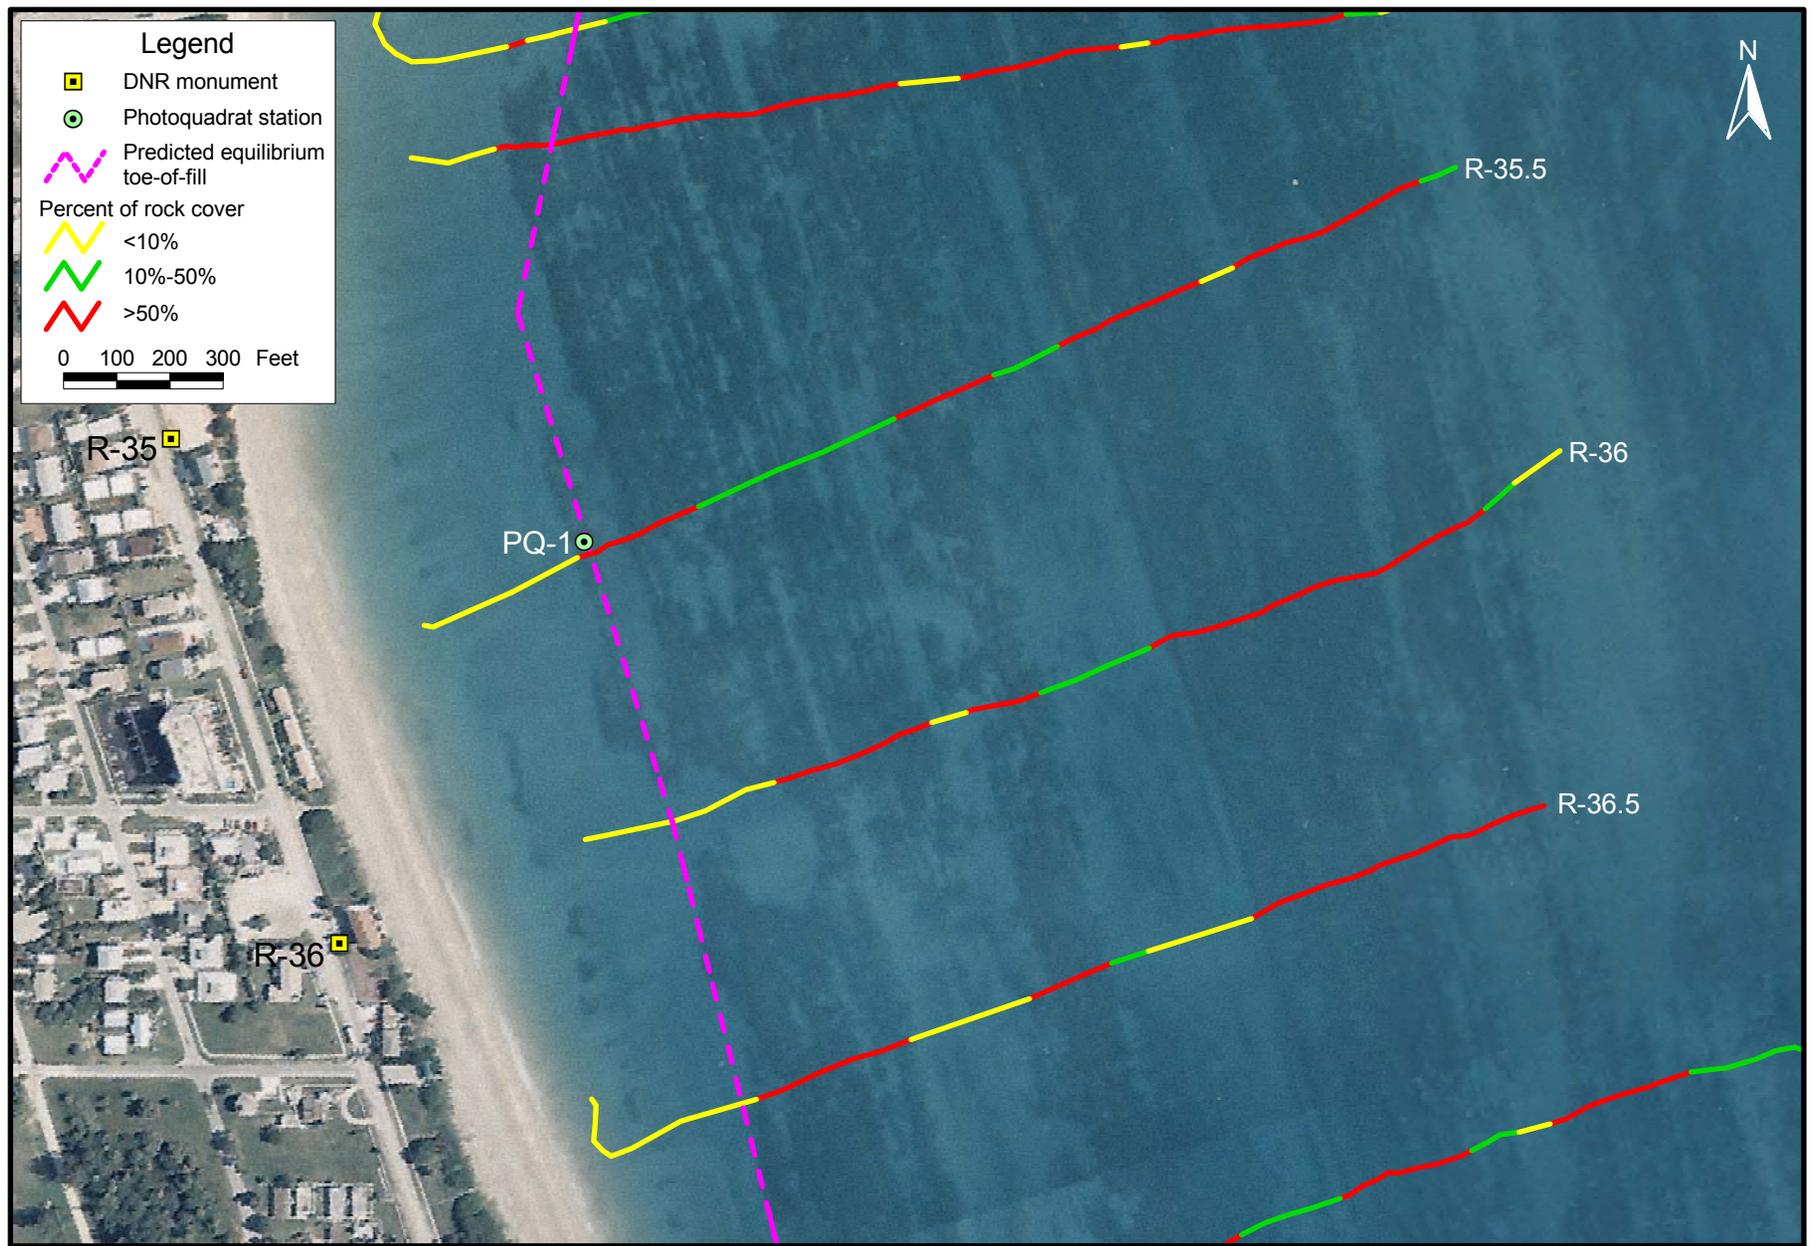
Figure 3. Post-plot Transects R-35.5, R-36, and R-36.5 with identified rock substrate classifications superimposed over 2001 aerial image.

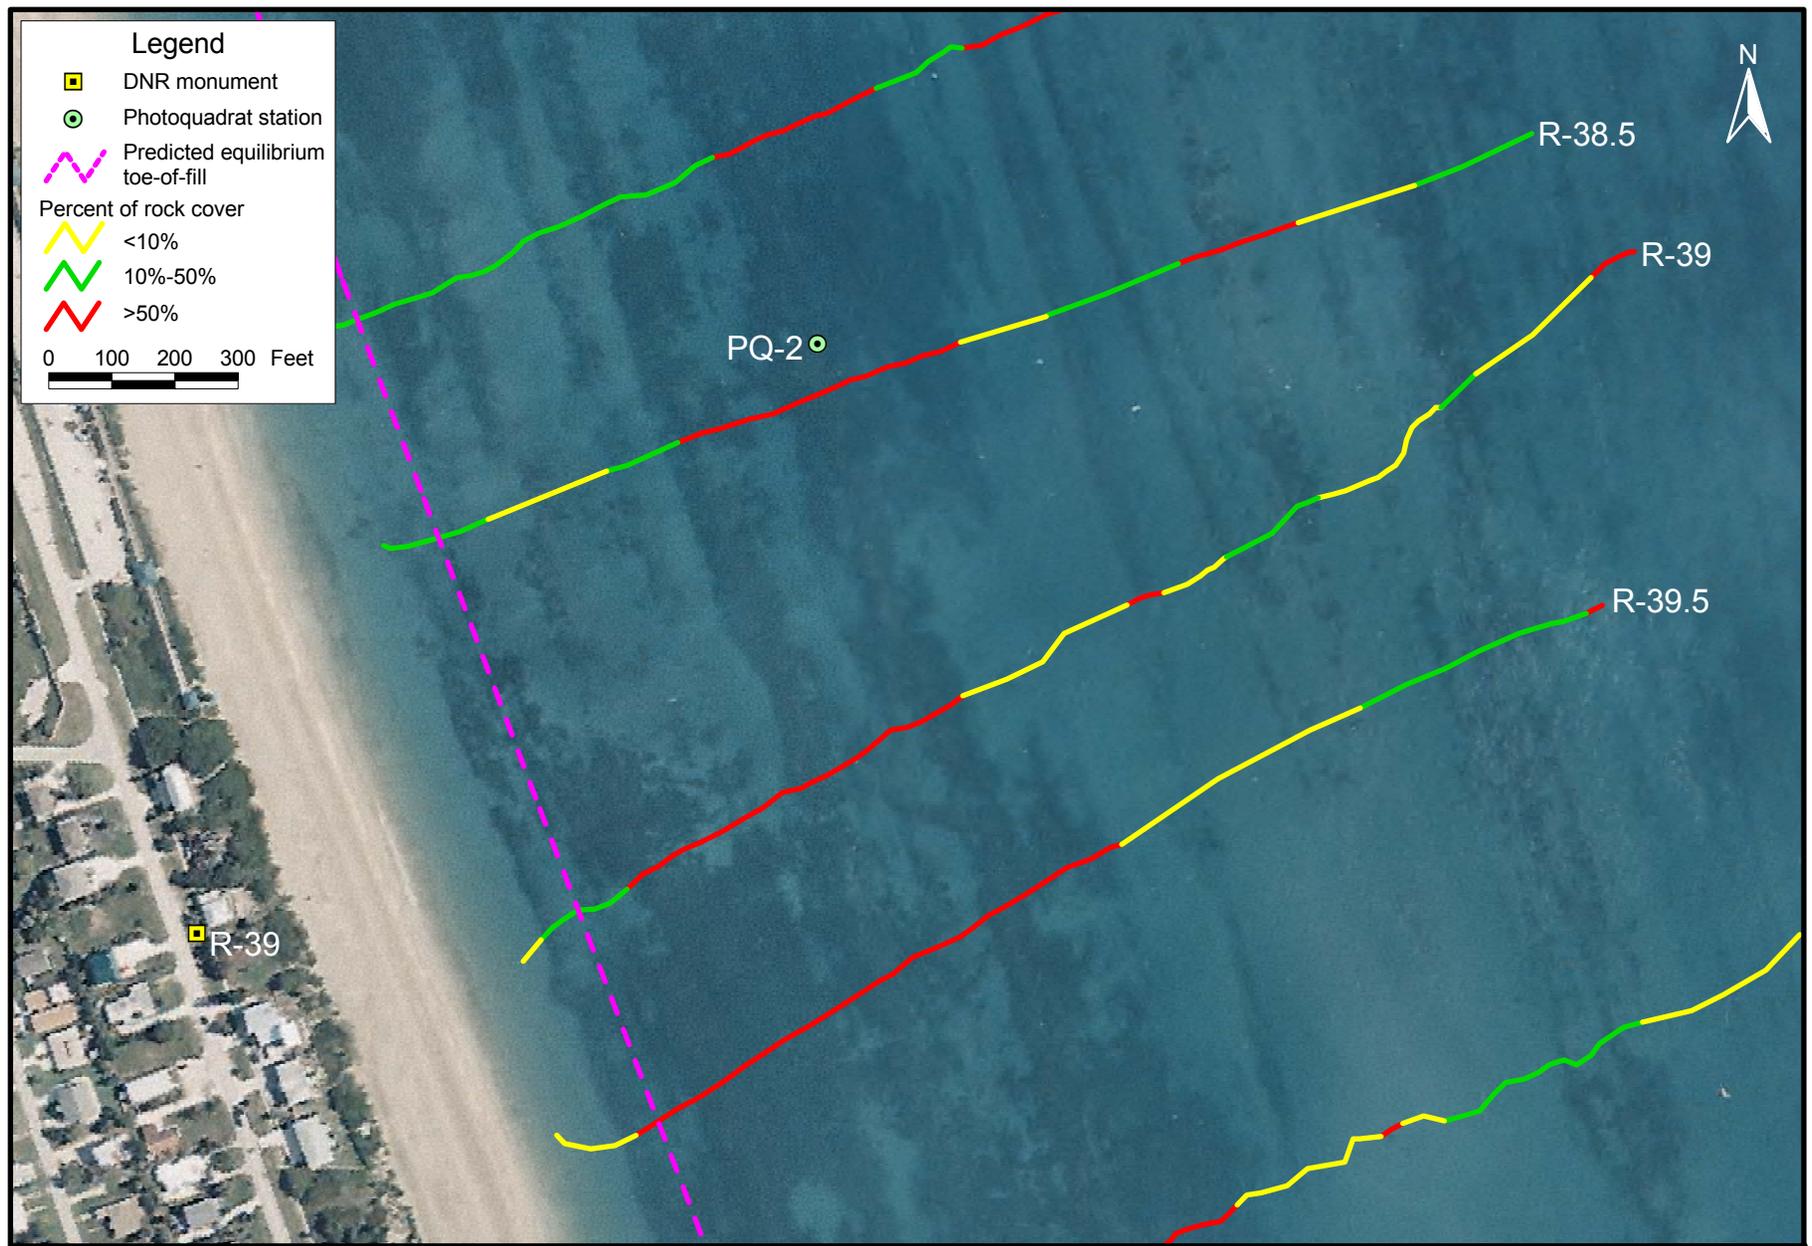
Figure 5. Post-plot Transects R-38.5, R-39, and R-39.5 with identified rock substrate classifications superimposed over 2001 aerial image.

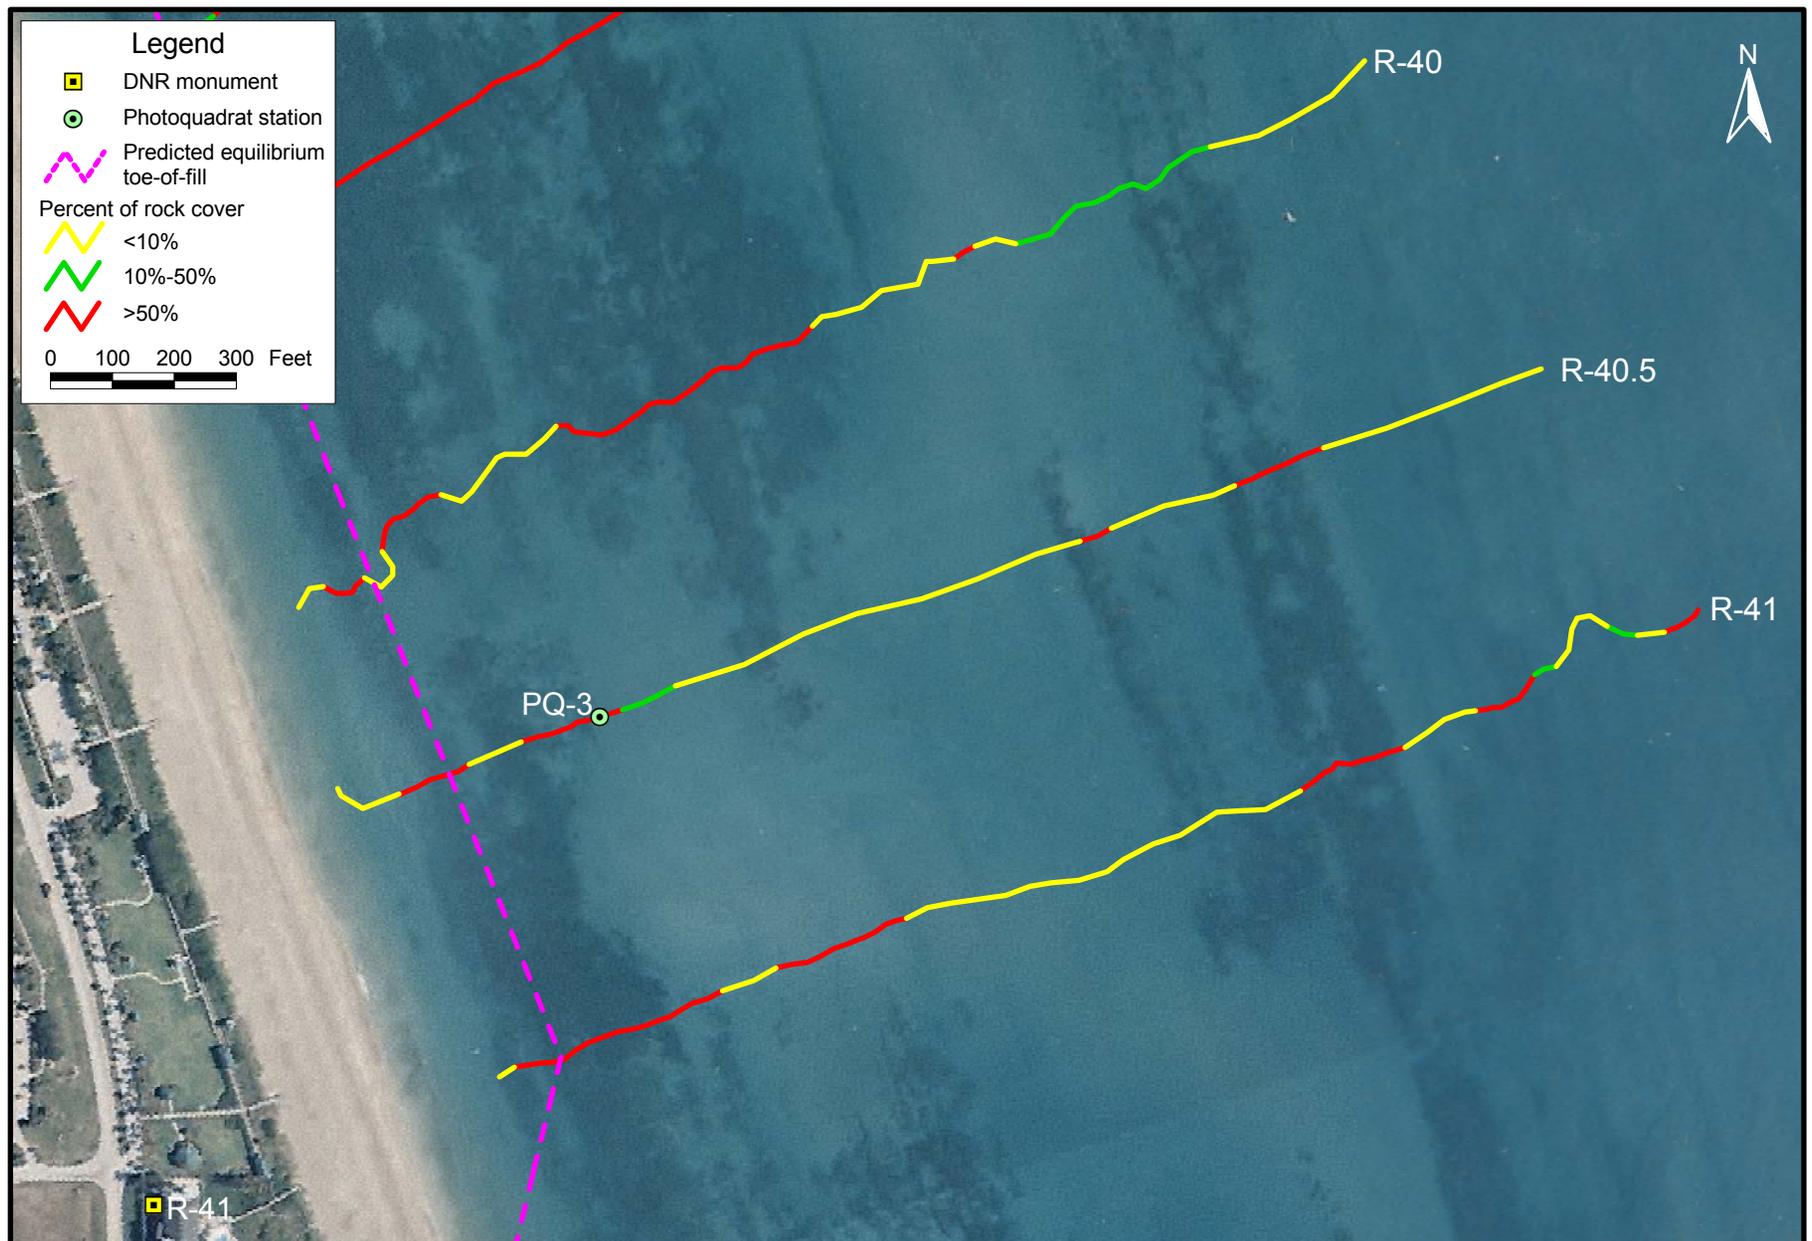
Figure 6. Post-plot Transects R-40, R-40.5, and R-41 with identified rock substrate classifications superimposed over 2001 aerial image.

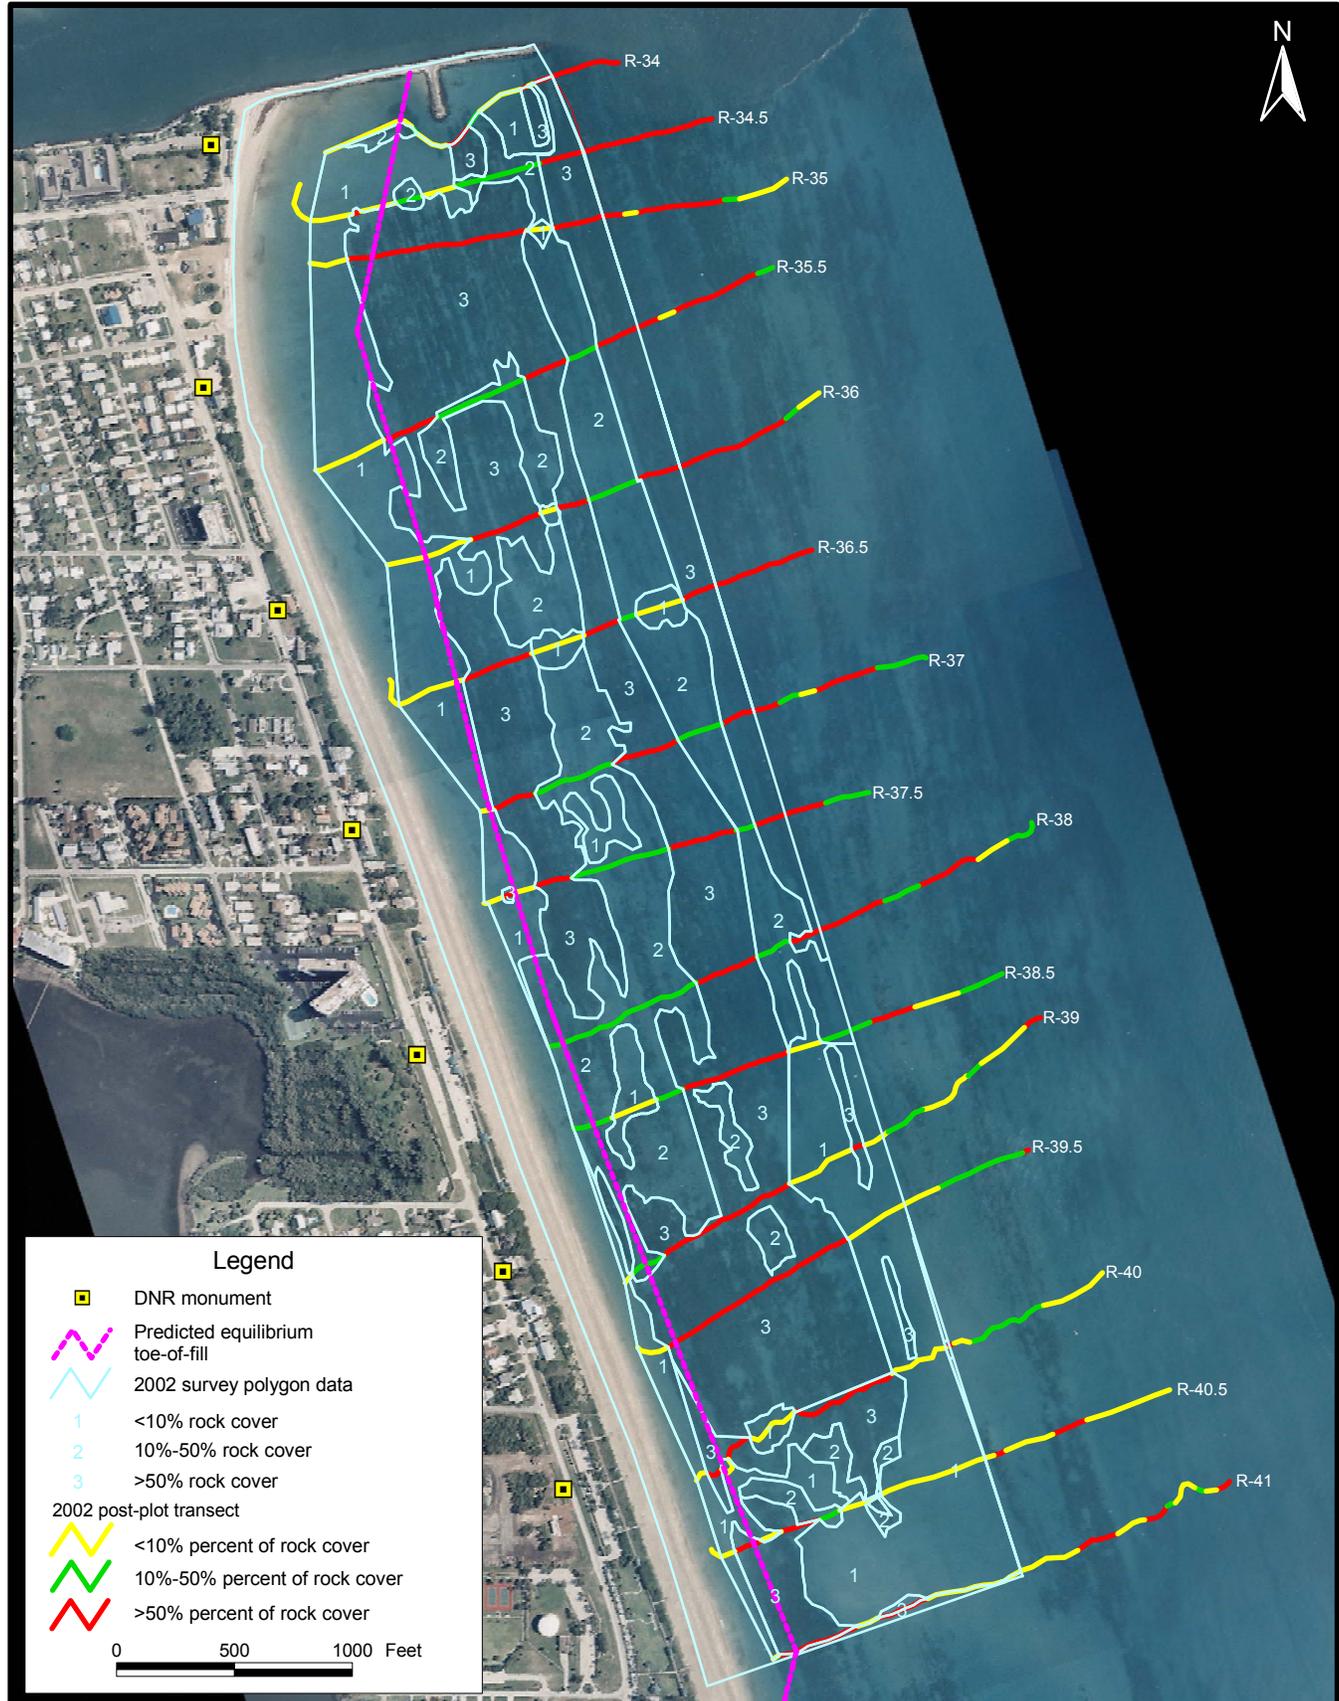
Figure 7 shows the May 2002 substrate classification polygons superimposed on 2001 aerial images. **Table 4** presents a summary of substrate classification areas from polygon data for the 2002 post-nourishment survey. The 2002 substrate classification polygons indicate that substrate with less than 10% exposed rock (42.1%) was the dominant substrate in the survey area. Substrate with greater than 50% exposed rock comprised approximately 38.6% of the total area surveyed. The substrate with the lowest estimated exposed rock cover was 10% to 50% exposed rock (19.3%). The percent cover of exposed rock substrate from transect and polygon data is presented in **Table 3**. The percent cover results of exposed rock substrate from transect and polygon data generally agree. The slight difference in the May 2002 results between the transect data and polygon data (**Table 3**) was possibly due to the interpretation of substrate classification between transects.

Figure 7. May 2002 rock substrate classification polygons with post-plot transects superimposed over the 2001 aerial images.

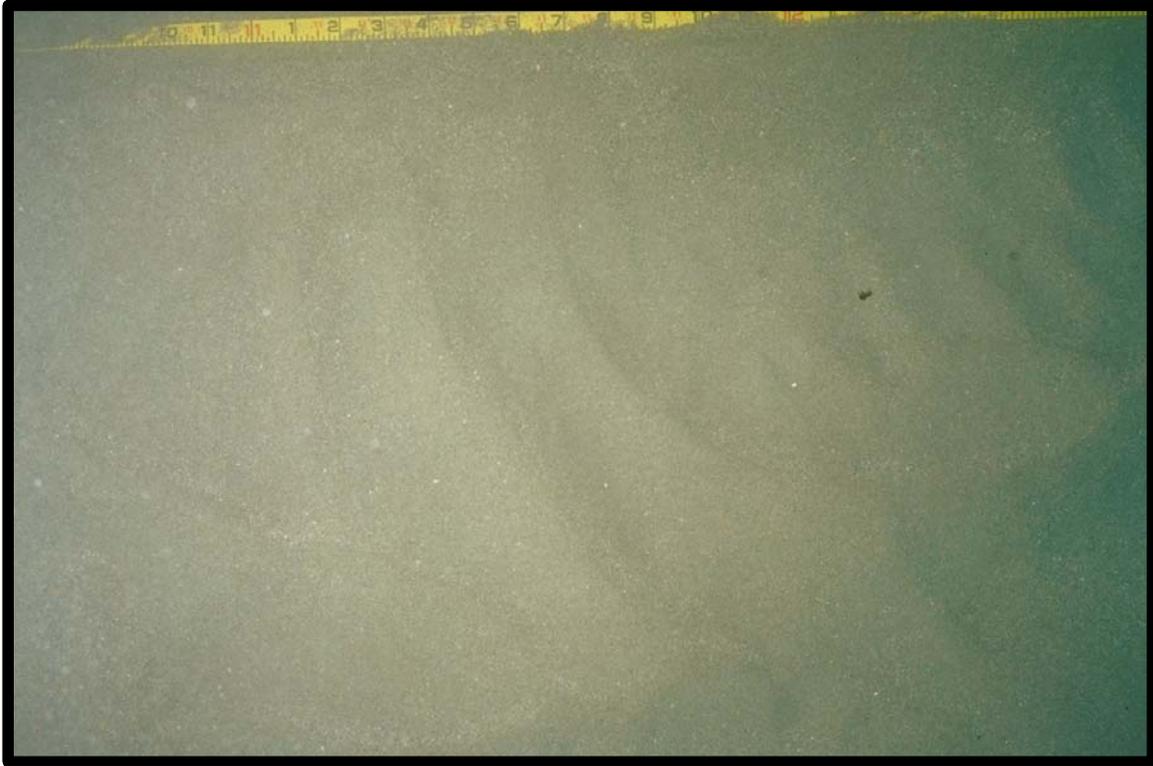
Photo 1. Quantitative image of sand bottom at photo quadrat station 1.

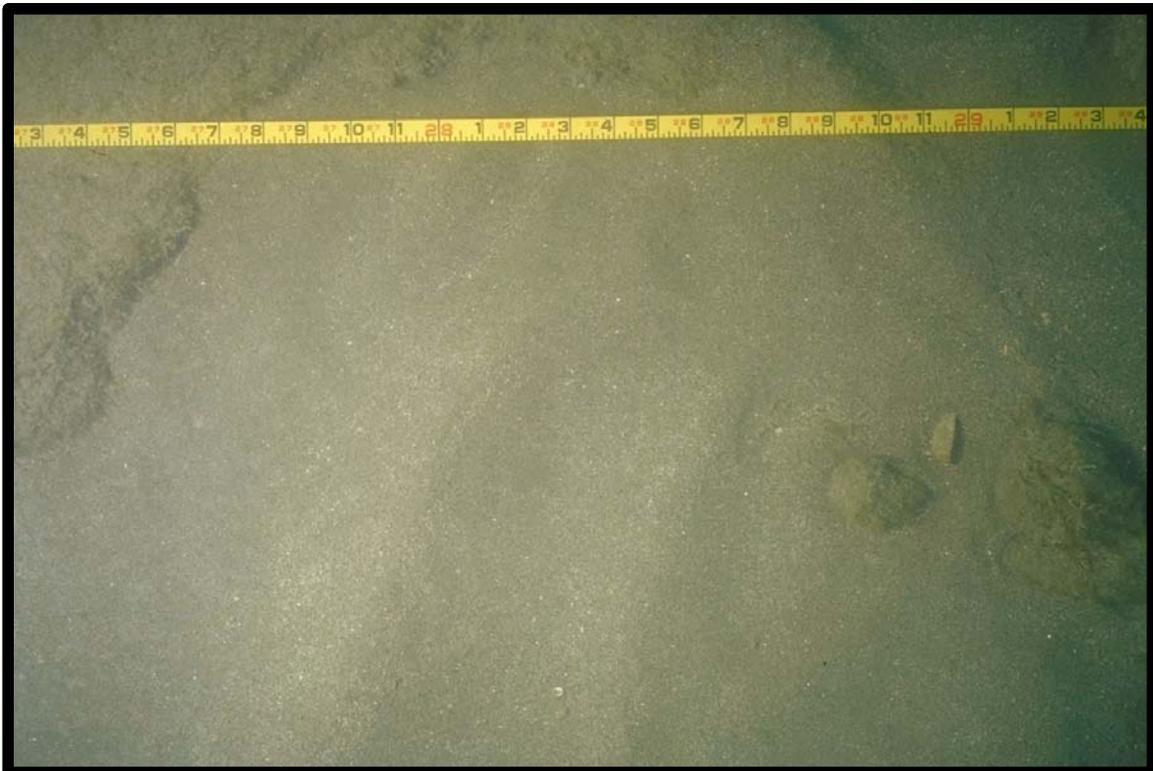
Photo 2. Quantitative image of sand veneered hard bottom at photo quadrat station 1.

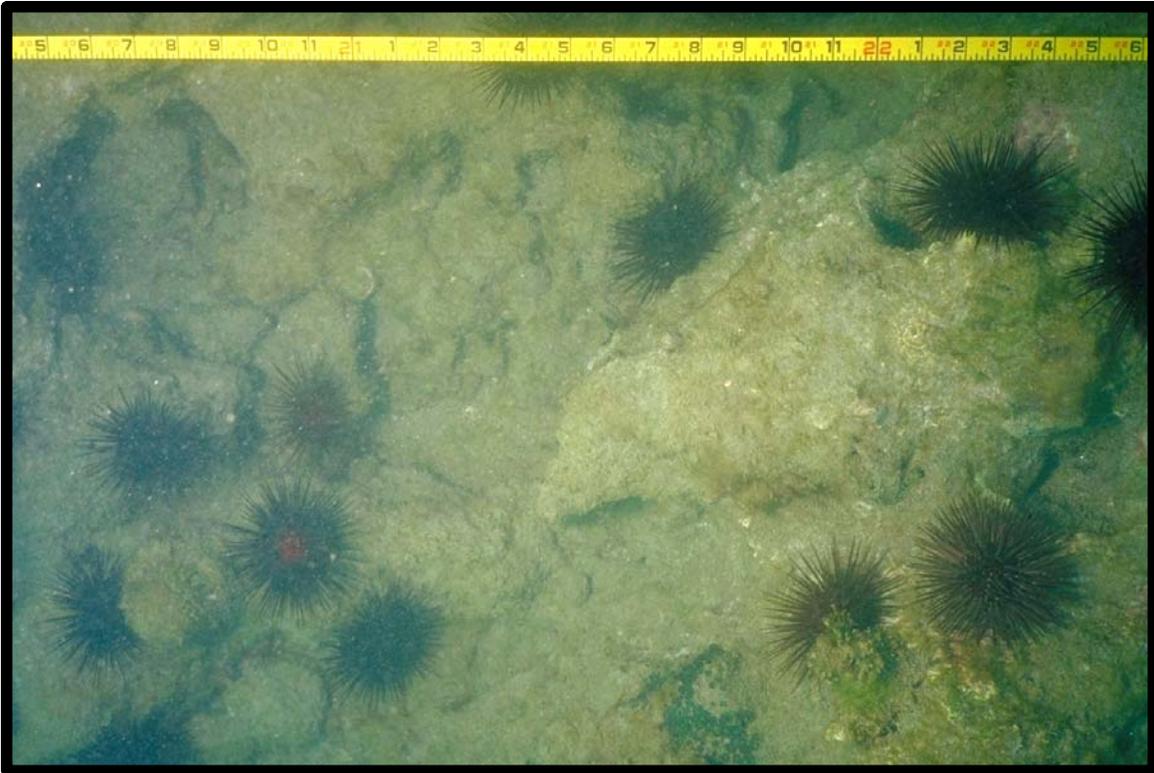
Photo 3. Quantitative image of purple sea urchins (*Arbacia punctulata*) on exposed hard bottom at photoquadrat station 2.

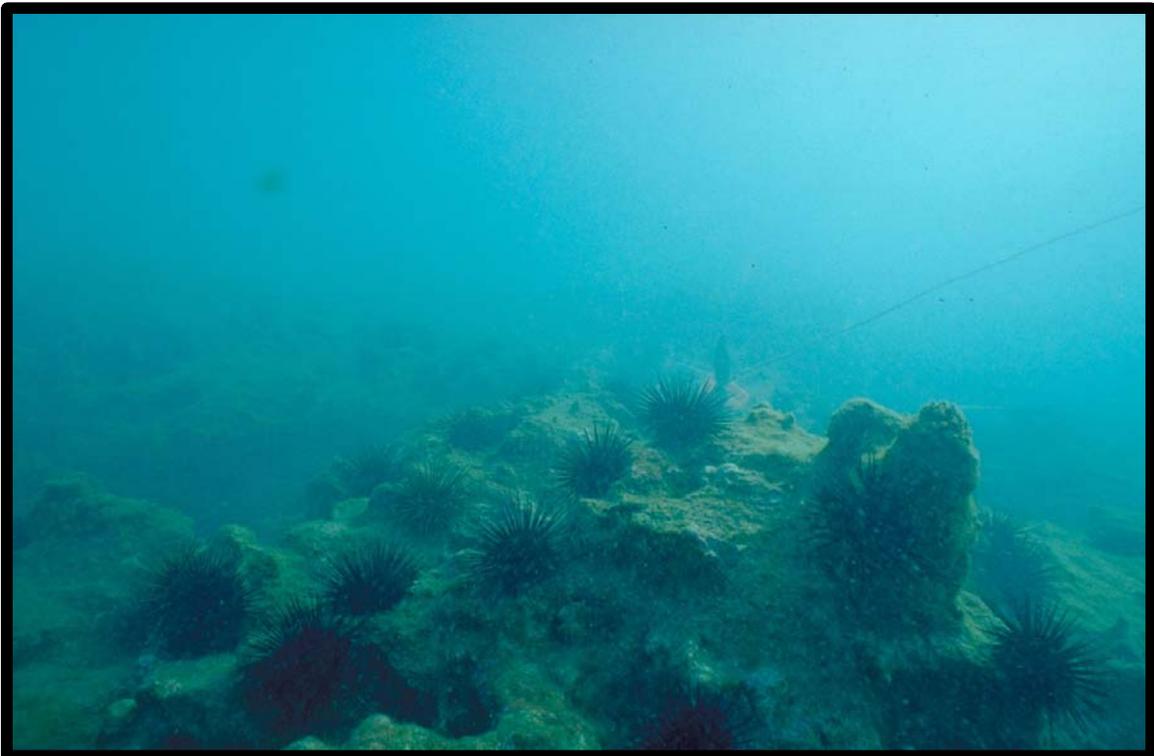
Photo 4. Qualitative image of purple sea urchins (*A. punctulata*) on exposed hard bottom near photoquadrat station 2.

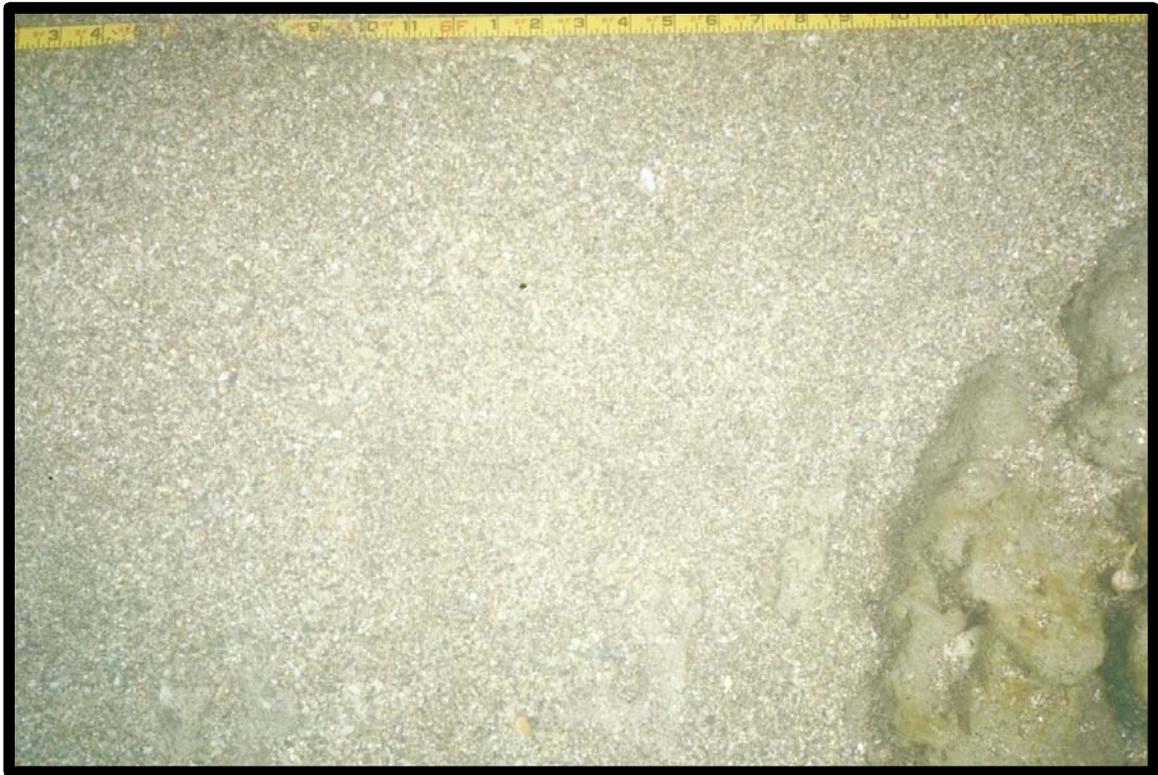
Photo 5. Quantitative image of sand bottom with recently exposed hard bottom at photoquadrat station 3.

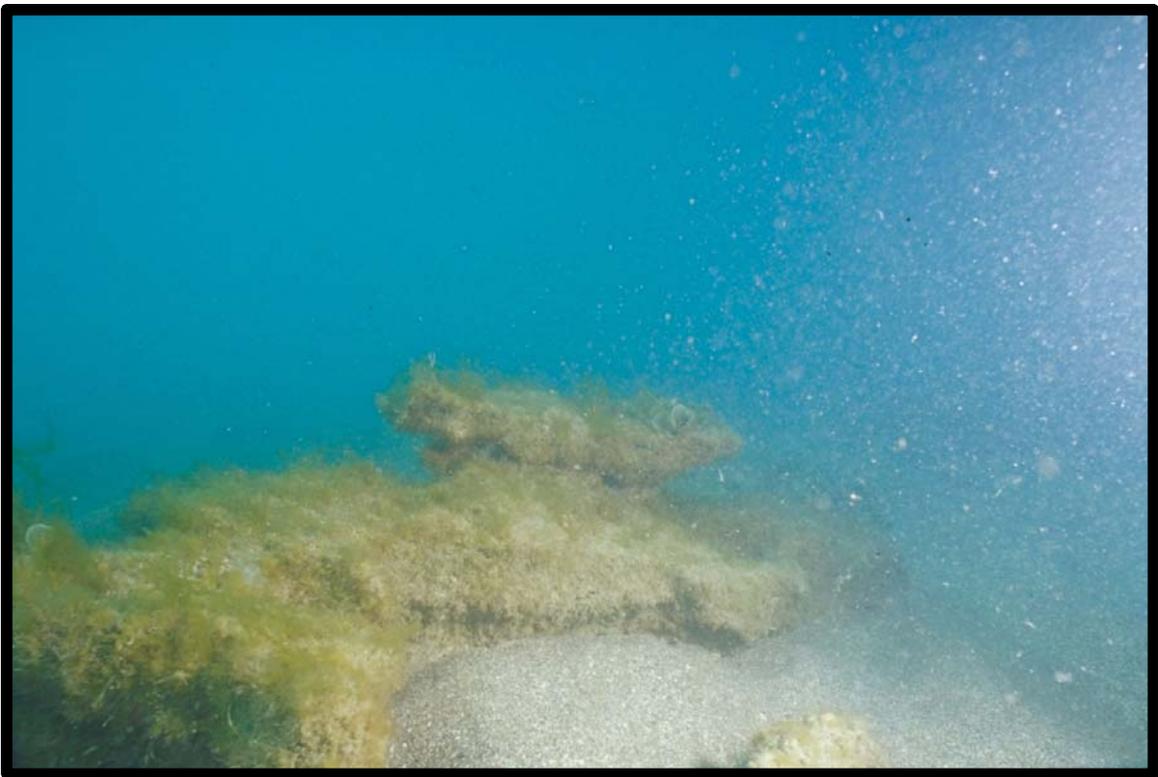
Photo 6. Qualitative image of exposed hard bottom with an unidentified filamentous green algae near photoquadrat station 3.

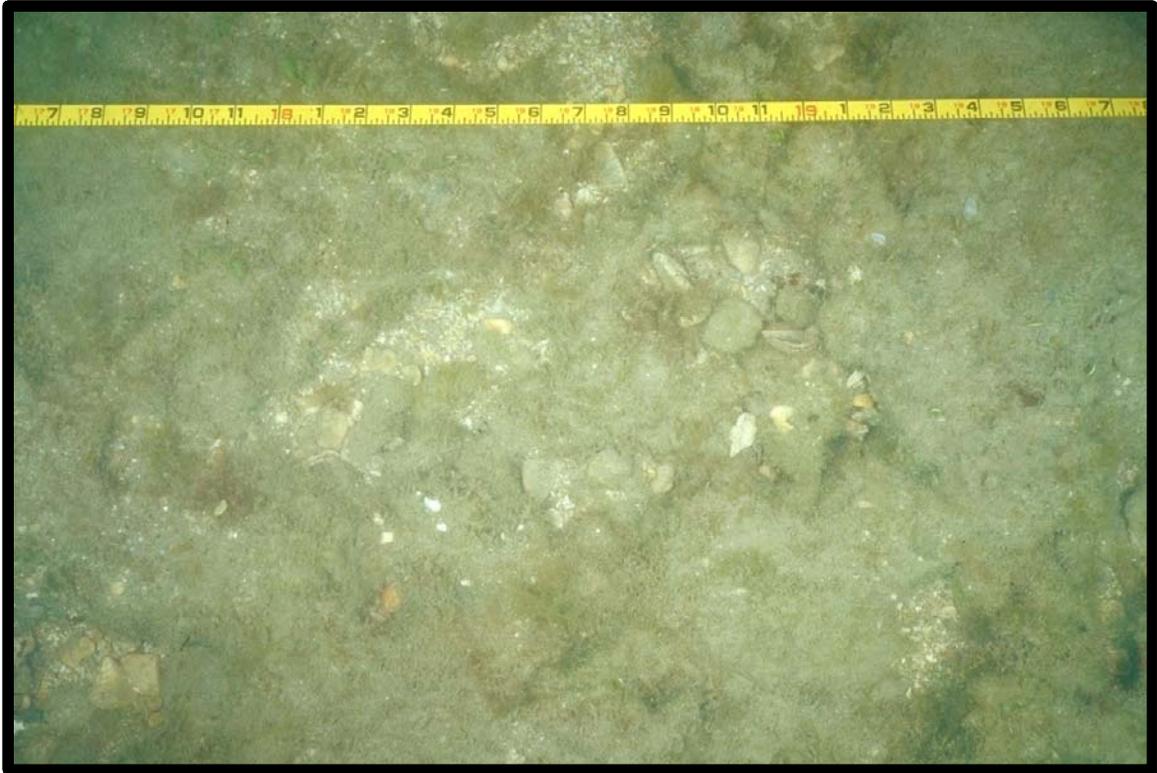
Photo 7. Quantitative image of exposed hard bottom with slight sand veneer at photoquadrat station 4.

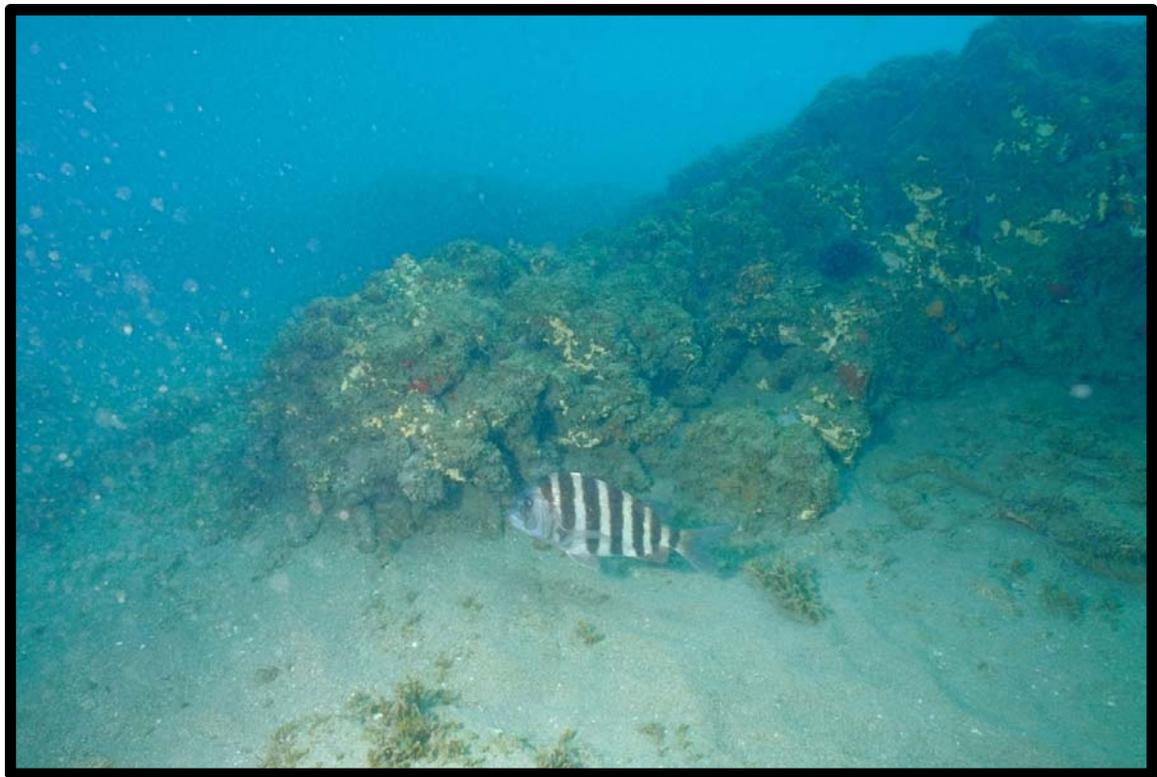
Photo 8. Qualitative image of a sheephead (*Archosargus probatocephalus*) over sabellariid worm rock (*Phragmatopoma lapidosa*) with purple sea urchins (*A. punctulata*) and unidentified ascidians near photoquadrat station 4.

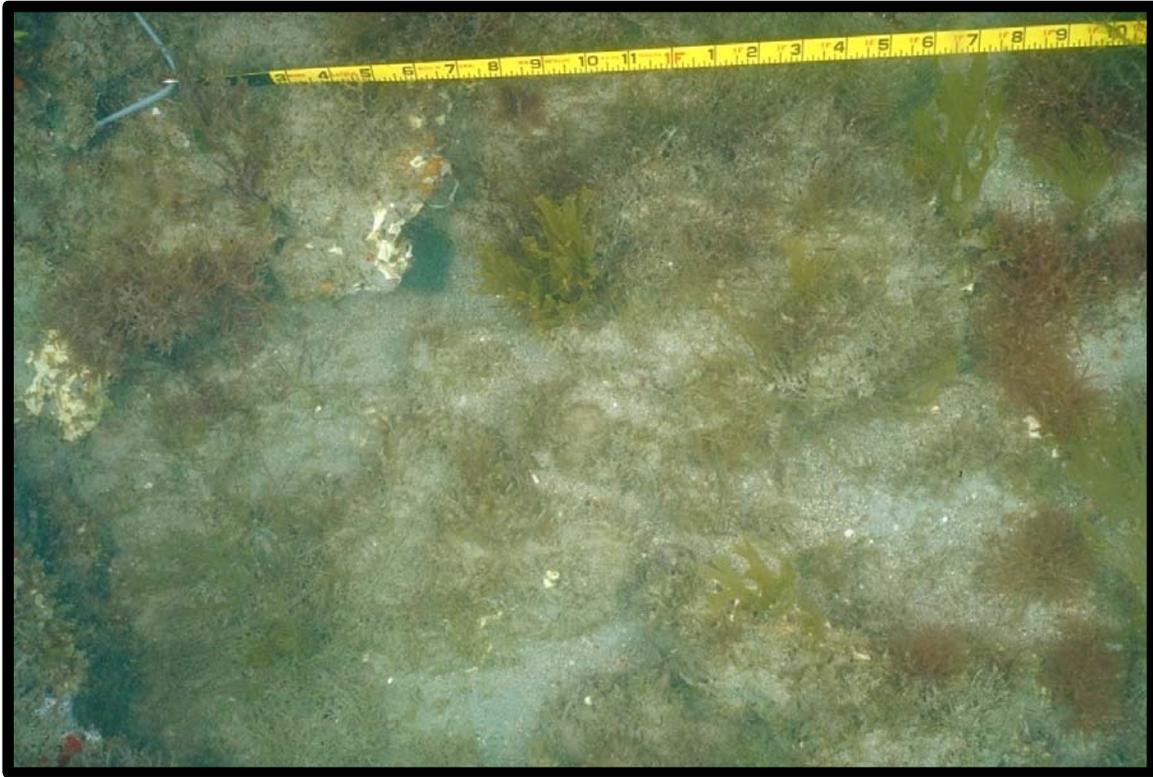
Photo 11. Quantitative image of exposed hard bottom with dense algal cover and unidentified colonial ascidians at photoquadrat station 6.

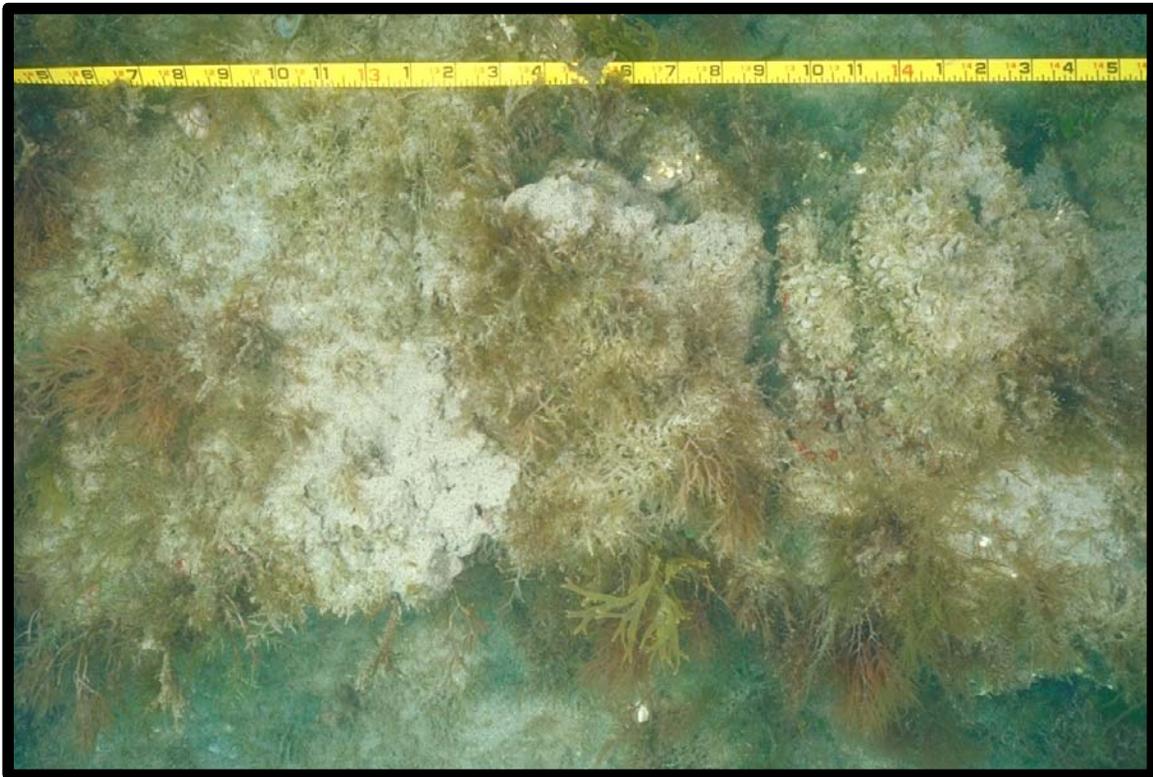
Photo 12. Quantitative image of exposed hard bottom with dense algal cover, unidentified colonial ascidians, and sabellariid worm rock (*P. lapidosa*) at photoquadrat station 6.

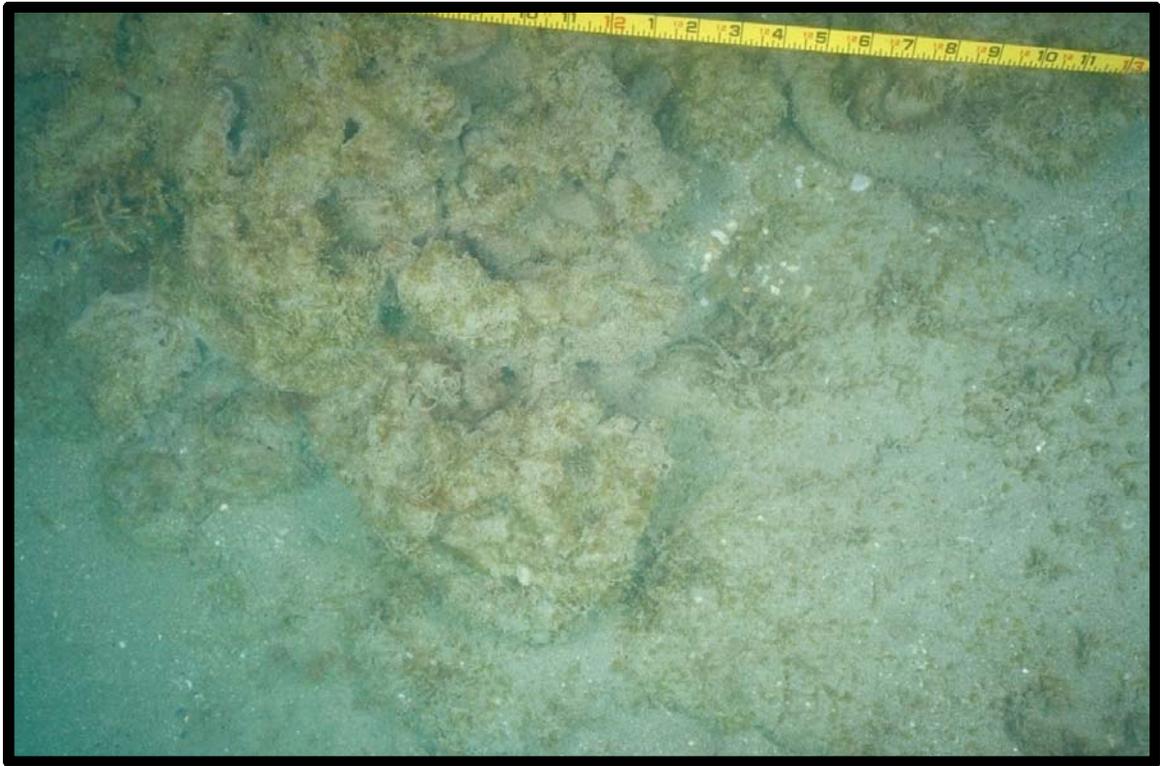
Photo 13. Quantitative image of sabellariid worm rock (*P. lapidosa*) with slight sand veneer at photoquadrat station 7.

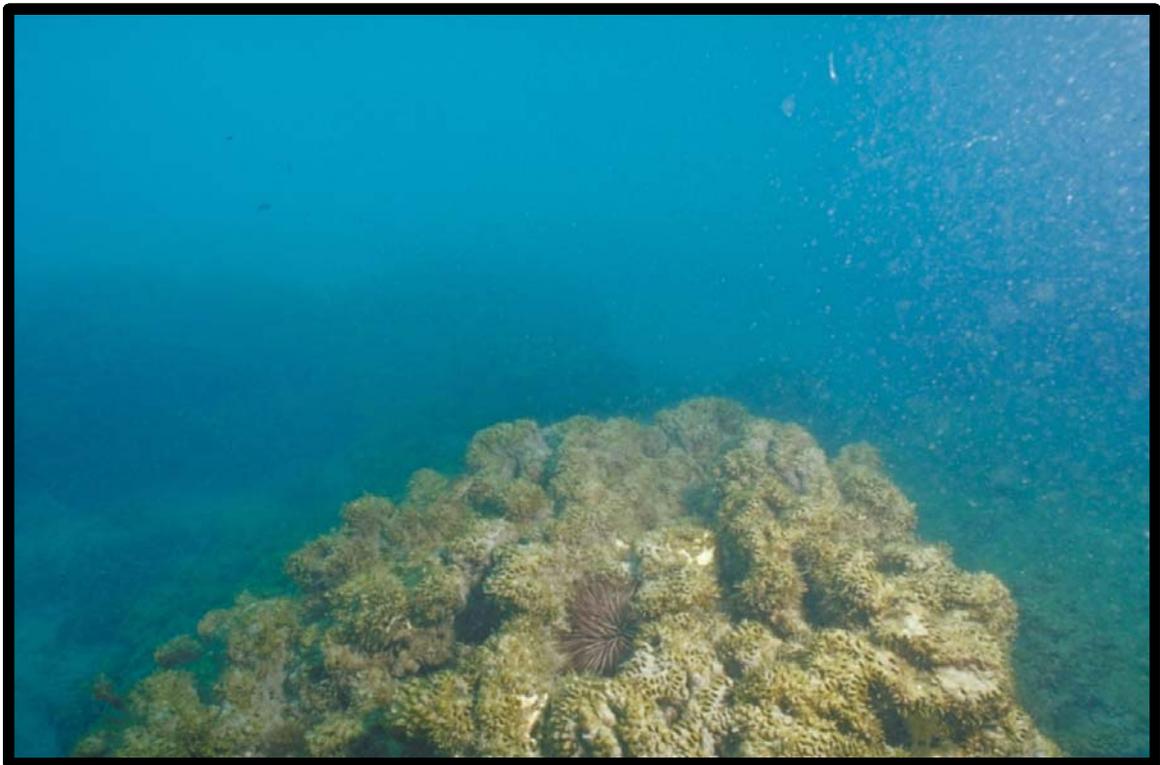
Photo 14. Qualitative image of rock-boring urchin on sabellariid worm rock (*P. lapidosa*) near photoquadrat station 7.
