**The Protected Species Watch Program
For Blasting Activities In
San Juan Harbor
San Juan, Puerto Rico**

FINAL REPORT

**US Army Corps of Engineers
Project Number
DACW17-99-C-0060
San Juan Harbor Deepening Phase II**

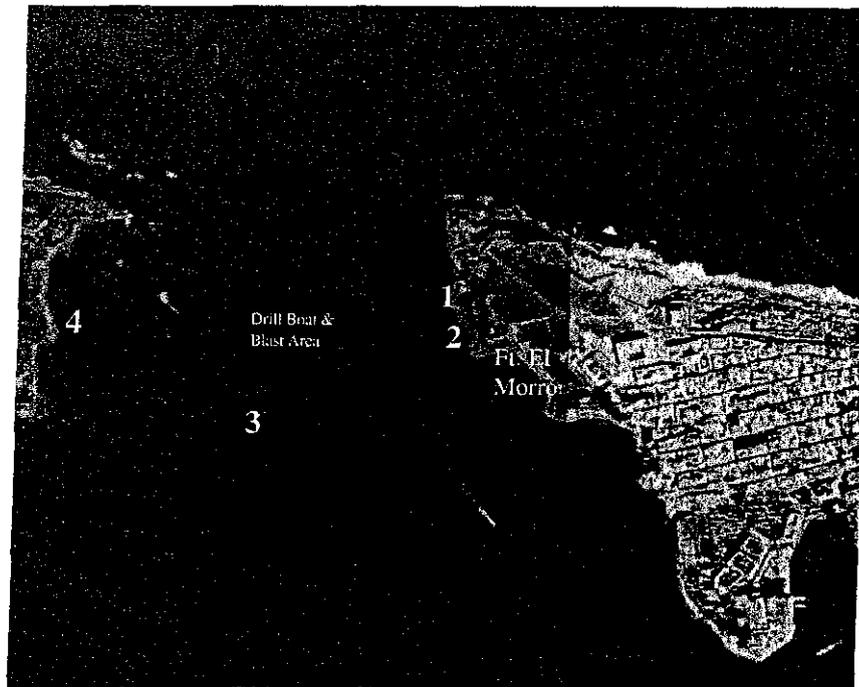
Figure 2. Locations of Stationary Observers: 1 & 2 are locations of Ft. El Morro observer; 3 is the location of the Alaska observer; 4 is the location of the Isla De Cabras observer. There was also an observer located on the Drill Boat. Positions changed slightly as the blast arrays changed location.

Water craft surveys were conducted continuously from the top of a boat throughout the 2000' safety zone at least one hour prior to the scheduled blasting. Post blast surveys were conducted within the same vicinity for 1 hour after the blast until 4 September when the post blast surveys were reduced to ½ hour per the approval of the NMFS. Three stationary observers were used within the safety zone, one observer was stationed on Fort El Morro, one was stationed on the Drill Boat Apache, and the third was stationed either on the Dredge Alaska or on Isla de Cabras (Figure 2).

Personnel involved in the Watch Program included the watch coordinator who was stationed on a small boat and three stationary observers. Stationary observers were placed on land and on barges to maximize their visibility of the 2000' danger zone depending on the location of the blast array.

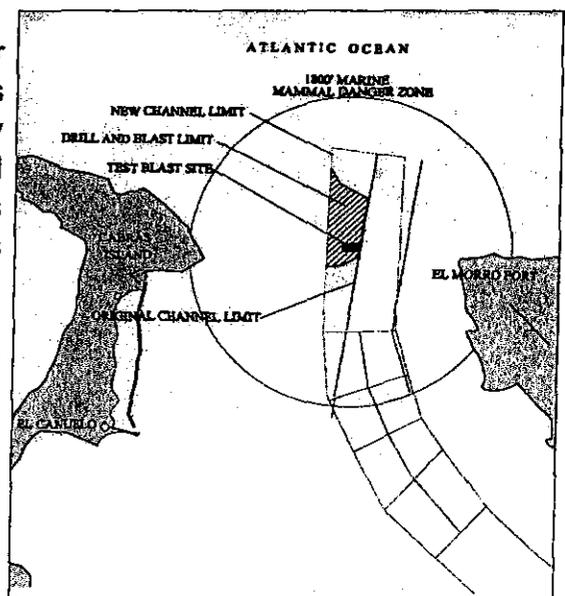
Figure 4. Diagram showing approximate safety zone for protected species.

A safety zone around the blast site was established to ensure the safety of protected marine species. This safety zone had to be clear of all protected species before blasting could be initiated. The safety area was calculated using the following formula:

The anticipated maximum pounds of explosives per delay for the San Juan Harbor blasting was approximately 375 lbs.; calculating to a safety radius of 1,875 ft. This radius was further modified to 2000 ft., for an added margin of safety. This 2000 ft zone covered all ingress and egress points for species to be entering the area (Figure 4).

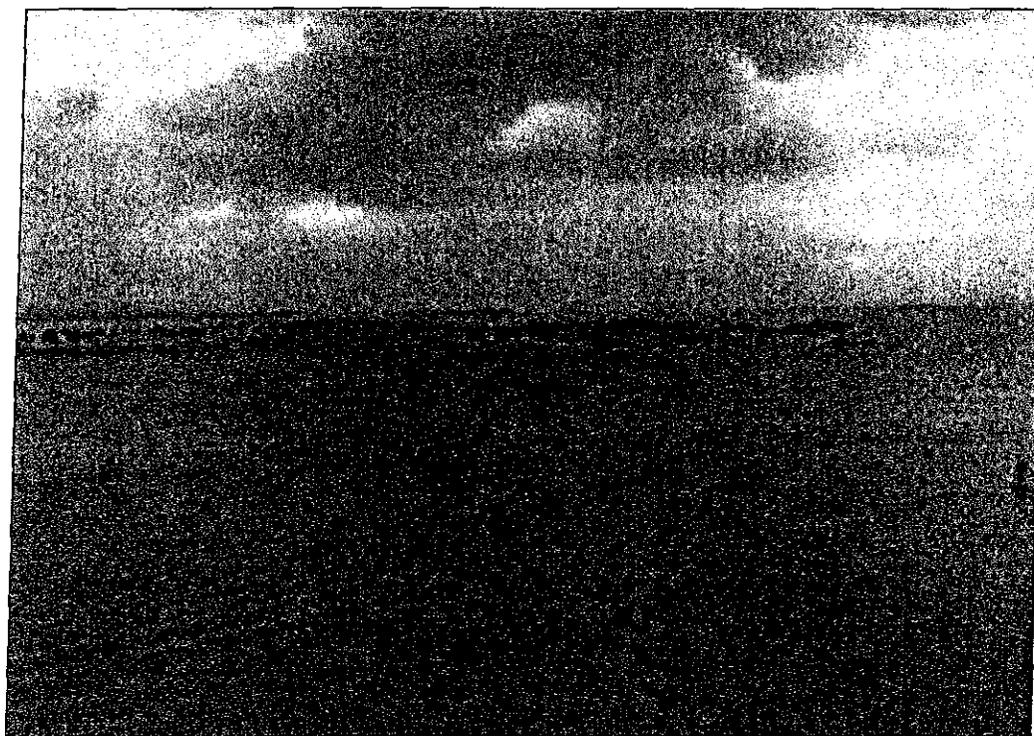
Figure 5. View from the highest point of Ft El Morro looking West toward the blast site.

One observer was placed on Fort El Morro on the east side of the blast site. The observer was placed on the highest possible location that allowed the best view of the survey area. This location was dependant on where the drill barge was located and as it moved farther north, so did the observer. Heights above the water surface for this observer ranged from approximately 6 meters to 45 meters (20' to 140').

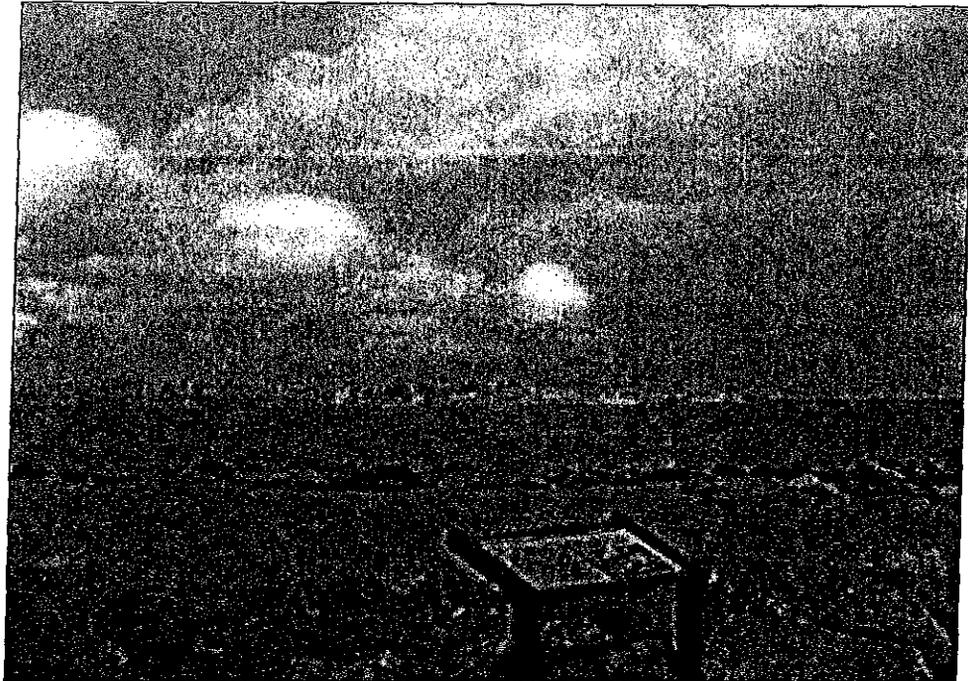
Figure 6. Another view from the lower walkway at Ft. El Morro looking west-northwest toward blast area.

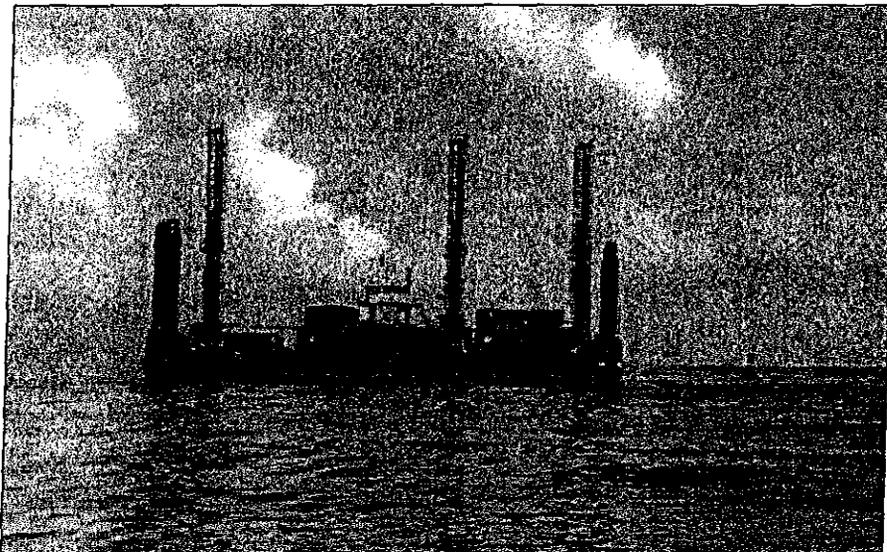
Figure 7. Drill boat Apache in place for blasting. Observer position is on catwalk surrounding central control tower (white).

One observer was placed on the upper catwalk of drill barge "Apache" which was within 500 ft of the blast array at all times. This observer primary responsibility was offshore to the north since the height, location and stability of the barge provided optimal visibility for that area of the danger zone. The height of this observer above the water was approximately 20 meters (60ft). The drill boat was located adjacent to the blast site during most of the watch period but pulled back from the blast zone approximately 15 minutes prior to blast time.
