**FINAL REPORT**

**IMPACTS OF COASTAL ROADWAY LIGHTING ON ENDANGERED  
AND THREATENED SEA TURTLES**

**(CONTRACT No. BB850)**

1. Report No.		2. Government Accession No.		3. Recipient's Catalog No.	
4. Title and Subtitle Impacts of coastal roadway lighting on endangered and threatened sea turtles				5. Report Date April, 2003

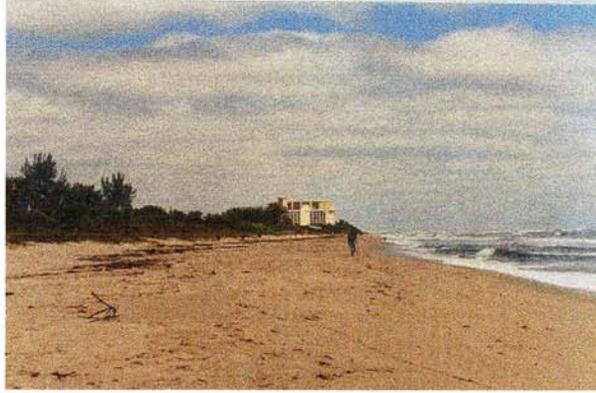
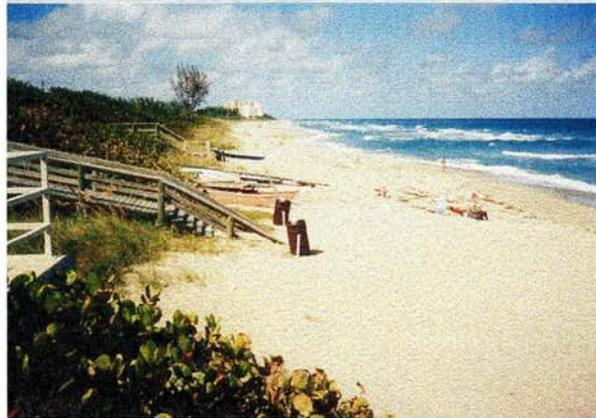
**Figure 2.** The study site at Jupiter, Florida. Photos are taken at the southern end of each study zone, looking north. (A) The northern control zone, (B) the central experimental zone, and (C) the southern control zone. Each zone is 425 m. in length.

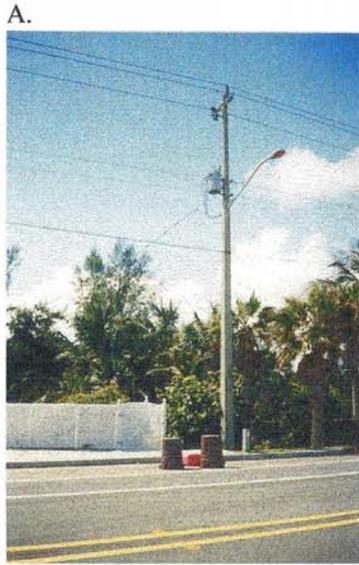
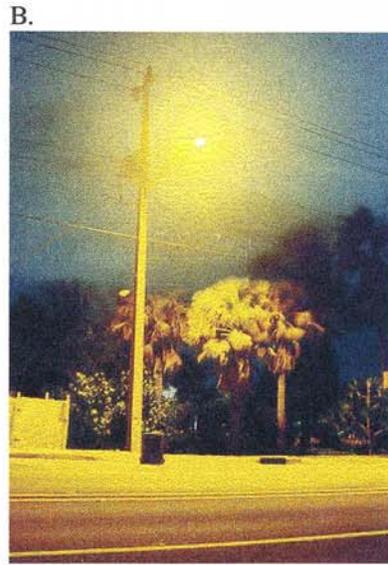
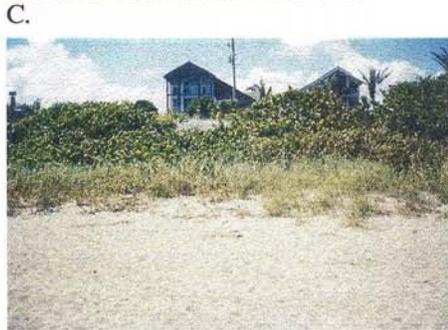
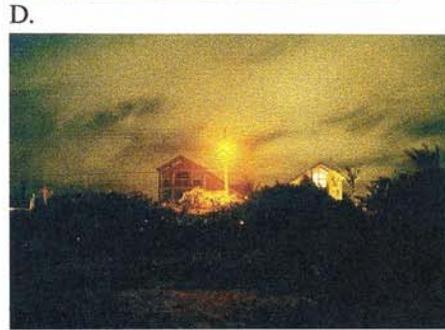
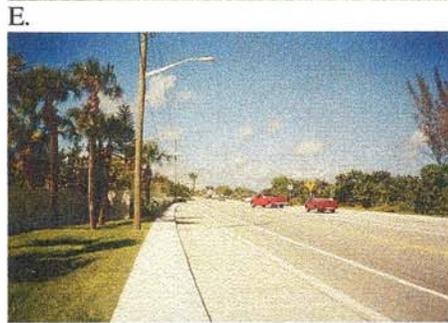
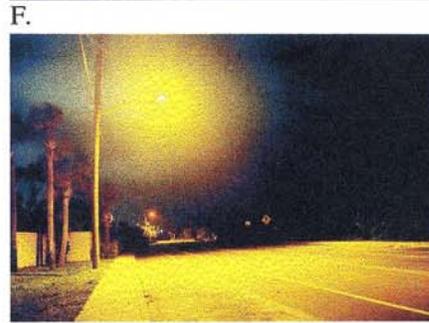
**Figure 3.** Day and nighttime views of streetlights used in the central experimental zone. (A-B) One streetlight on the west side of A1A. (C-D) One streetlight viewed from the beach. (E-F) The streetlights viewed looking north along A1A.

The street lights (Fig. 3) used for this experiment were standard “cobra heads”, equipped with drop lenses and elevated by 9.1 m tall poles. Street lights were modified for this experiment as follows. First, each was fitted with a 75 W high-pressure sodium (HPS) lamp, a light source that is normally disruptive to sea turtles (Witherington and Martin, 1996). Second, the drop lenses were replaced with flat lenses. Finally, each light was equipped with a # 2422 acrylic filter. This filter prevents the transmission of wavelengths below 540 nm (Fig. 4).

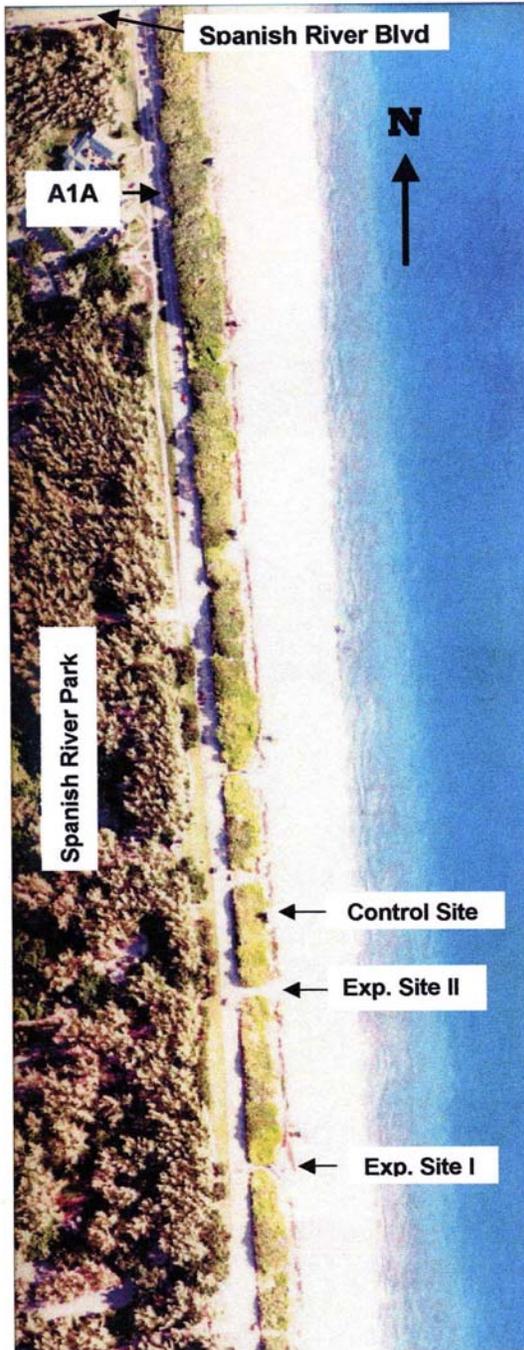
**Figure 1**

**Figure 1.** Aerial photograph of the study site at Spanish River Park, showing the control and two experimental sites.

All experiments were performed at an East Coast beach site in Boca Raton, Florida (Palm Beach County), between July and September of 2001 (Fig. 1). The site (Spanish River Park) was chosen for three reasons. First, the park is a forested area interposed between the city and the beach; it acts as a barrier that reduces (but does not eliminate) city lighting that reaches the beach. Second, the park is a zoning barrier that eliminates residential lighting (that might also upset hatchling orientation) from the area. As a consequence, the lighting environment is “simplified” making it likely that if detrimental behavioral effects occur, they are caused by street lighting. Third, a coastal highway (A1A) parallels the beach in front of the park. It contains poled streetlights with high-pressure sodium vapor (HPS) luminaires. At several locations where there are gaps in the dune vegetation (between the beach and roadway) for public beach access, these lights are visible at the beach and could disturb hatchling orientation.

Three locations along the length of the beach were selected as sites for arena experiments (Fig. 1). Two of these were Experimental Sites (those where four or more street lights were visible from the center of the arena); the third location was a Control Site (where dune vegetation blocked the transmission of street lighting to the beach). The two Experimental sites were located South of the Control Site. Experimental Site 2 was located immediately to the East of the Spanish River Park south tunnel. Experimental Site 1 was located 155 m, while the Control Site was located 212 m, to the north of Experimental Site 2.

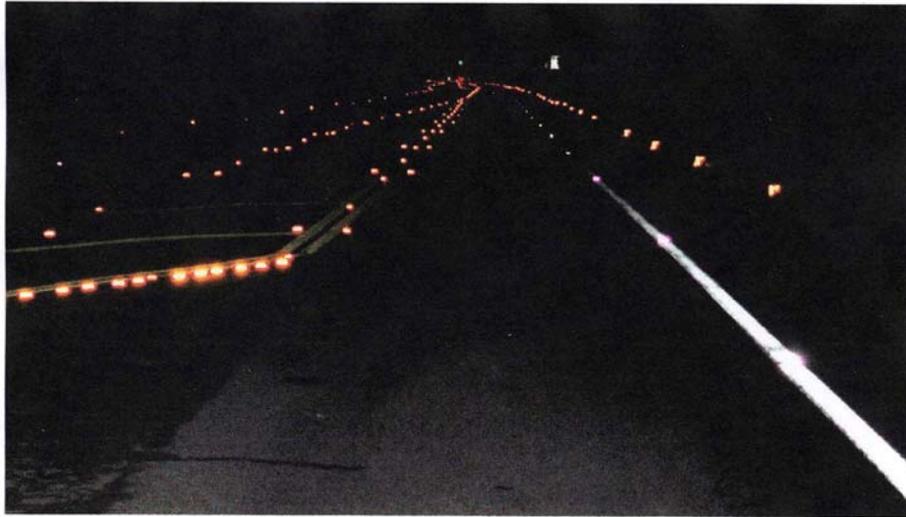
**Figure 2**

**Figure 2.** Photographs looking North from the South end of the coastal roadway (A1A). Above, with the streetlights (filtered HPS luminaries on, and (below) with the roadway illuminated only embedded roadway lighting.
