Sea Turtle Take Assessment
Wilmington Harbor Ocean Bar, Maintenance Dredging
Contract No W912HN-08-C-0002
Dredge Liberty Island

Summary

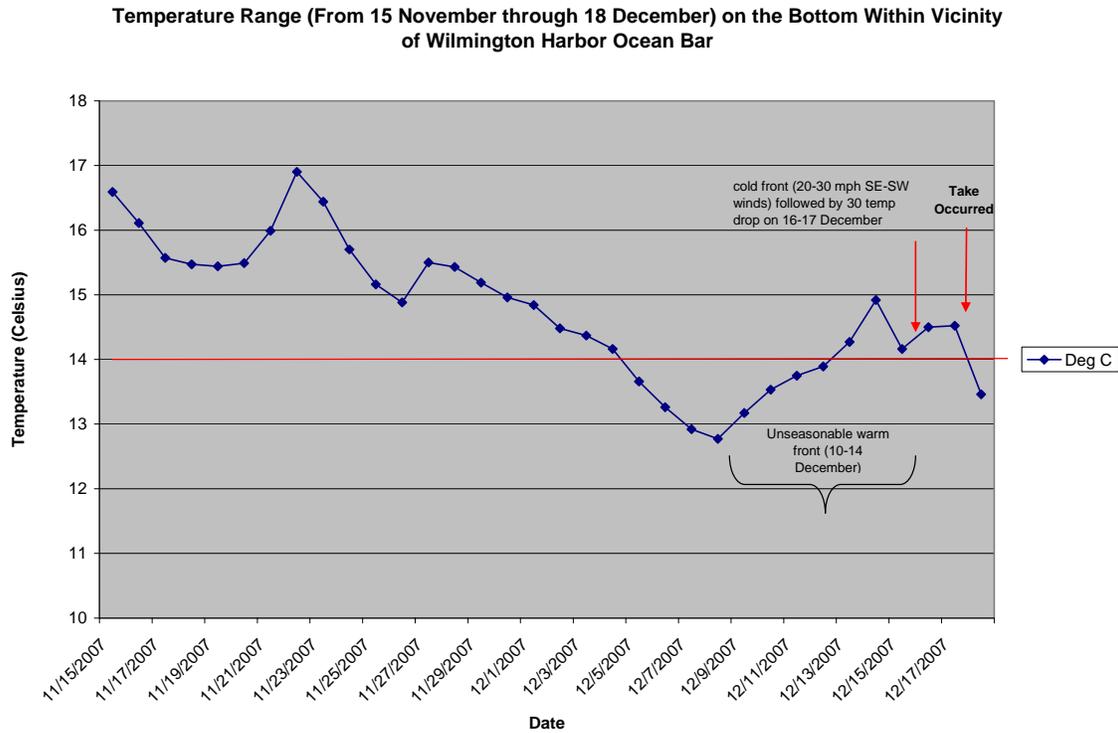
Figure 1. Bottom water temperature data was collected from an Acoustic Doppler Current Profiler (ACDP) located nearby the project vicinity in Oak Island. From 15 November through 09 December there was a generally cooling trend from ~16°C to ~13 °C. From 10-14 December the air temperature was unseasonably warm resulting in an increase in water temperature back up to about 15 °C. (Based on the Wilmington District’s sea turtle take history, a water temperature threshold of 14°C is considered the point at which turtle take risk is reduced). This warm weather pattern was followed by a cold front arriving on 15 December bringing strong SE-SW wind and swell. The strong winds from the southerly direction likely pushed warmer gulfstream water closer inshore and the increased swell contributed to a mixed the water column. The subsequent warmer water and southerly push could have provided more favorable conditions for sea turtles in the area during an otherwise low risk timeframe. On December 16-17 the air temperature dropped significantly with a low of about -4 °C (25°F). Subsequently, the water temperature began to quickly drop. This warming and cooling trend relative to the weather patterns can be seen in the sea surface temperature maps as well, provided in Figures 2-5. Considering the take occurred on the evening of the 17th following the significant drop in temperature, it is possible that the turtle was cold stunned and more vulnerable to take by the dredge; however, this can not be confirmed.

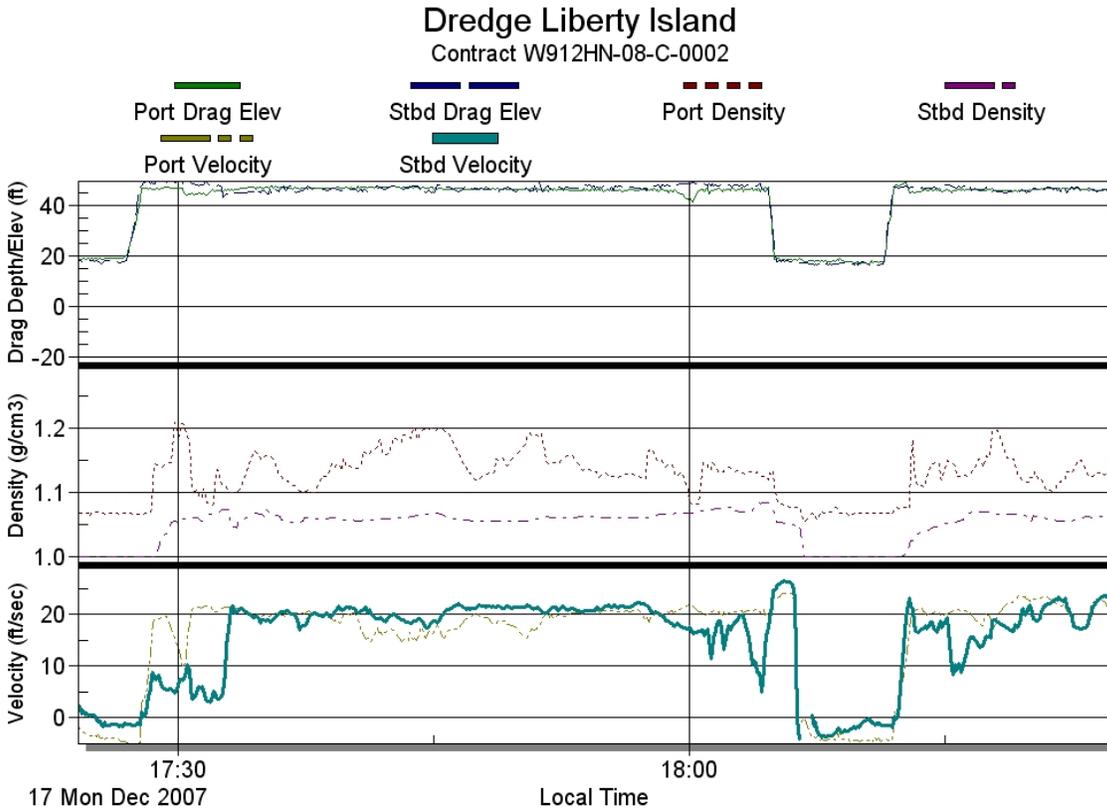
Figure 6. At about 1800, the port draghead suddenly raised up about 4 ft. The density decreased at that time, possibly to the point of pumping water. There were no turns going on at that time; thus, this sudden change could be due to the dragtender having to clear debris plugging the lines.

turtle take incident (Figures 6-8). Specifically, the data near the beginning of the load show the draghead suddenly dropping (2-3ft) into holes or ruts with the velocity and density remaining relatively constant. This would imply that the contractor is accounting for the holes by putting some slack in the dragwire. Any time the draghead suddenly drops into a hole, the potential for a take exists. Though these circumstances are inherent in most hopper dredging contracts with specific dredging difficulties as outlined above, the Contractor should continue to be diligent of the draghead operating requirements for sea turtle compliance and consider ways to minimize turtle take risk when clearing lines due to plugging. Specific details regarding weather and water temperature as well as Silent inspector data analysis are provided in Figures 1-8.

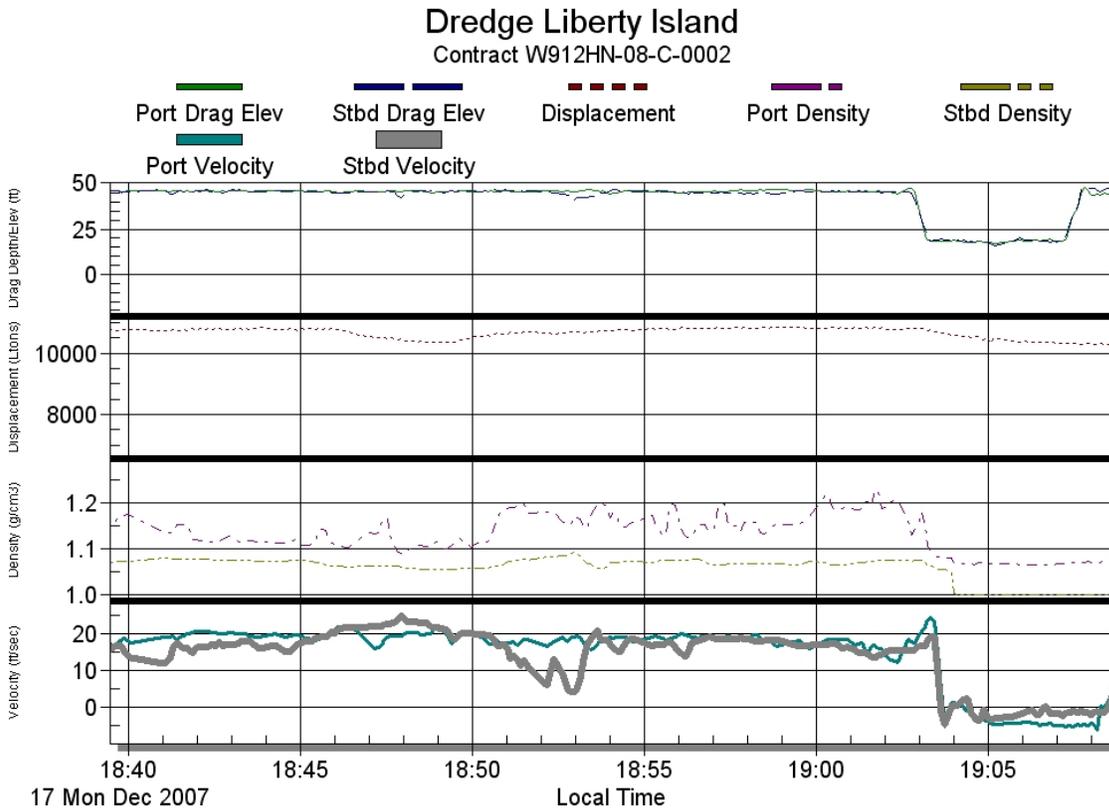
Figure 7. At about 1850 the dragtender raised the stbd draghead off the bottom. The data show a near pipe plugging incident, where the density goes up and the velocity down. The drag tender raised the arm to pump more water and clear the pipe (see Figure 8).

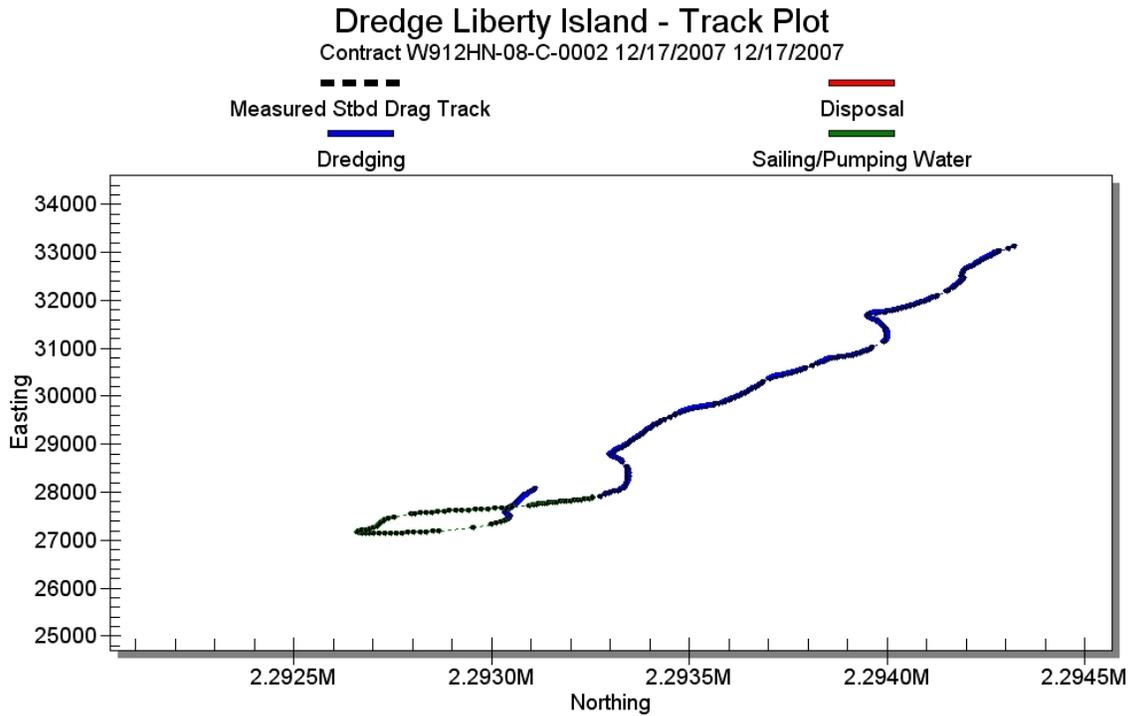
Figure 8. The position data was plotted for the Figure 7 time series and it appears that the dredge was in a rather sharp turn with the drags down. SOP in soft bottom dredging with turtle deflectors is to dig in S curves to avoid going over the same dredge tracks. However it could be that during this particular turn more material was presented to the drag arm than it could handle without plugging. Also, the drag could have been crabbing under the ship during the turn, requiring it to be raised to avoid damage.

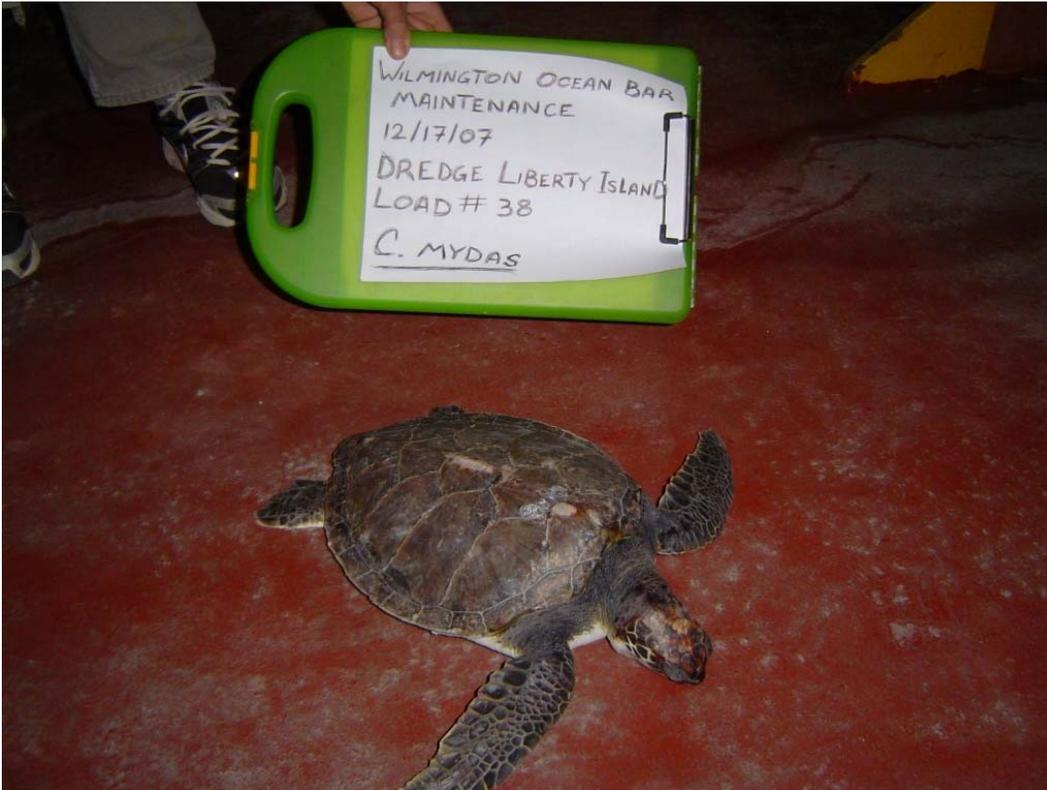
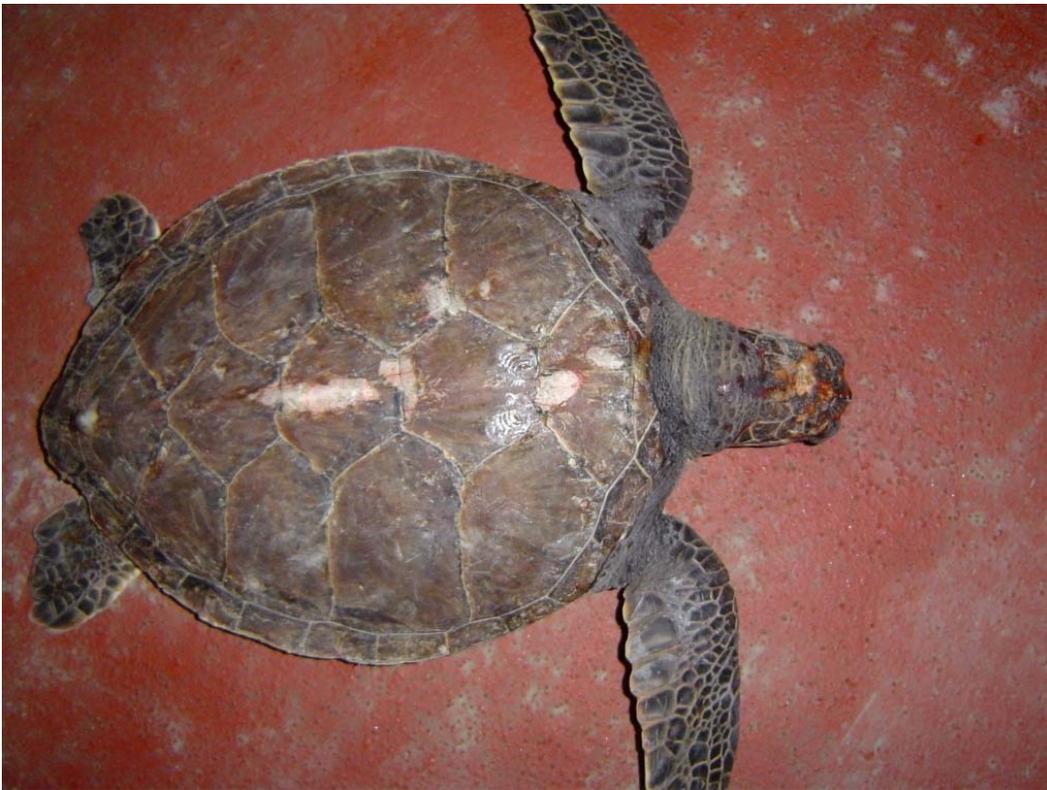
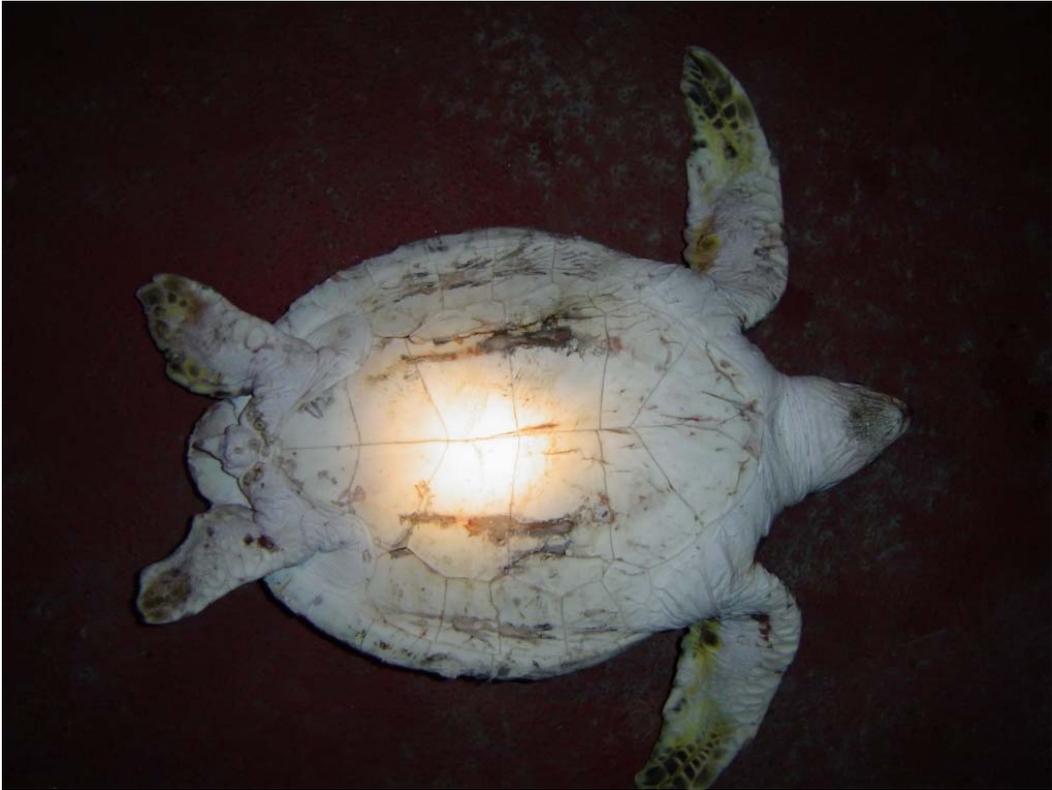
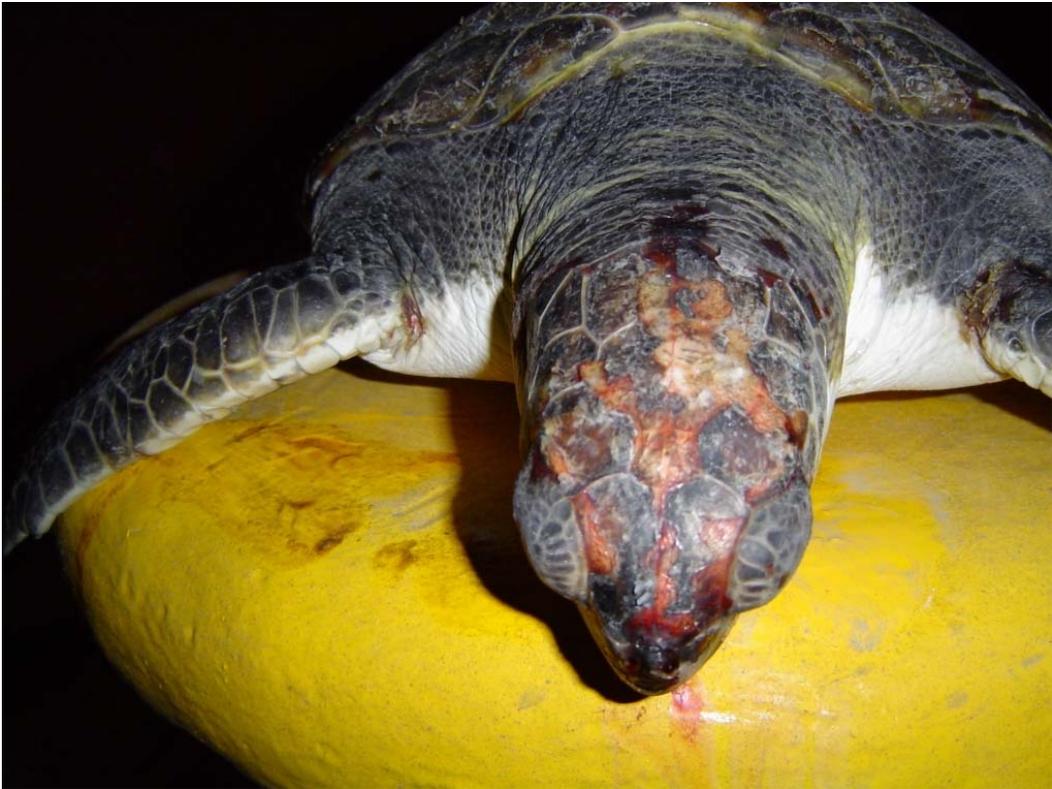
Incidental Take Photographs (1-4)

Condition of specimen: THE TURTLE WAS INTACT WITH ABRASIONS ON THE HEAD, CARAPACE, PASTRONS, AND FLIPPERS. BLOOD WAS PRESENT IN THE MOUTH AND WOUNDS. NO ODOR OF DECOMPOSITION WAS EVIDENT.
