ENDANGERED SPECIES OBSERVER PROGRAM

Project: Freeport Texas

INCIDENT REPORT OF SEA TURTLE TAKE BY DREDGING ACTIVITY

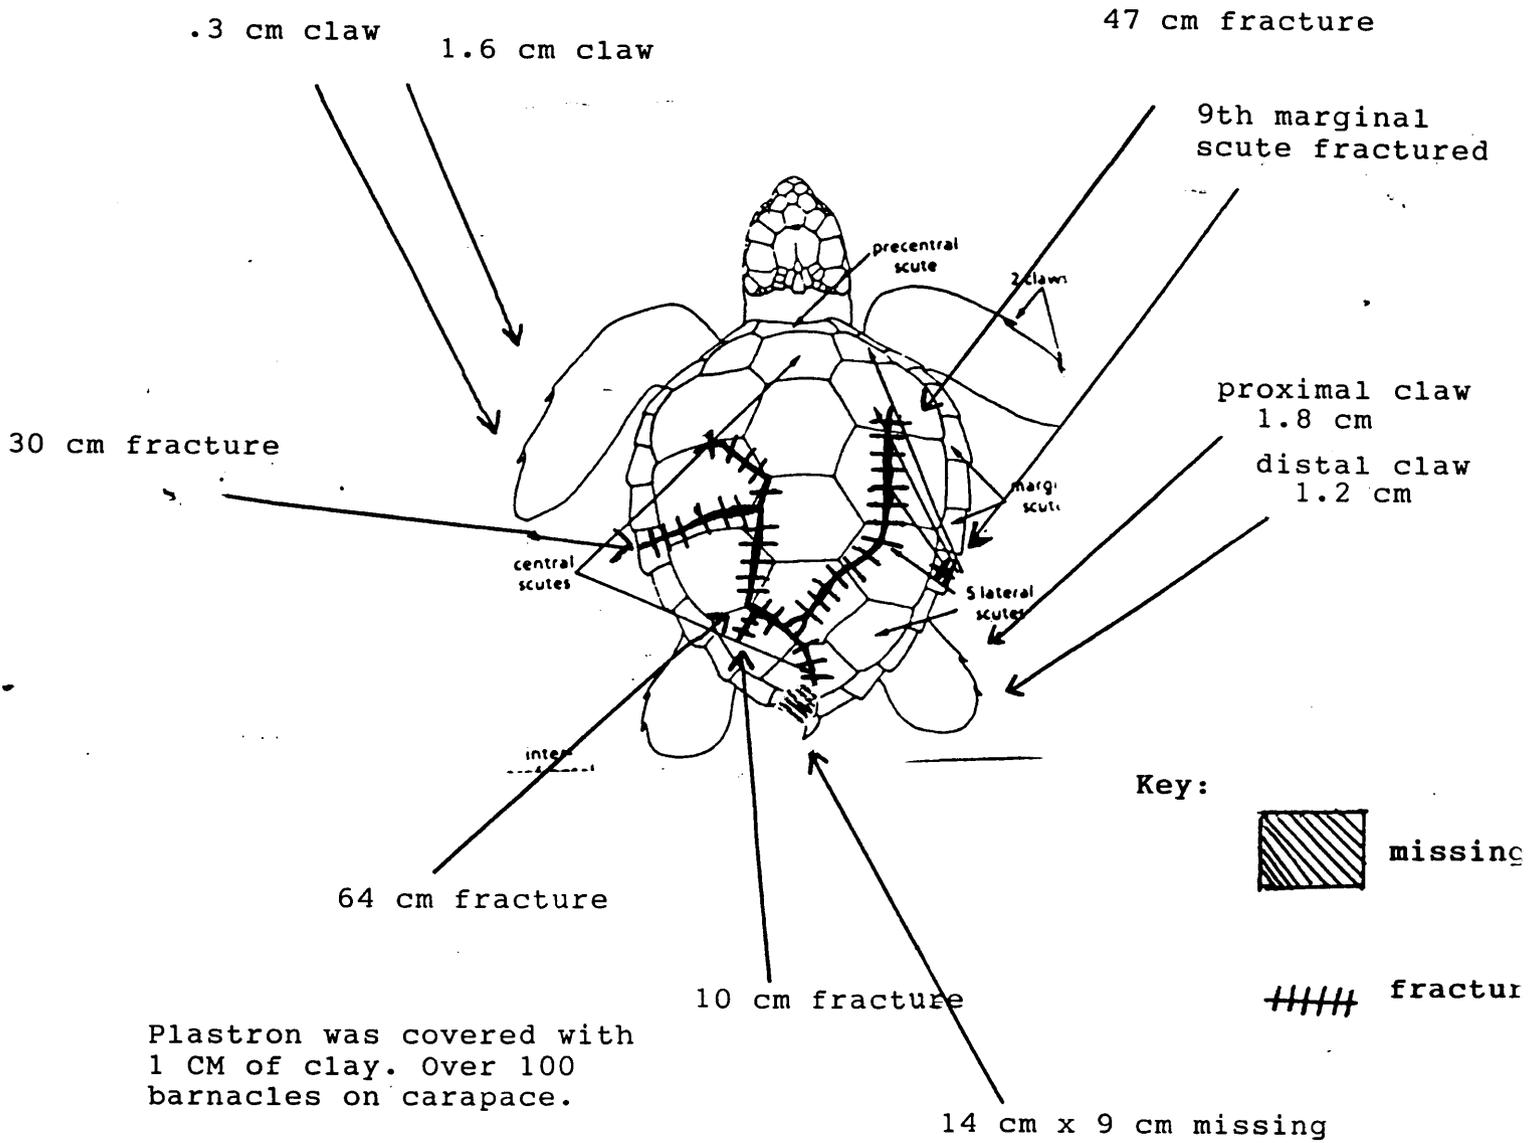
Dredge Atchafalaya
 Freeport Entrance
 Channel
 Sampled 10-09-95
 Fresh Dead
 Caretta caretta
 Load#254

Condition of Specimen(s) Sampled Fresh dead, carapace had several cracks in it.

The two largest cracks were 64 CM and 47 CM. The carapace was caught in the draghead. Three sections of intestines was sampled in the lander, intestines

Comments The turtle was covered with clay, plastron had 1 CM of clay covering.

The Loggerhead was stuck in the draghead. The turtle had to be pried out. The carapace was severely crushed. The turtle showed slight signs of life for a couple of minutes as flipper movements were detected. These movements ceased after a couple of minutes. Three 150 CM of intestines was sampled in the lander. Intestines had pieces of black-fingered mud crab in it. One small piece of intestine was sampled on the next load. Material digging in this section is mud and clay.
