Post-Construction Monitoring Survey of Nearshore Hard Bottom Habitats South of Fort Pierce Inlet Fort Pierce, Florida

December 2004

Continental Shelf Associates, Inc.
759 Parkway Street
Jupiter, Florida 33477
Telephone: (561) 746-7946

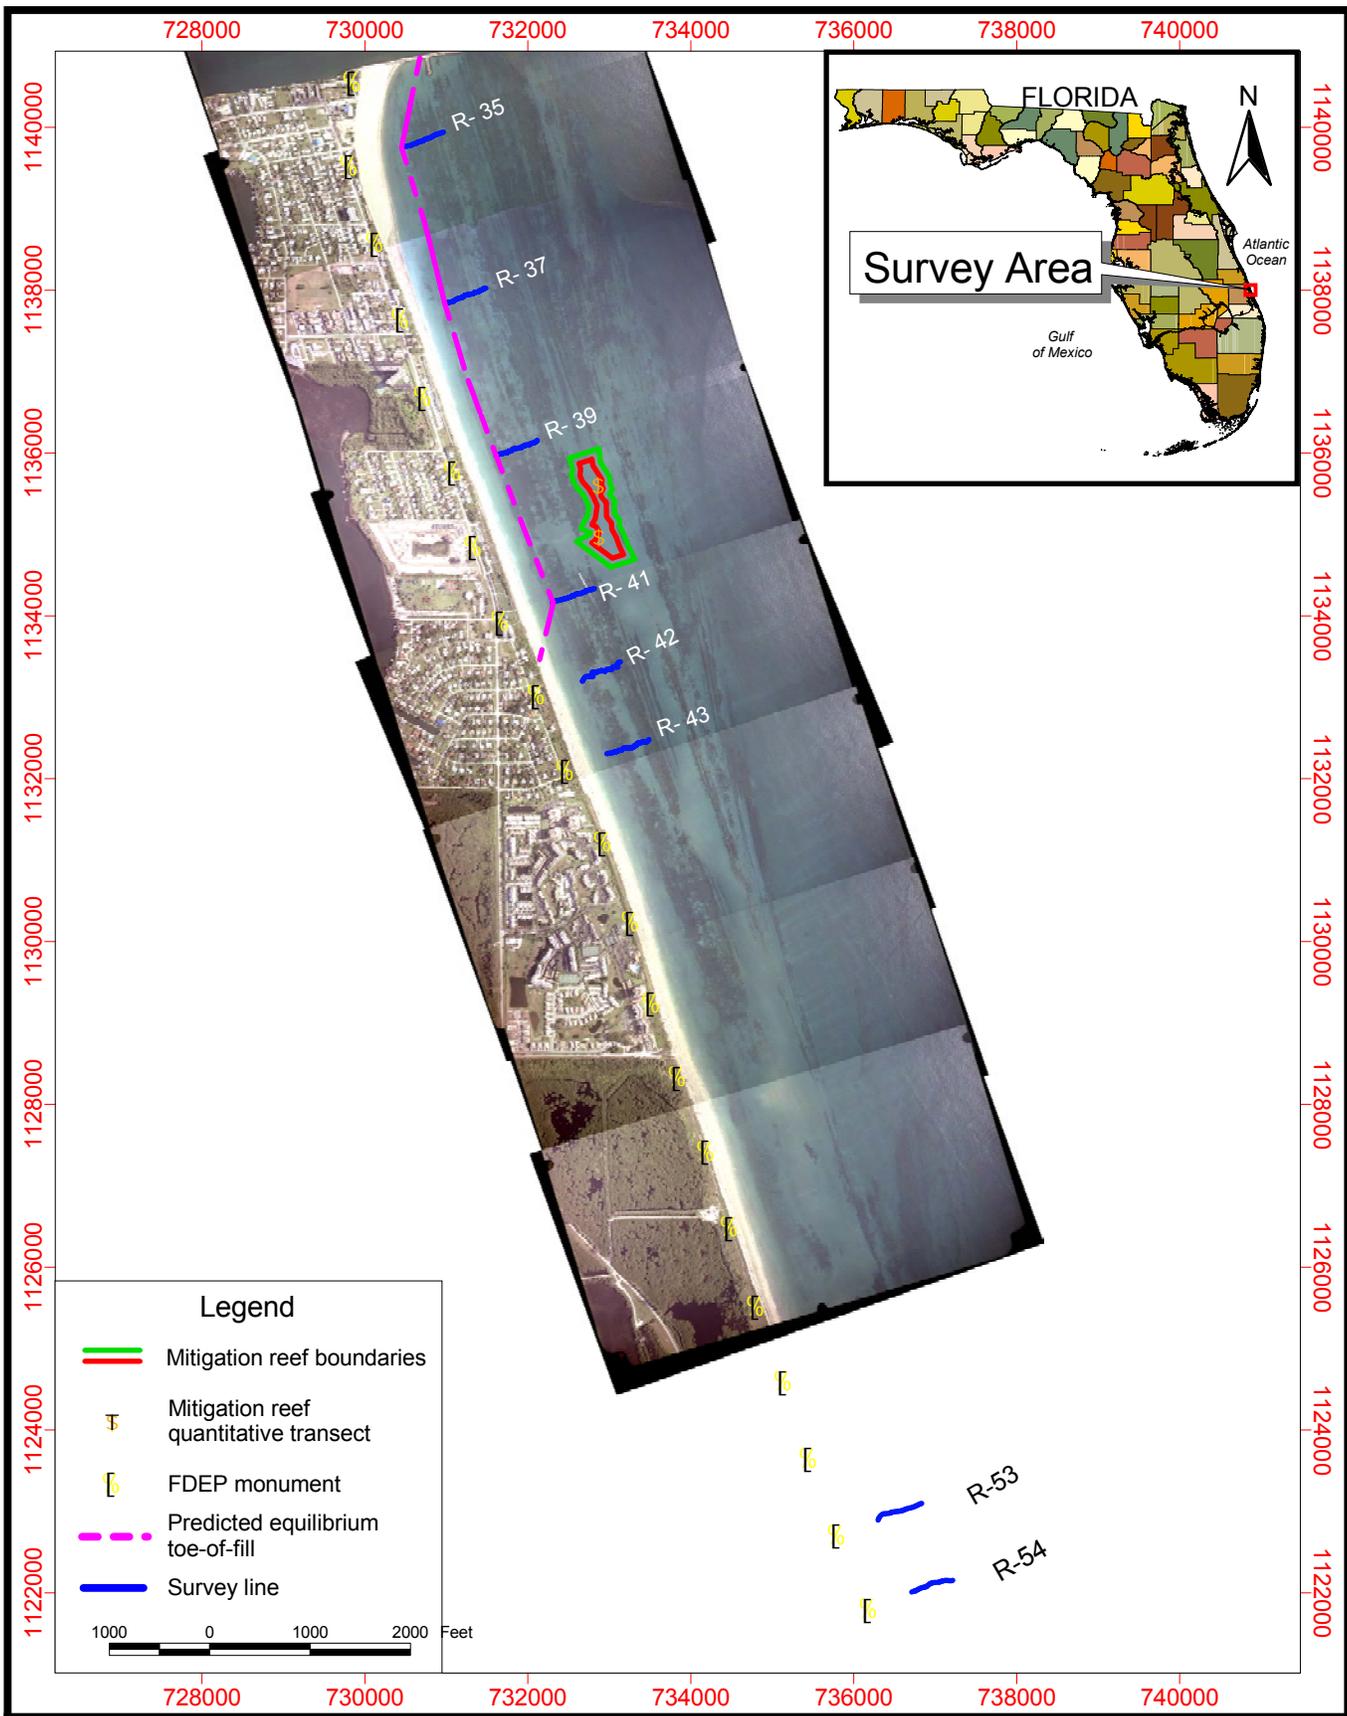
Figure 1. Overview of the survey area south of Fort Pierce Inlet, Fort Pierce, Florida. Aerial imagery for Survey Lines R-53 and R-54 is not available.

Two 20-m quantitative transects were installed on the mitigation reef located seaward of FDEP Monuments R-39 and R-41 (**Figure 1**). **Table 1** provides the navigation coordinates for the quantitative transects on the mitigation reef. Permanent markers with numbered tags were installed at either end of each quantitative transect and secured to the substrate with epoxy.

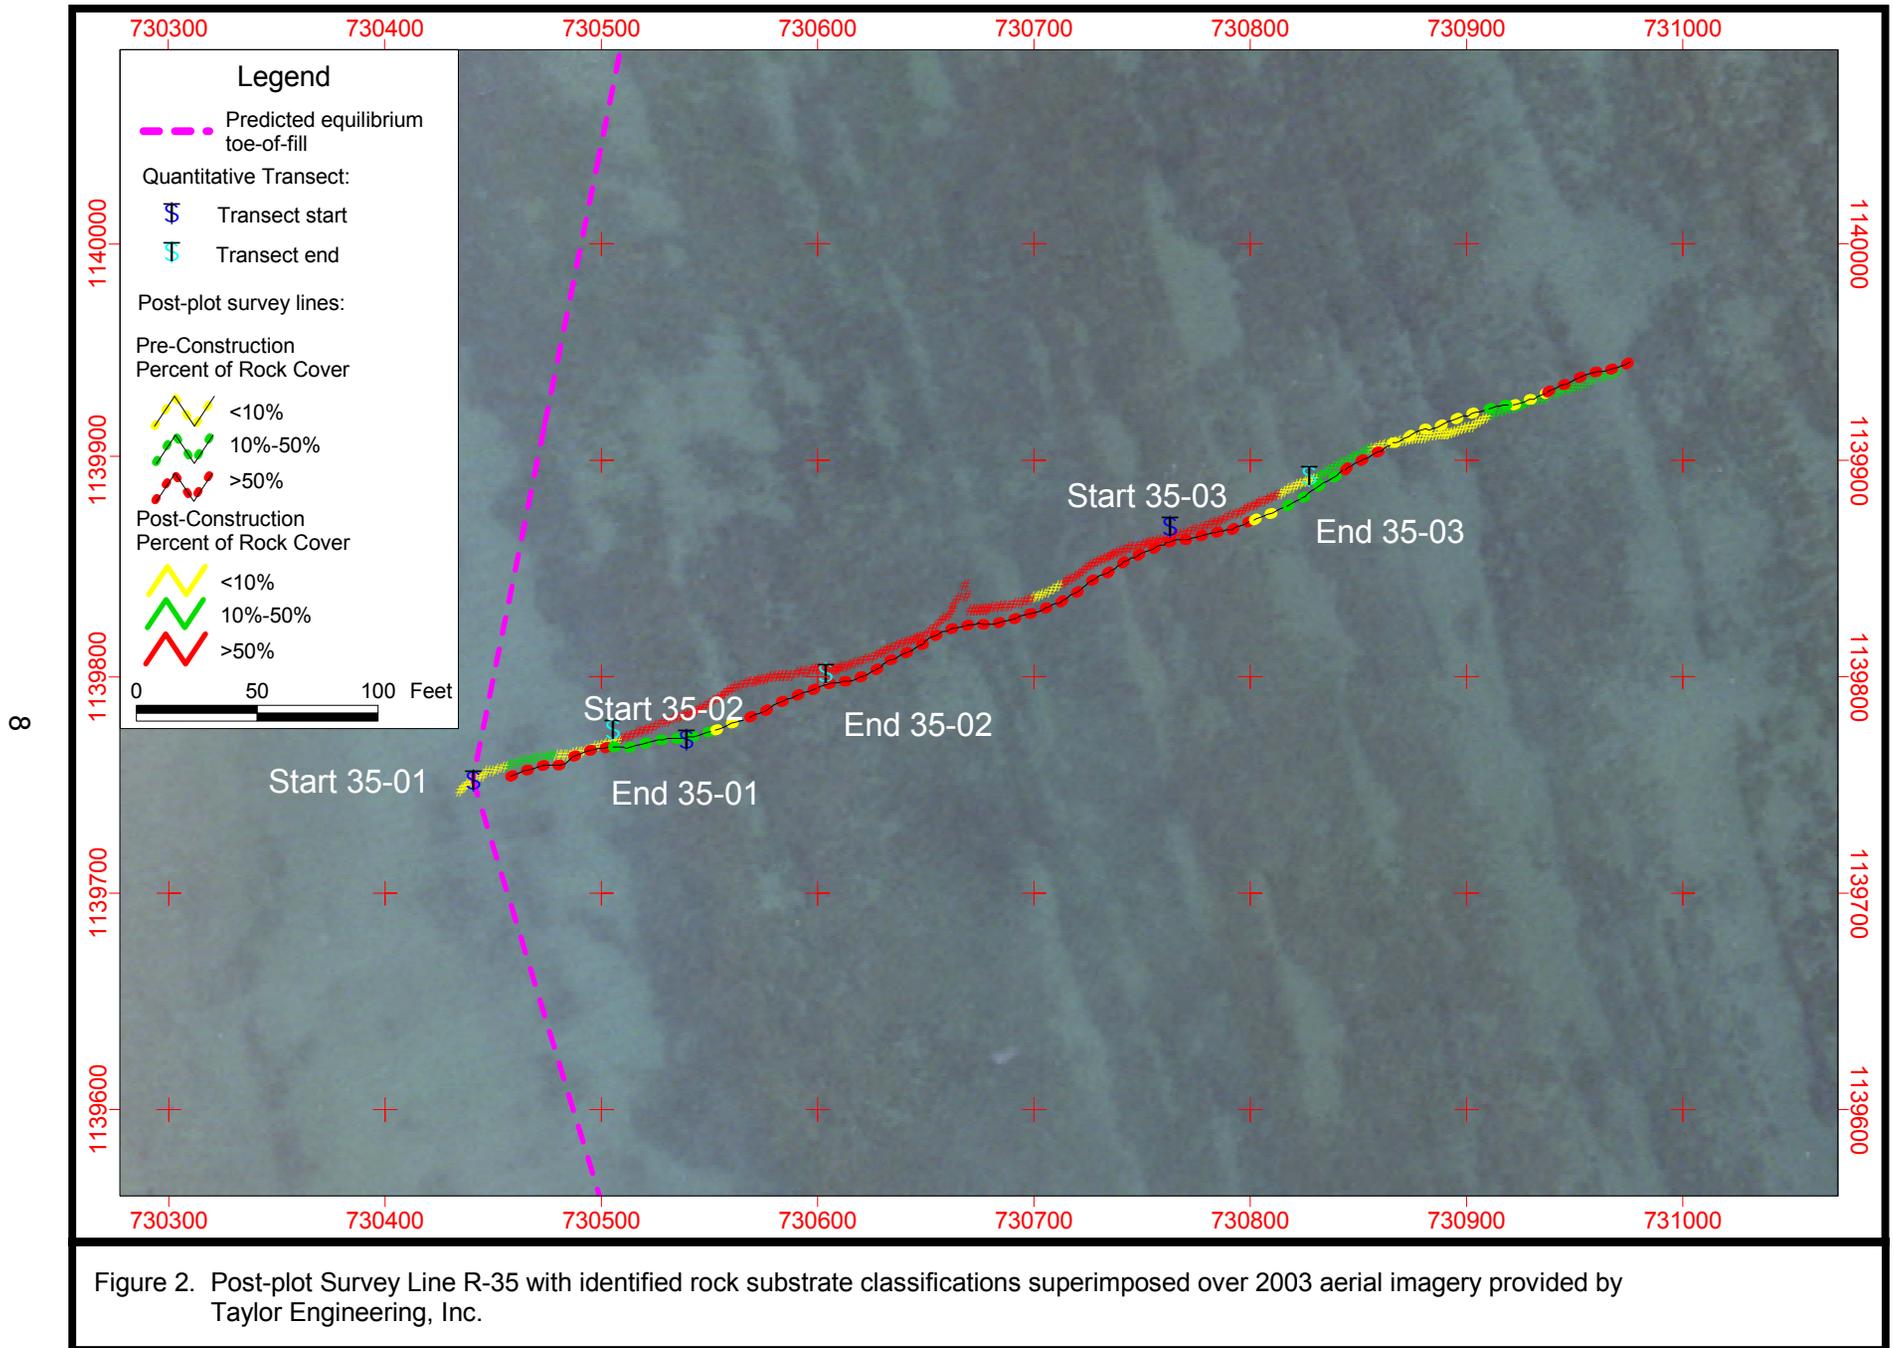
Video data were collected along eight survey lines from FDEP Monuments R-35 through R-54. **Figures 2 through 9** show the substrate type distribution along each survey line superimposed over 2003 aerial imagery provided by Taylor Engineering, Inc. Substrate types observed along each survey line were placed into one of three categories: 1) predominantly sand bottom with less than 10% exposed rock cover; 2) 10% to 50% exposed rock cover; or 3) substrate with greater than 50% exposed rock cover. **Table 2** presents the composition of the substrate categories from each cross-shore survey line. Representative photographs of substrate types are presented in the **Appendix**. The hard bottom habitat observed south of the Fort Pierce Inlet was predominantly exposed limerock with an algal-dominated community that parallels the shoreline. Based on the analysis of qualitative data collected along the survey lines, the dominant substrate type observed during the survey was greater than 50% exposed rock cover, which composed an average of 42.7% of the total area surveyed. **Figure 10** shows percent cover of identified substrate classifications along each survey line. There was a decrease of 15.8% in the average percent contribution of 50% exposed rock cover between the pre- and post-construction surveys. The 50% exposed rock cover was still abundant along survey lines in the northern portions of the survey area, but sand bottom increased along the southern survey lines. Substrate relief in areas with greater than 50% exposed rock cover ranged from low (less than 2 ft) up to high (6 ft) relief, with an estimated average between 2 and 3 ft.

Two isolated areas in the middle and along the eastern portions of Survey Line R-35 were identified as predominantly sand bottom substrate, and the aerial imagery indicates this substrate was exposed rock cover (**Figure 2**). An area identified as greater than 50% exposed rock cover along the eastern portion of Survey Line R-37 appears to be predominantly sand bottom in the aerial image (**Figure 3**). Two small areas identified as greater than 50% exposed rock cover in the western and eastern portions of Survey Line R-39 appear to be predominantly sand bottom in the aerial image (**Figure 4**). An area along the eastern portion of Survey Line R-41 was identified as predominantly sand bottom but appears to be exposed rock cover in the aerial image (**Figure 5**). An area identified as greater than 50% exposed rock cover along the eastern portion of Survey Line R-42 appears to be predominantly sand bottom in the aerial image (**Figure 6**). Two areas along Survey Line R-43 were different from the aerial images. An area identified as predominantly sand bottom along the western portion of Survey Line R-43 appears to be partially covering exposed hard bottom. Another area identified as 10% to 50% exposed rock cover east of the middle portion of Survey Line R-43 appears to be predominantly sand bottom in the aerial image (**Figure 7**). Aerial images were not available for Survey Lines R-53 and R-54.

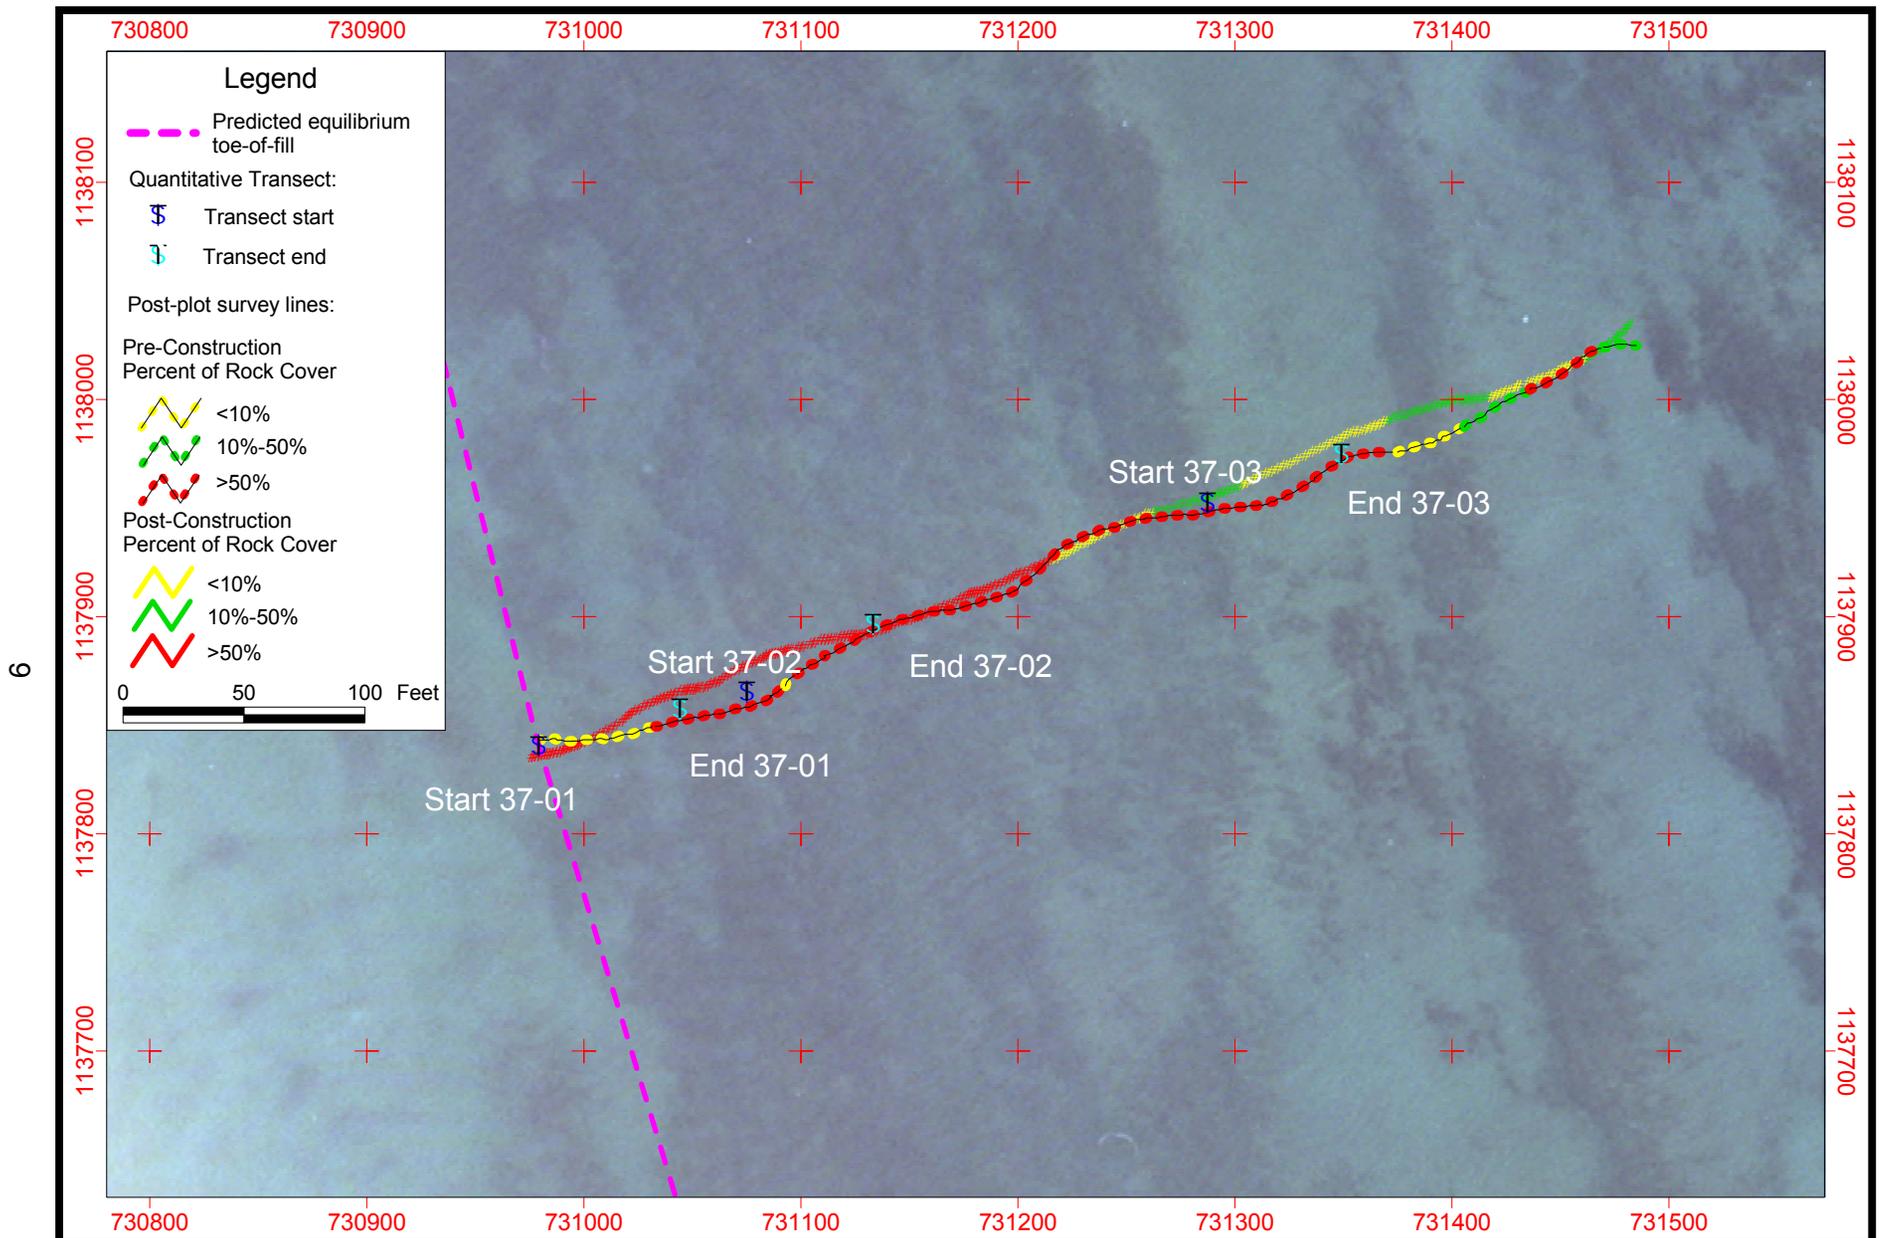
Figure 3. Post-plot Survey Line R-37 with identified rock substrate classifications superimposed over 2003 aerial imagery provided by Taylor Engineering, Inc.

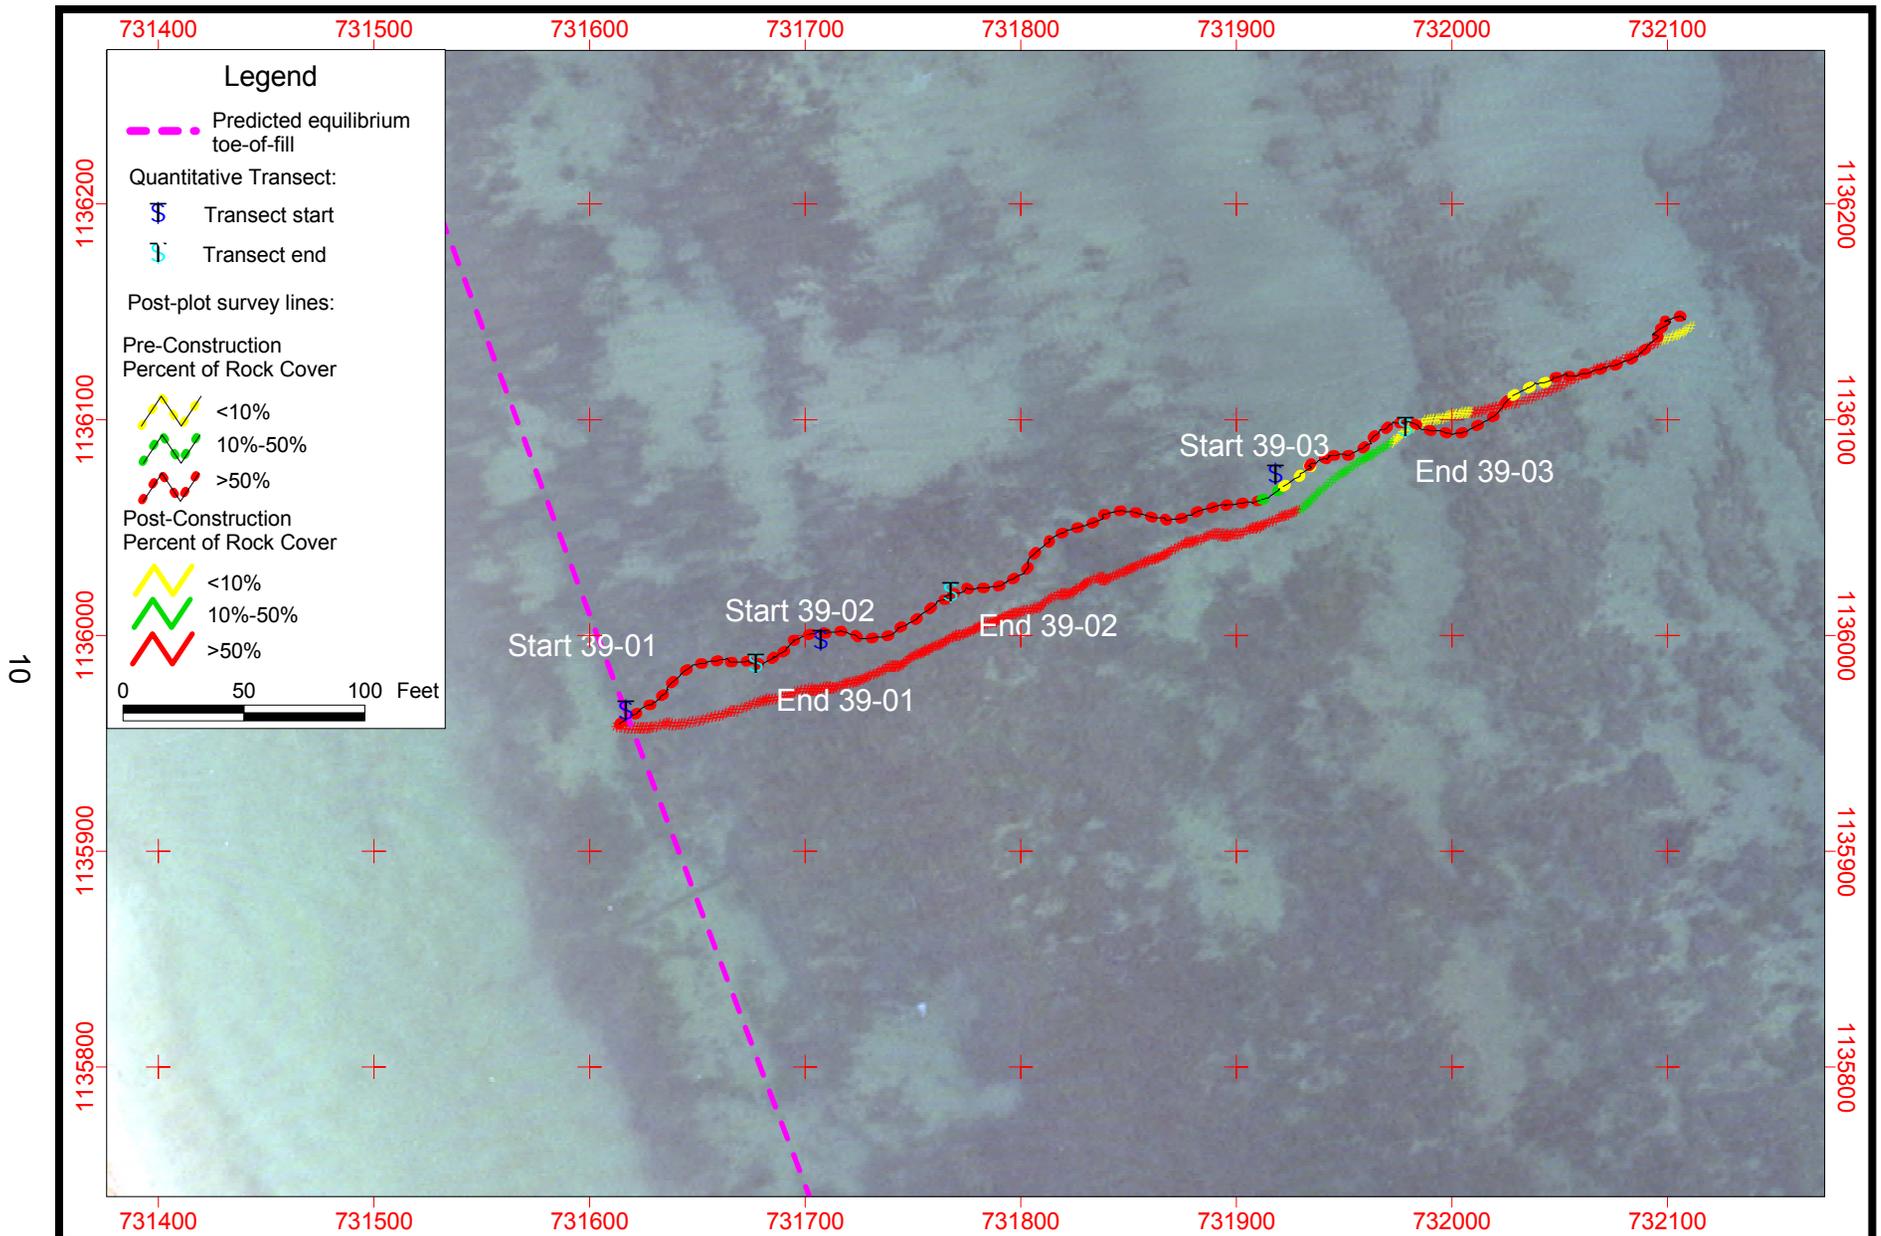
Figure 4. Post-plot Survey Line R-39 with identified rock substrate classifications superimposed over 2003 aerial imagery provided by Taylor Engineering, Inc.

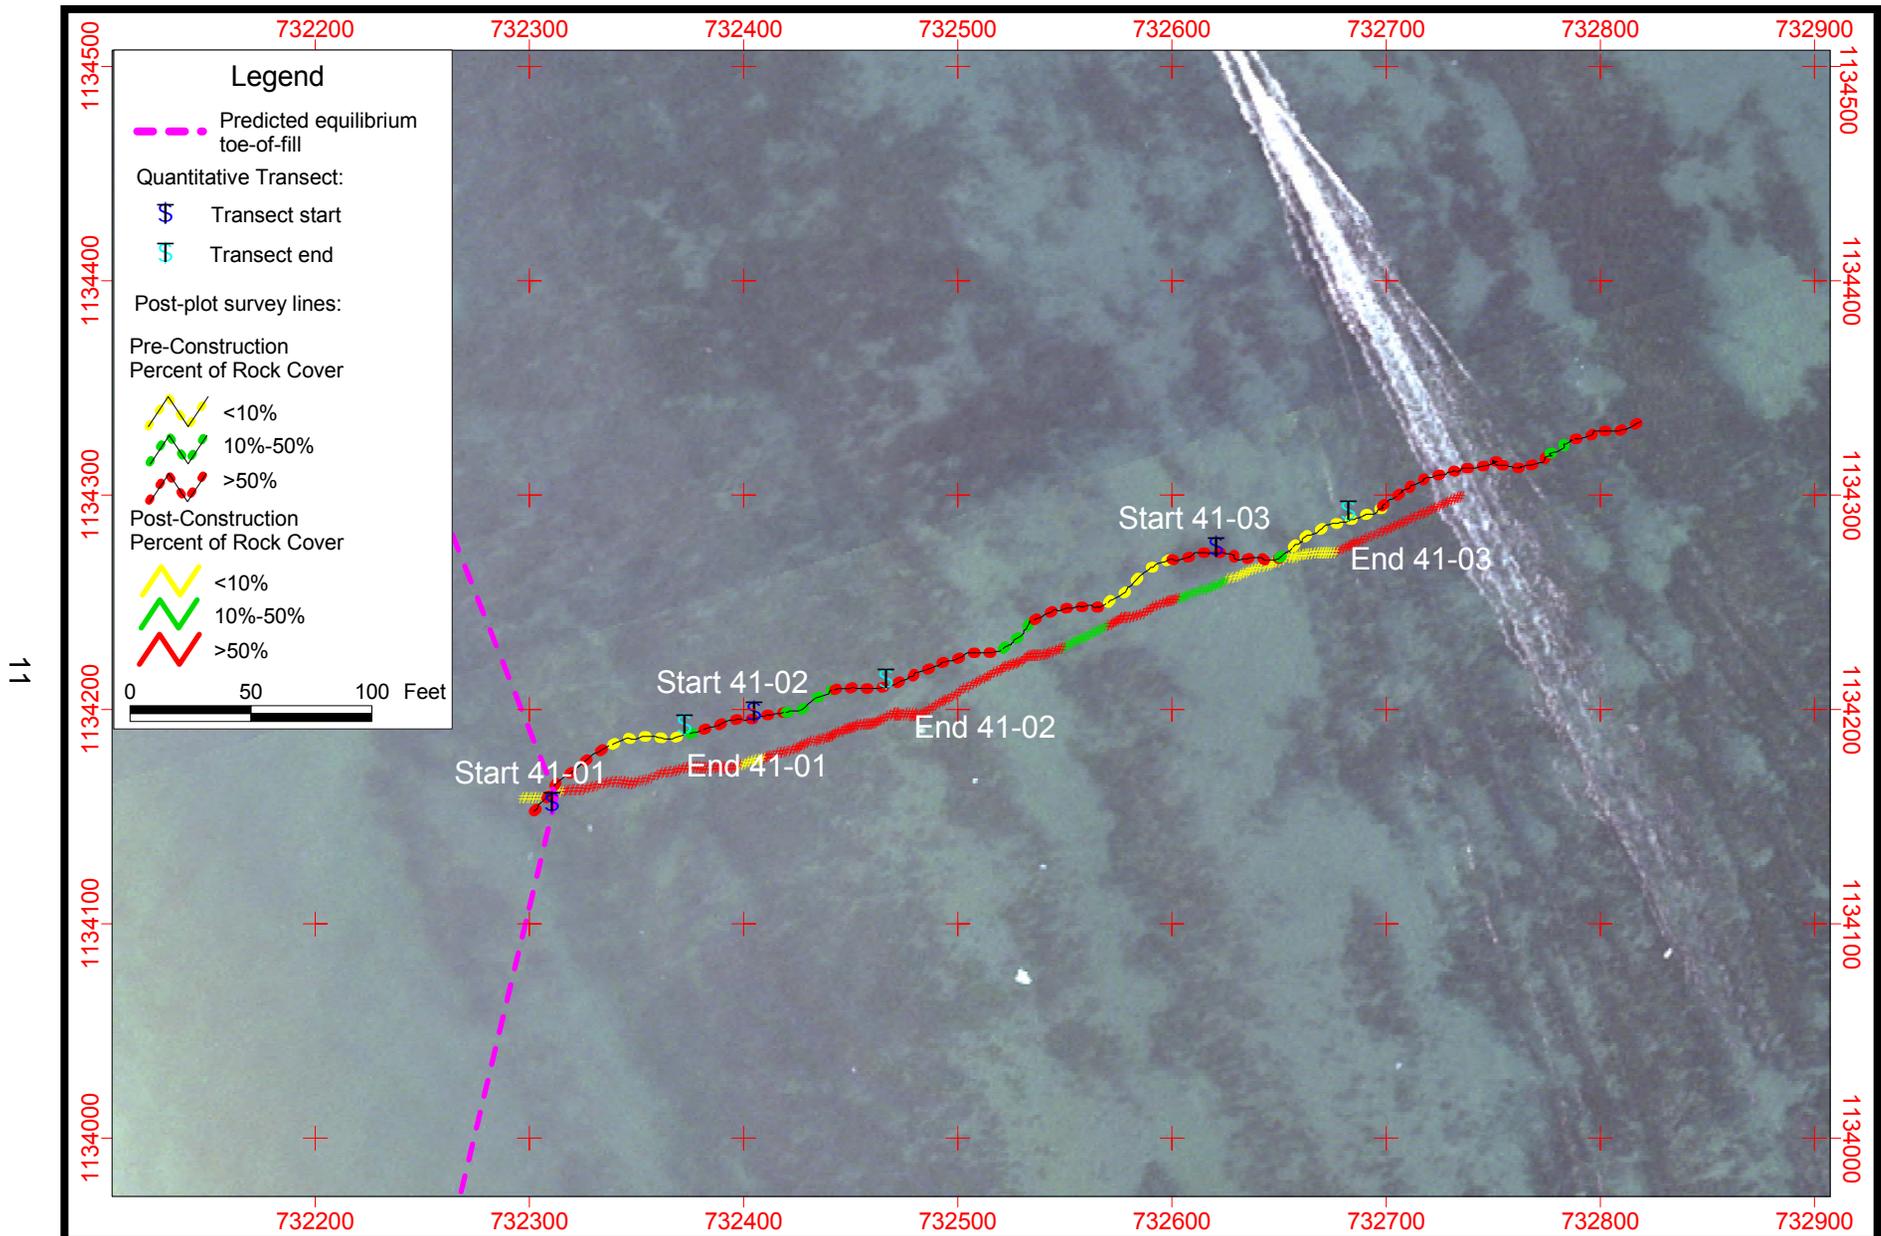
Figure 5. Post-plot Survey Line R-41 with identified rock substrate classifications superimposed over 2003 aerial imagery provided by Taylor Engineering, Inc.

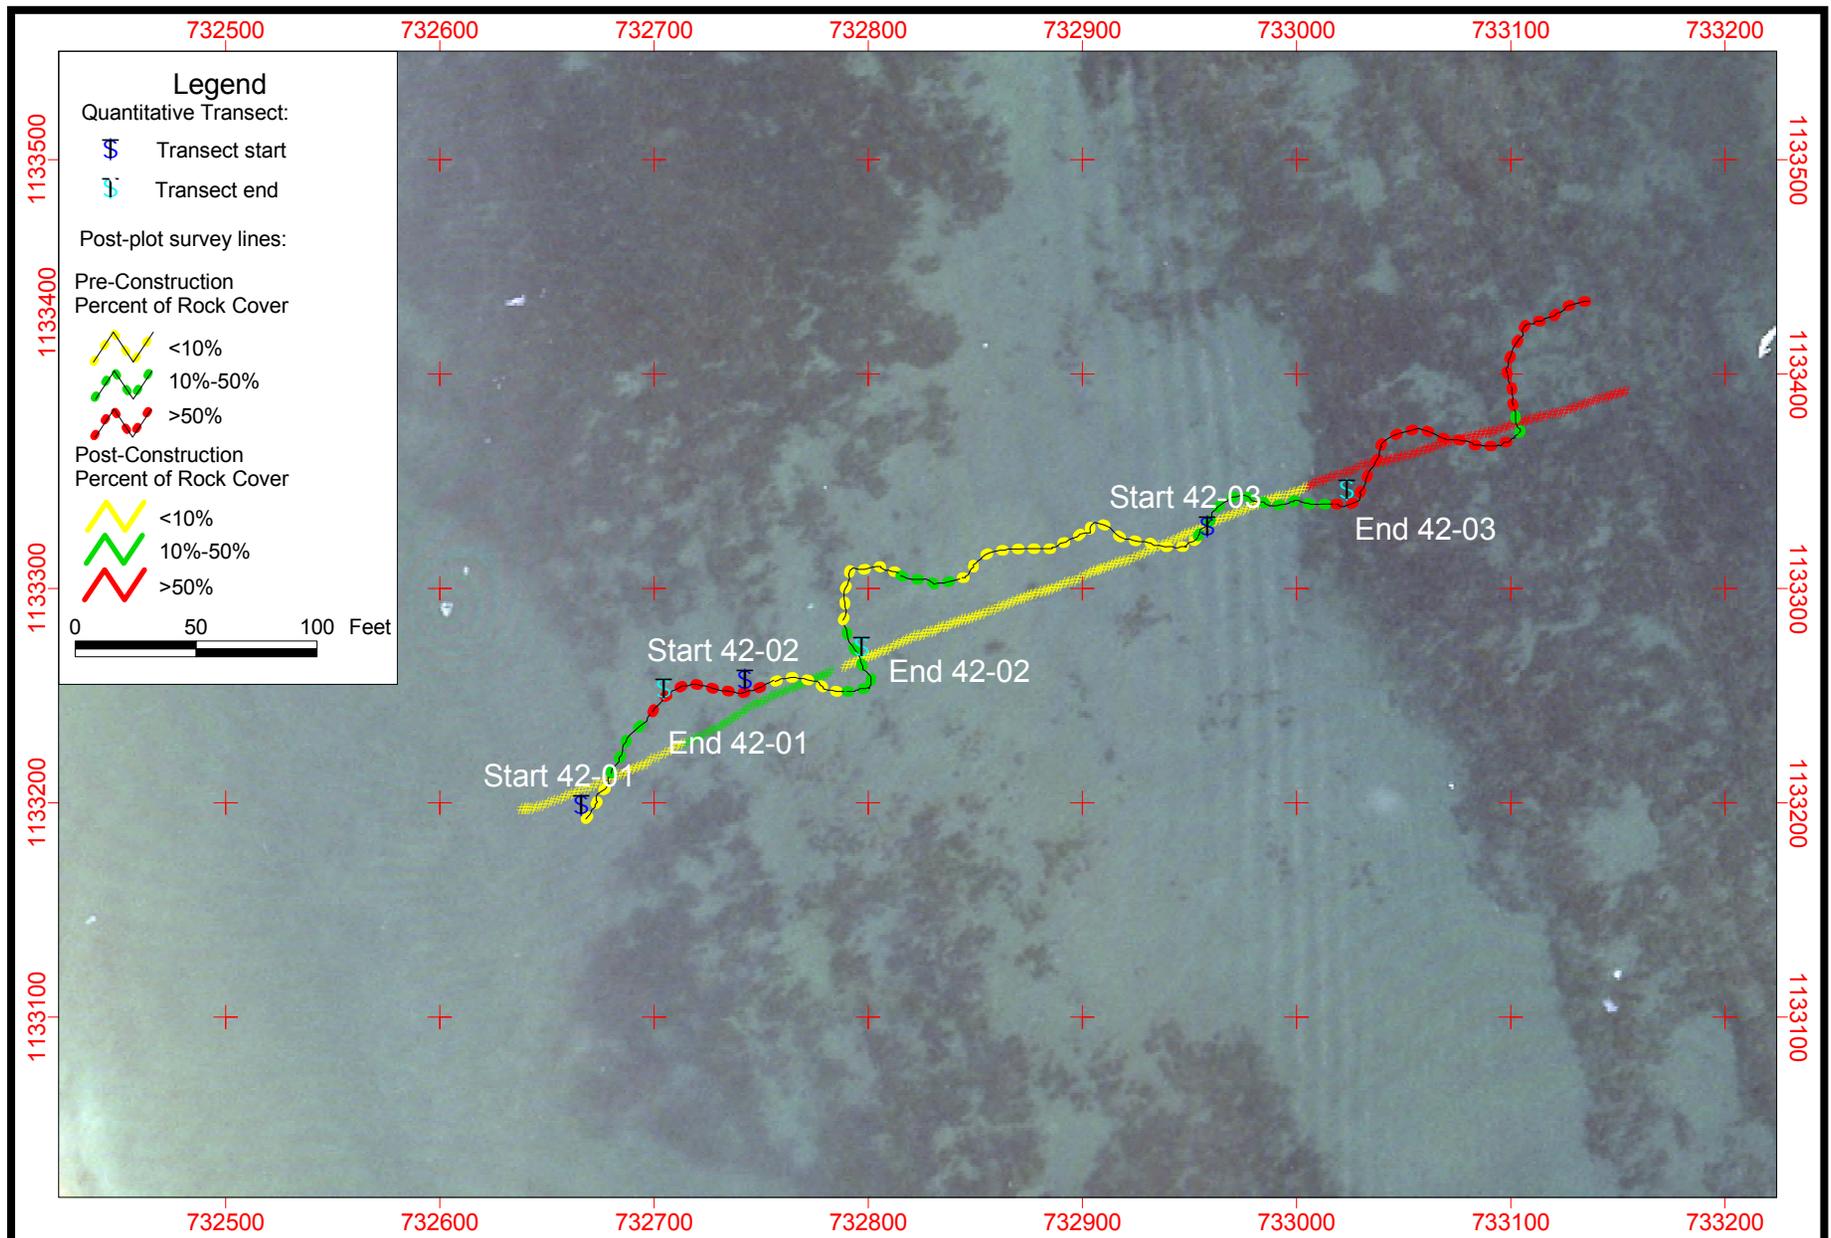
Figure 6. Post-plot Survey Line R-42 with identified rock substrate classifications superimposed over 2003 aerial imagery provided by Taylor Engineering, Inc.

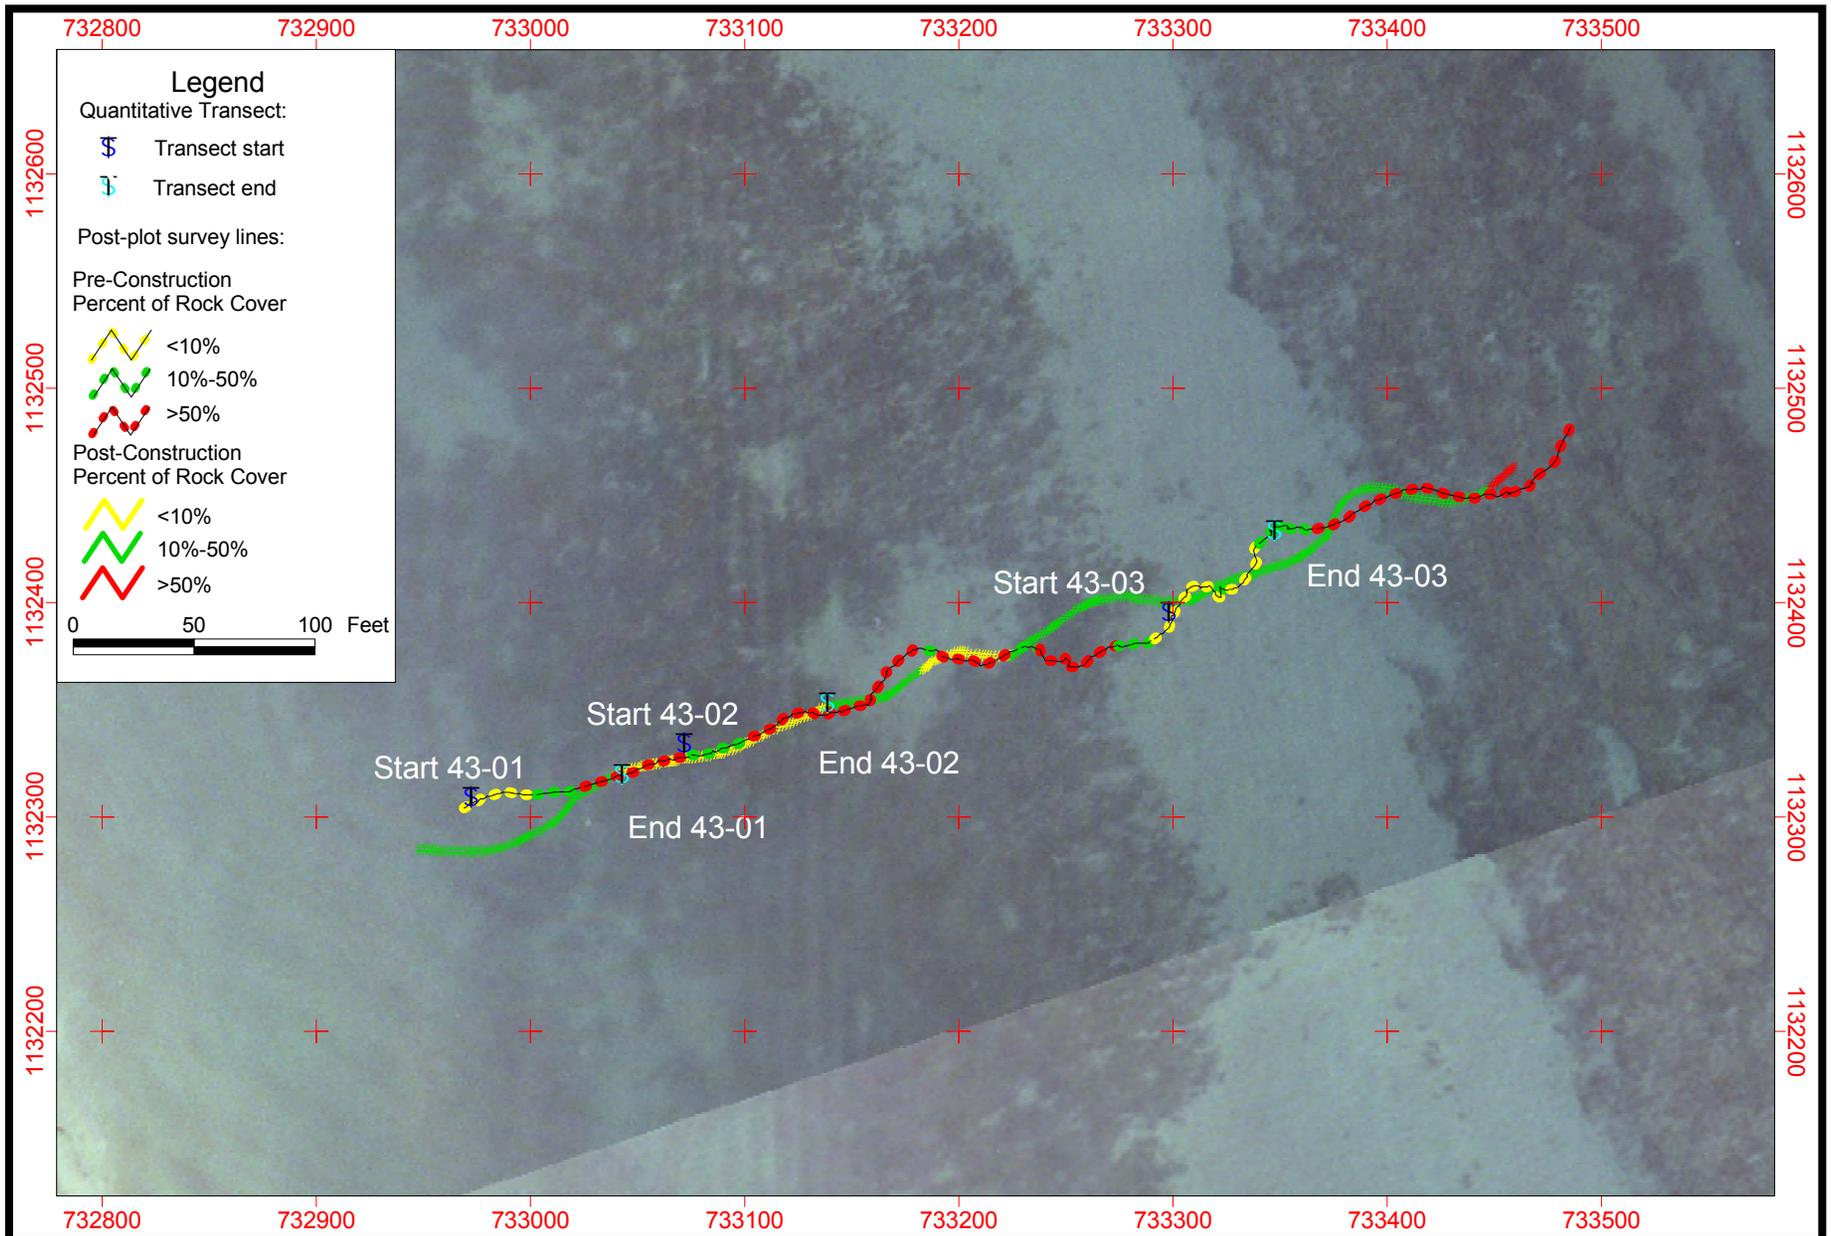
Figure 7. Post-plot Survey Line R-43 with identified rock substrate classifications superimposed over 2003 aerial imagery provided by Taylor Engineering, Inc.

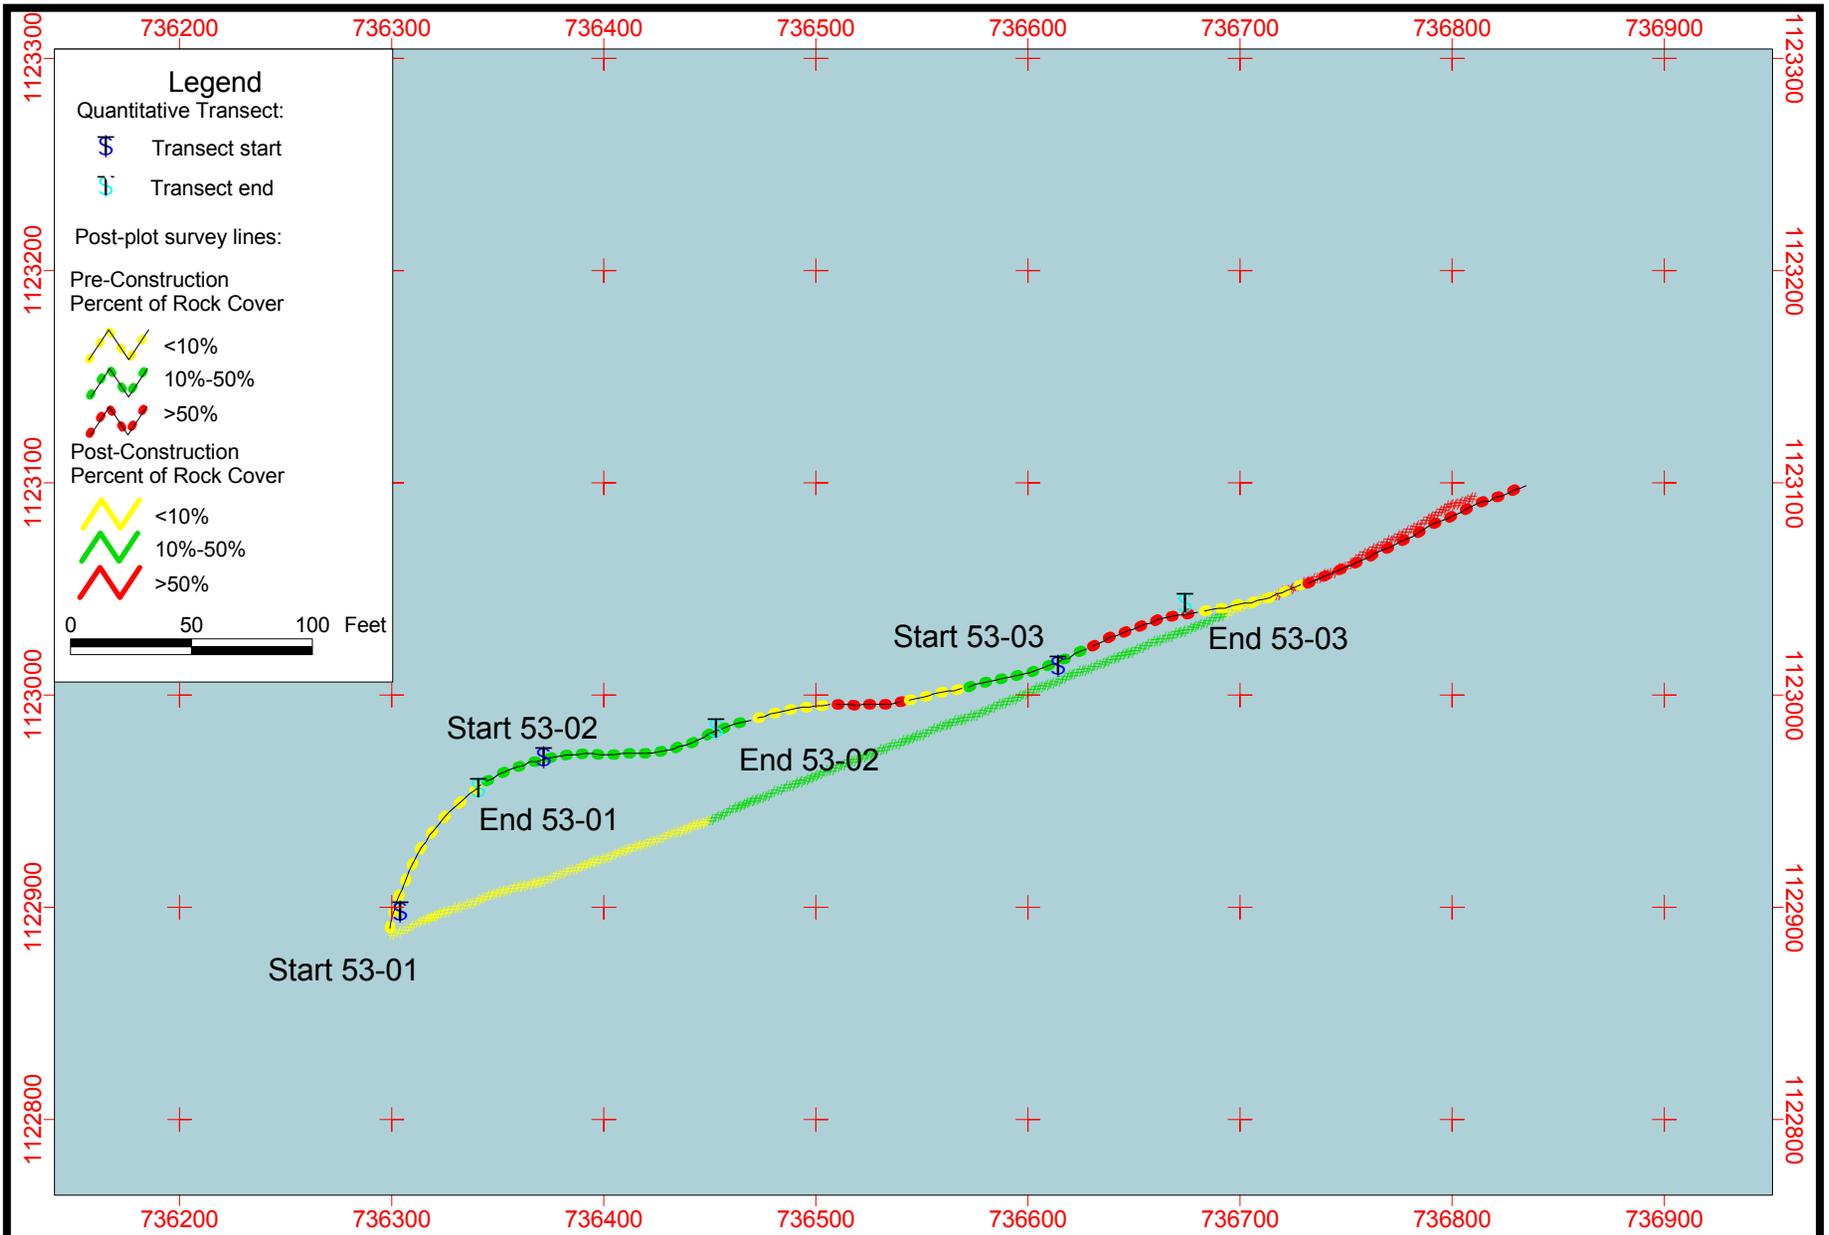
Figure 8. Post-plot Survey Line R-53 with identified rock substrate classifications. Aerial imagery for Survey Line R-53 is not available.

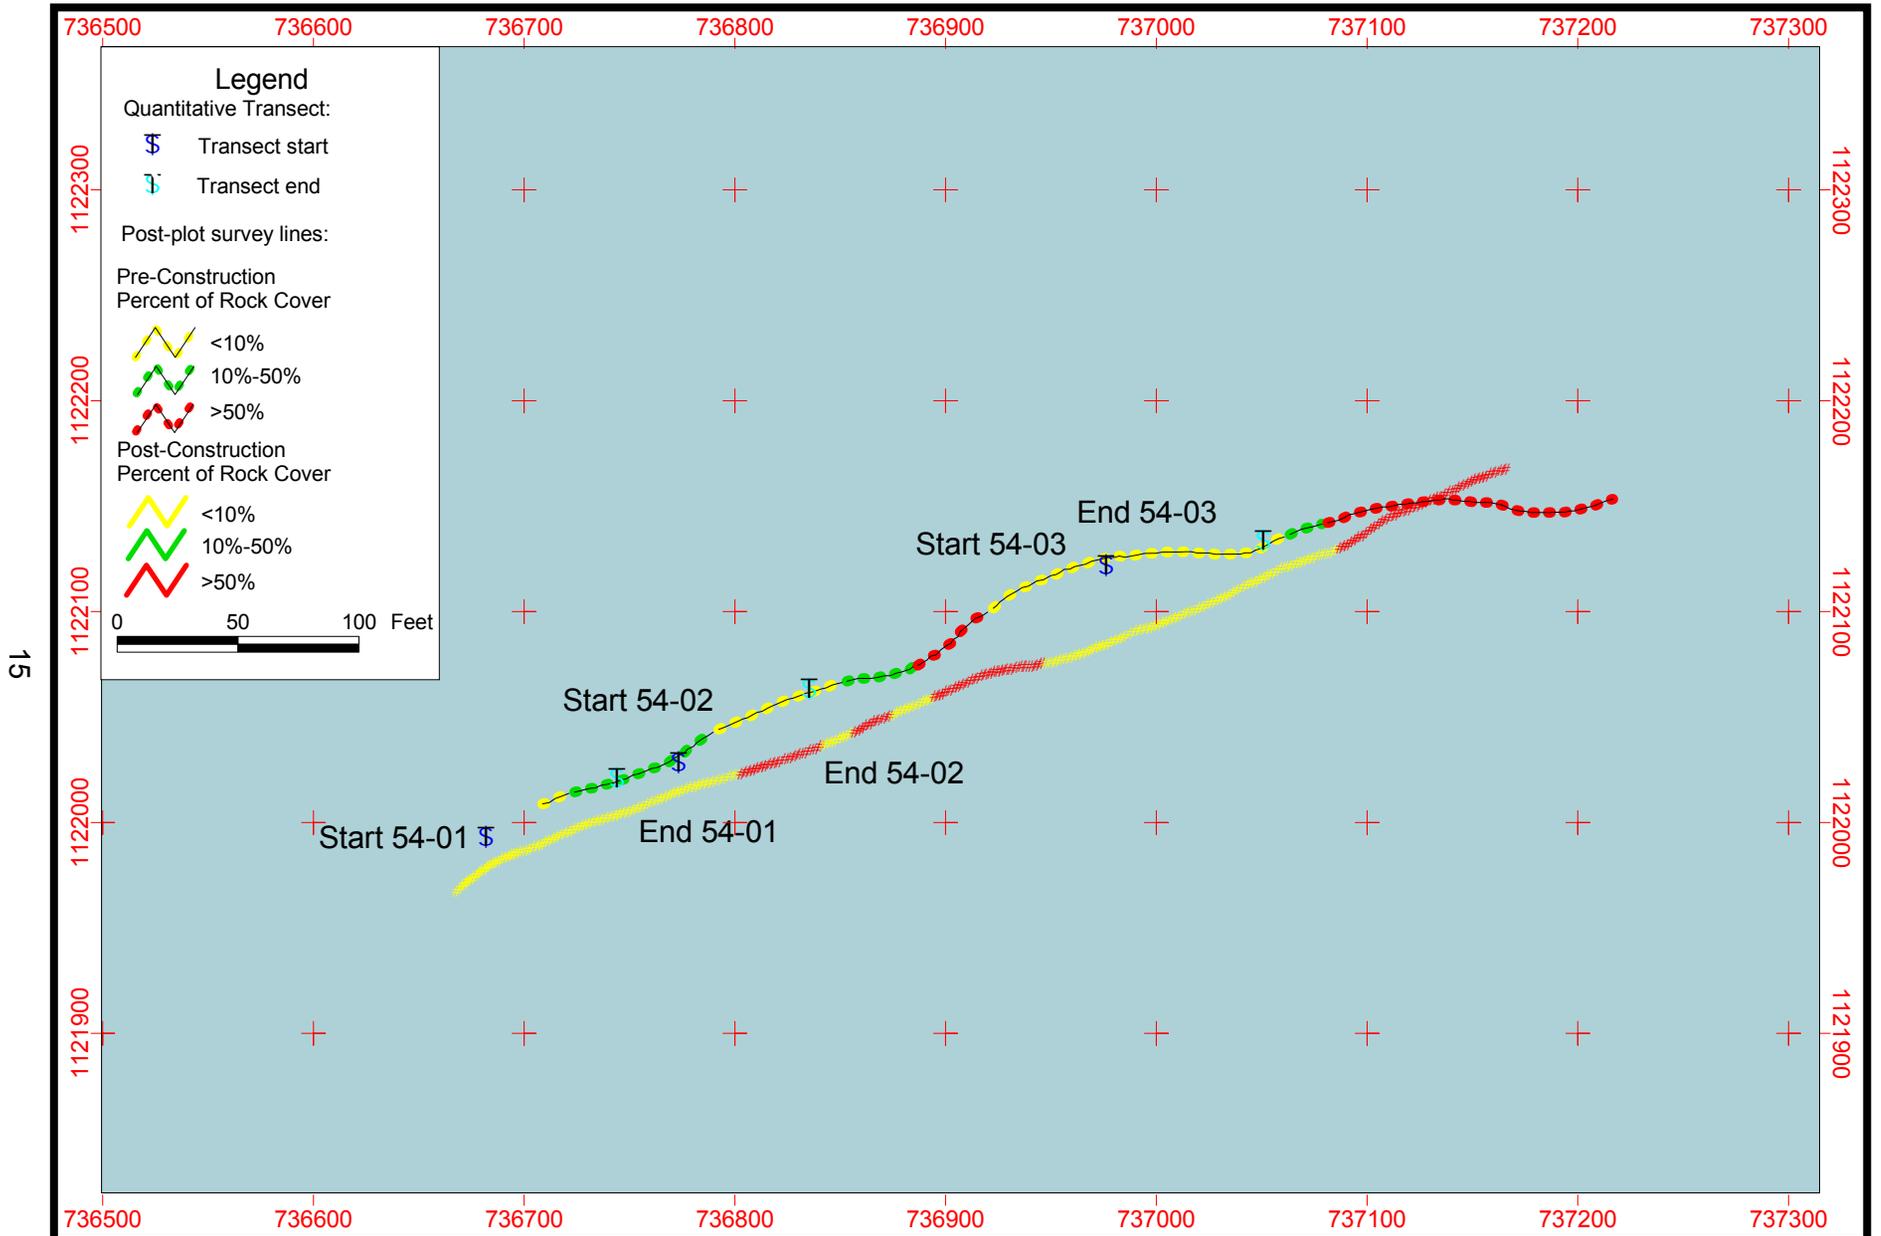
Figure 9. Post-plot Survey Line R-54 with identified rock substrate classifications. Aerial imagery for Survey Line R-54 is not available.
