Post-Construction Monitoring Survey of Nearshore Hard Bottom Habitats South of Fort Pierce Inlet Fort Pierce, Florida

December 2004

Continental Shelf Associates, Inc.
759 Parkway Street
Jupiter, Florida 33477
Telephone: (561) 746-7946

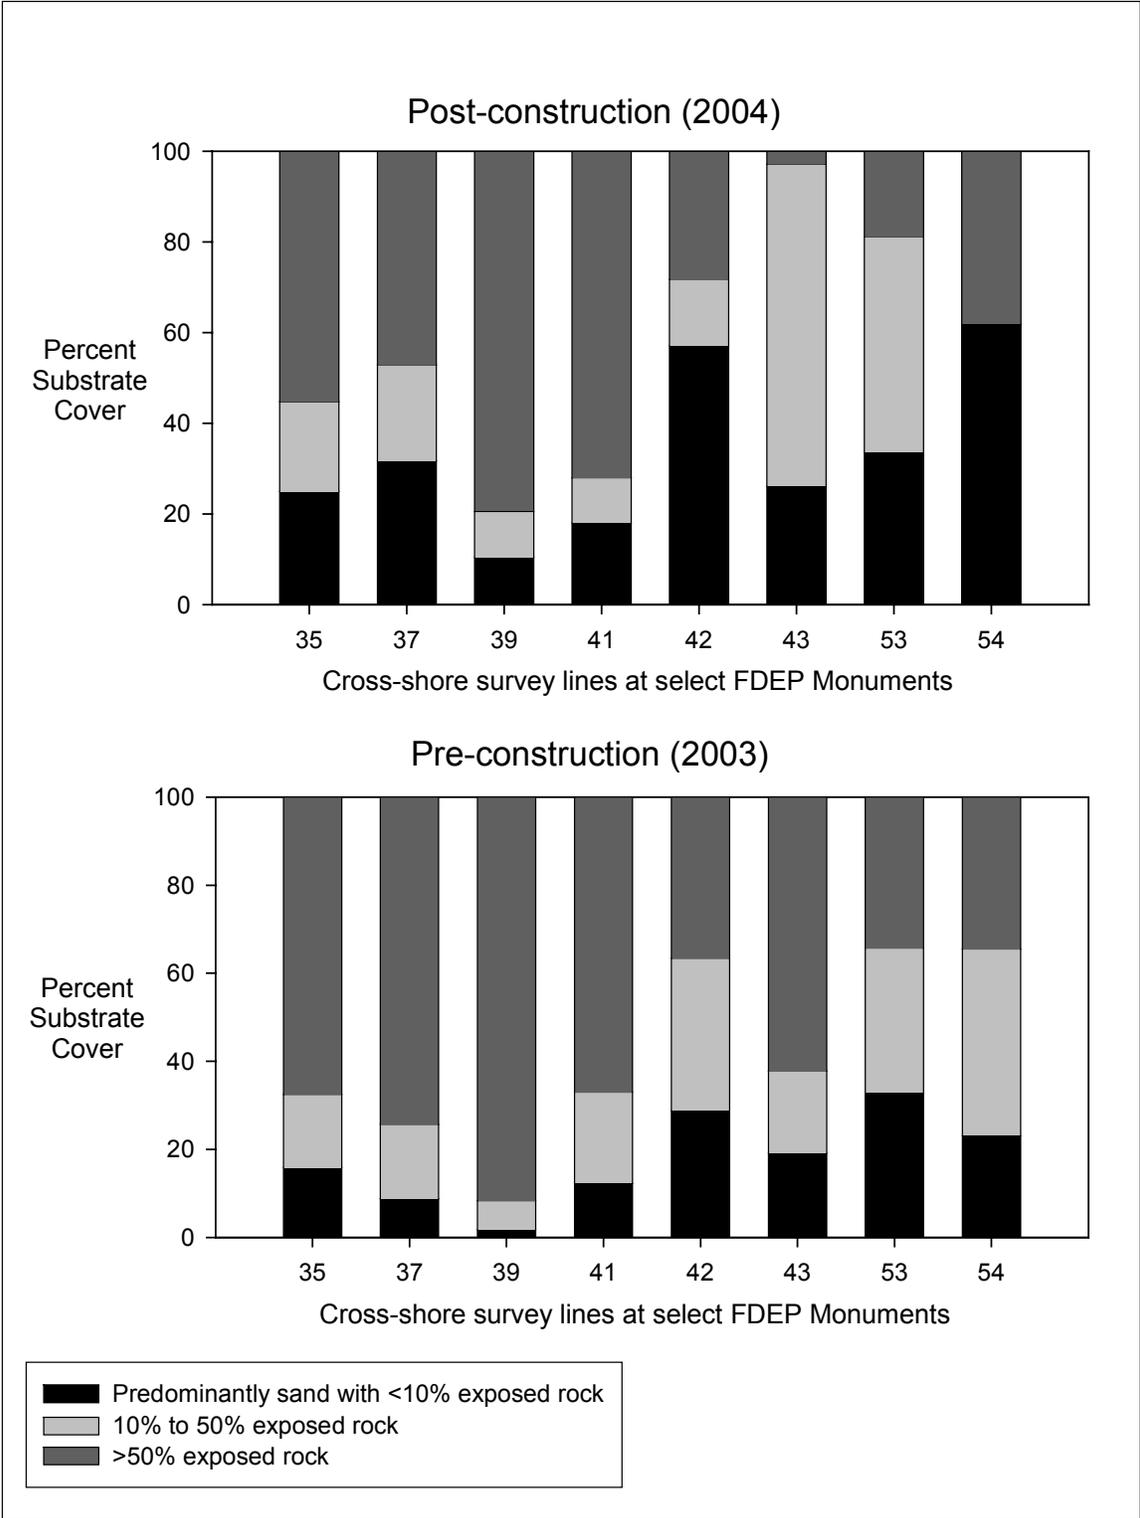
Figure 10. Percent cover of identified substrate classifications along each survey line. Cross-shore survey lines were located at Florida Department of Environmental Protection (FDEP) Monuments.

Substrate with 10% to 50% exposed rock cover composed an average of 24.3% of the total area surveyed. This substrate was most common along Survey Lines R-43 (71.0%) and R-53 (47.5%). There was only a slight difference in 10% to 50% exposed rock cover (3%) between the pre- and post-construction surveys. The biggest difference in 10% to 50% exposed rock cover between the pre- and post-construction surveys occurred at Survey Line R-54 and was 42.4% and 0.0%, respectively. Relief in areas of 10% to 50% exposed rock cover was less than 2 ft.

The predominantly sand with less than 10% exposed rock cover composed an average of 33% of the total area surveyed. The post-construction survey data indicated a considerable increase of this substrate type at most of the lines surveyed compared with the pre-construction survey estimates. The largest increases in sand bottom cover were observed along Survey Lines R-39 (post-construction 10.5% and pre-construction 1.8%), R-37 (post-construction 31.7% and pre-construction 8.8%), R-54 (post-construction 61.9% and pre-construction 23.1%), and R-42 (post-construction 57.1% and pre-construction 28.8%). The predominantly sand bottom areas observed along the survey lines were interspersed between the worm rock reef and were occasionally observed covering hard bottom with algae and other benthic epibiota emergent.

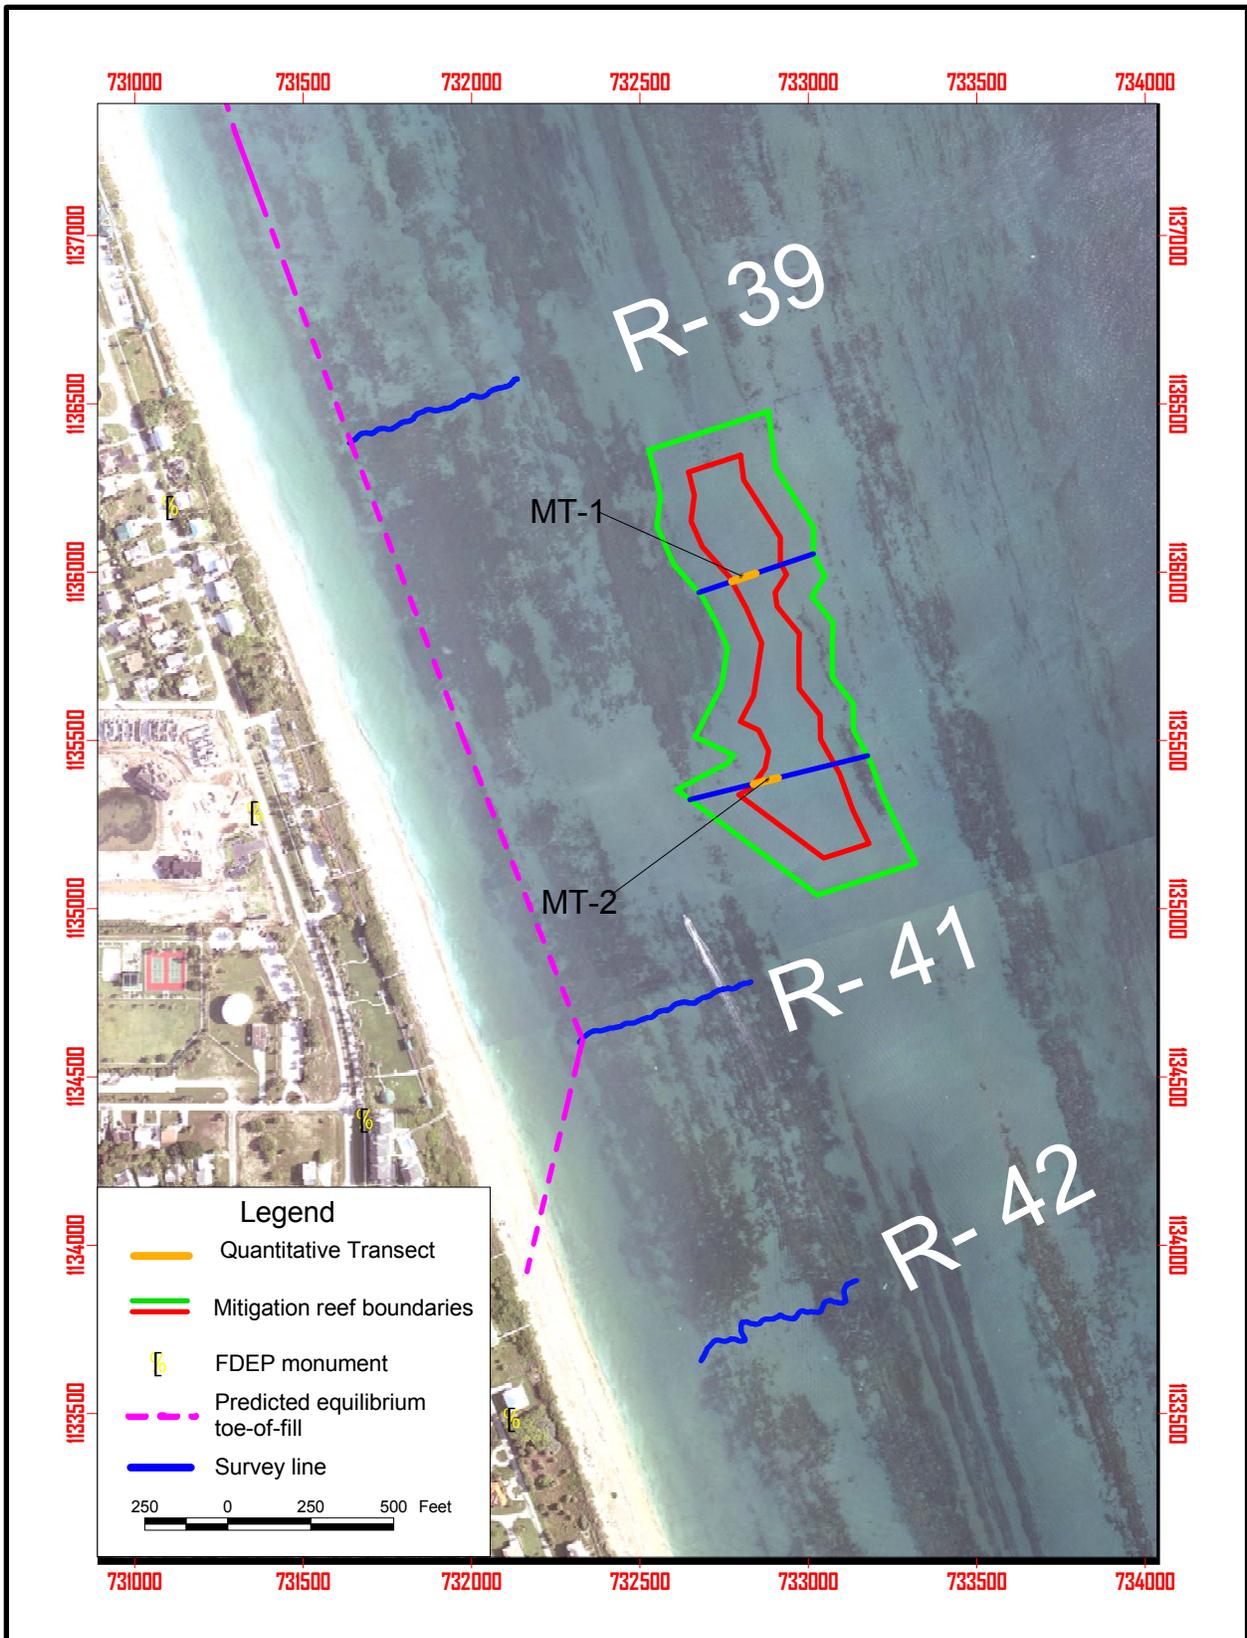
Two quantitative transects were established and surveyed on the mitigation reef (**Figure 11**). Limestone boulders were interspersed on sand bottom, often in groups of multiple boulders with sand bottom between boulders. Divers also swam a qualitative survey line that extended from west to east across the entire mitigation reef, starting from each quantitative transect location (**Figure 11**). The high relief of several groups of boulders created shallow water hazards that prevented towing a diver across the reef. Substrate, mostly sand (39.1% average cover) and exposed rock (12.6% average cover), was the dominant cover on the mitigation reef. This is due to the relatively short time of deployment and the density of the boulders that were placed on the bottom. The dominant biotic cover was algae (33.4% average cover) and is typical of artificial reef material at this stage of deployment. Sabellariid worm rock (*Phragmatopoma lapidosa*) and unidentified colonial tunicates (Ascidacea) were the most common benthic invertebrates within the mitigation reef survey areas.

Figure 11. Quantitative Transects MT-1 and MT-2 along survey lines located on the mitigation reef.

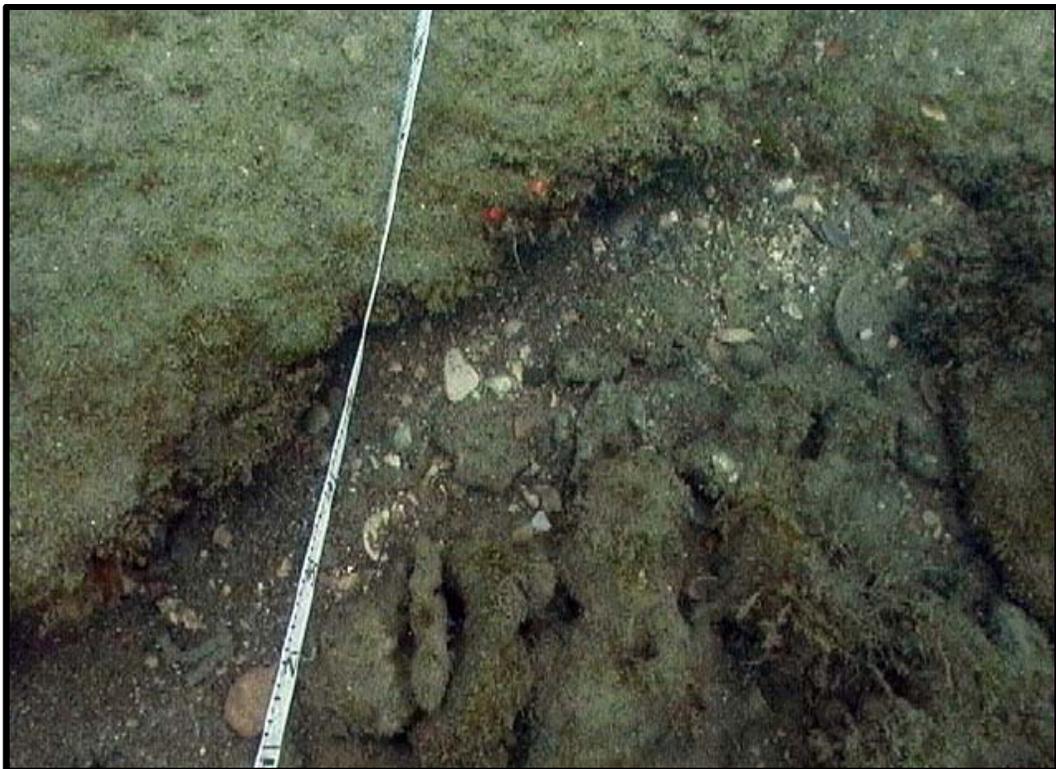
Photo 2 - Exposed hard bottom with algal cover and isolated patch of shell hash along Survey Line R-35.

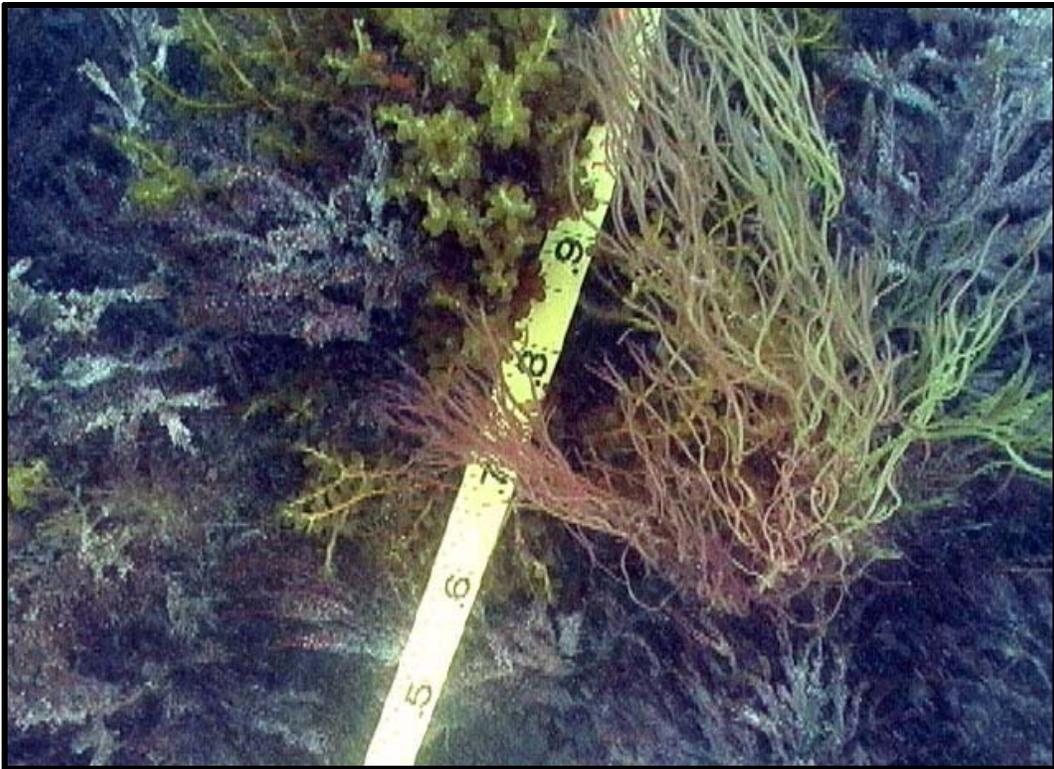
Photo 4 - Macroalgae on exposed hard bottom along Survey Line R-37.

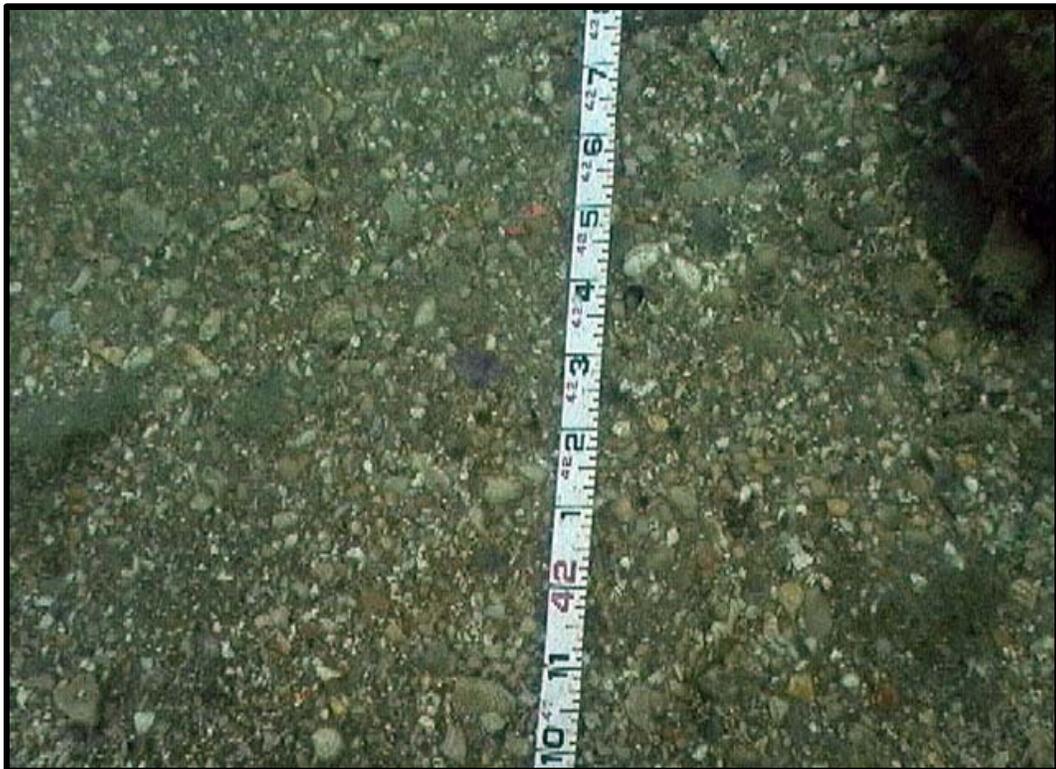
Photo 6 - Shell hash bottom with scattered macroalgae along Survey Line R-39.

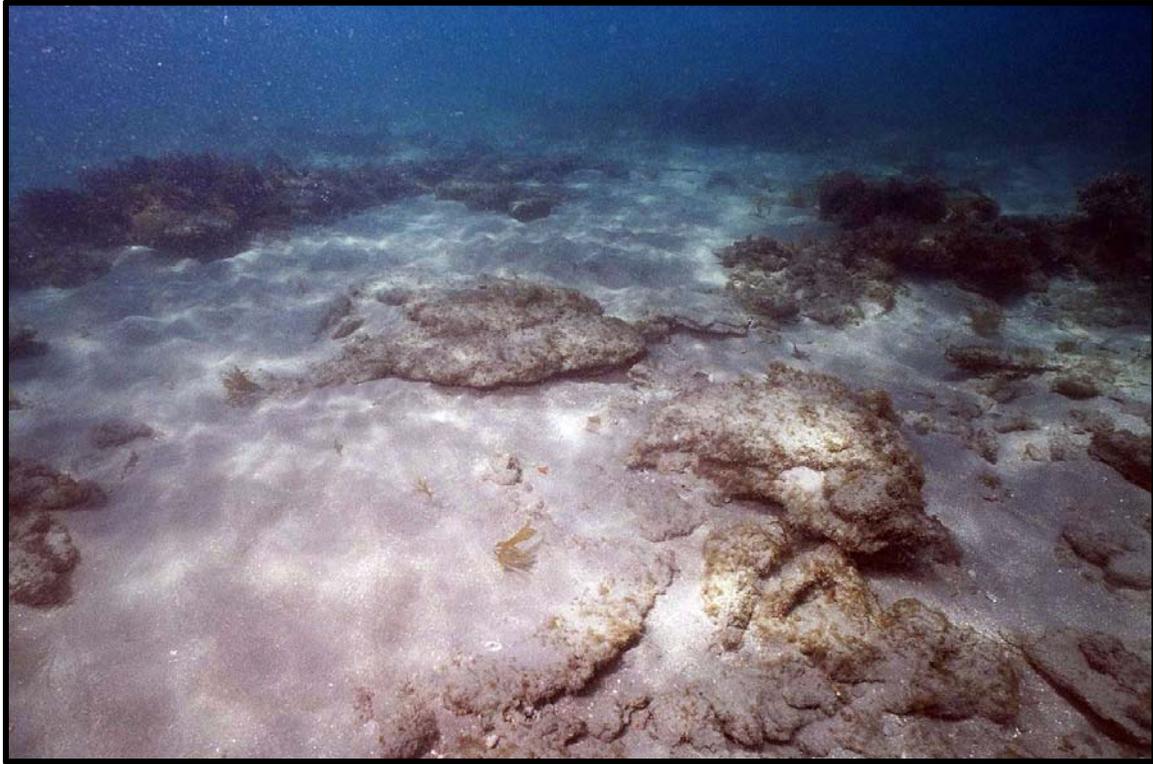
Photo 7 - Scattered exposed hard bottom along Survey Line R-41.

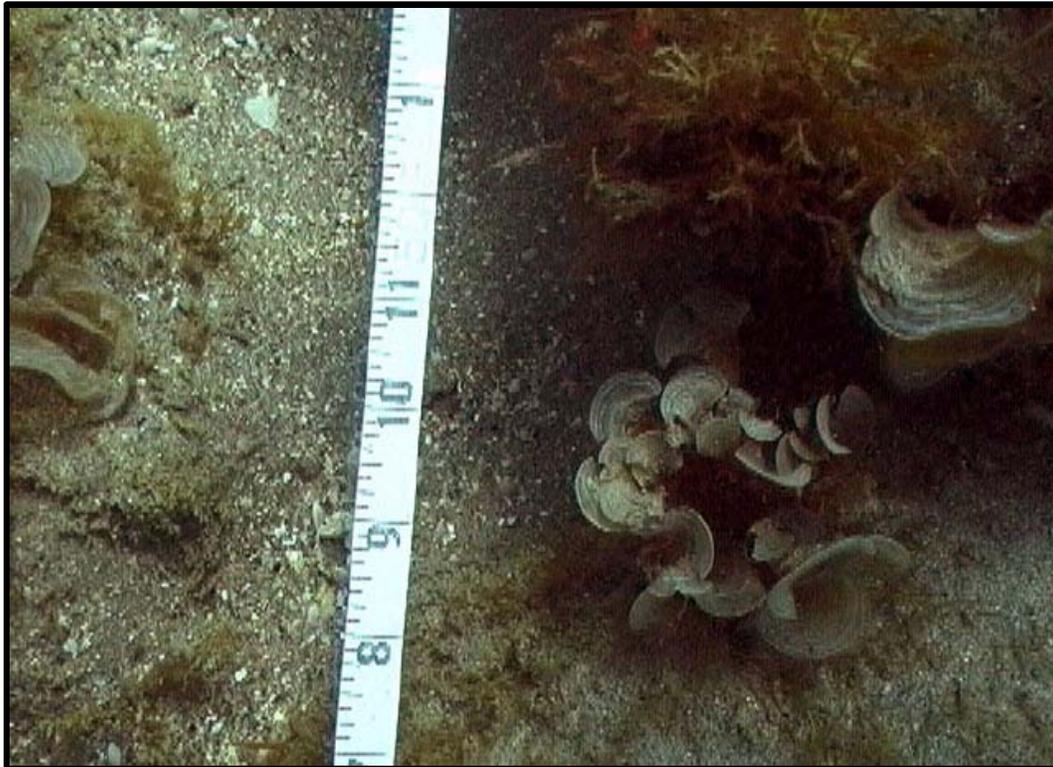
Photo 8 - Exposed hard bottom with macroalgae and sand along Survey Line R-41.

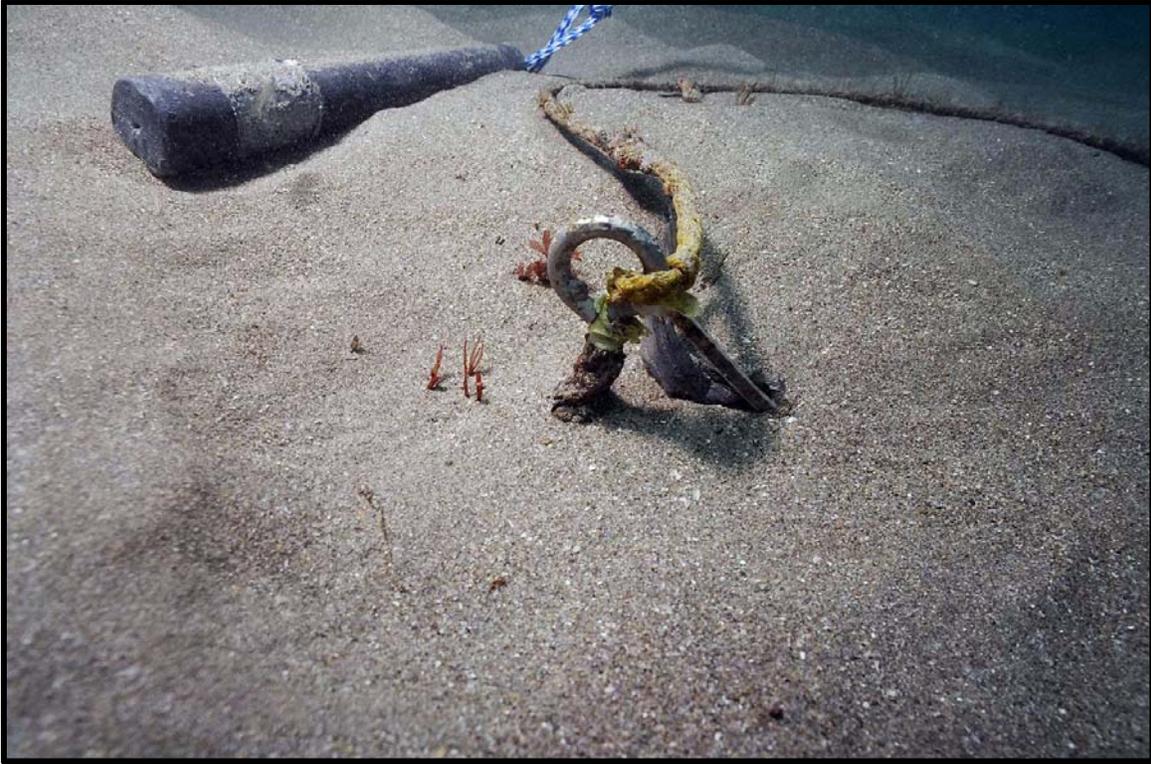
Photo 9 - Sand bottom near permanent transect marker along Survey Line R-42.

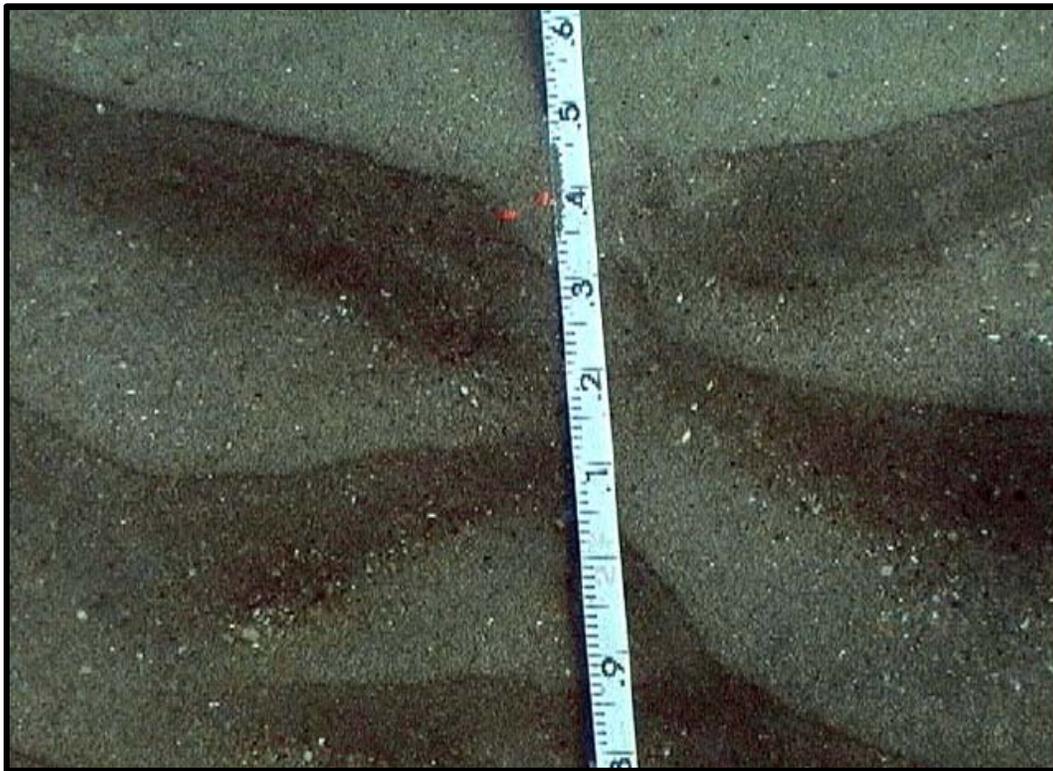
Photo 10 - Sand bottom along Survey Line R-42.

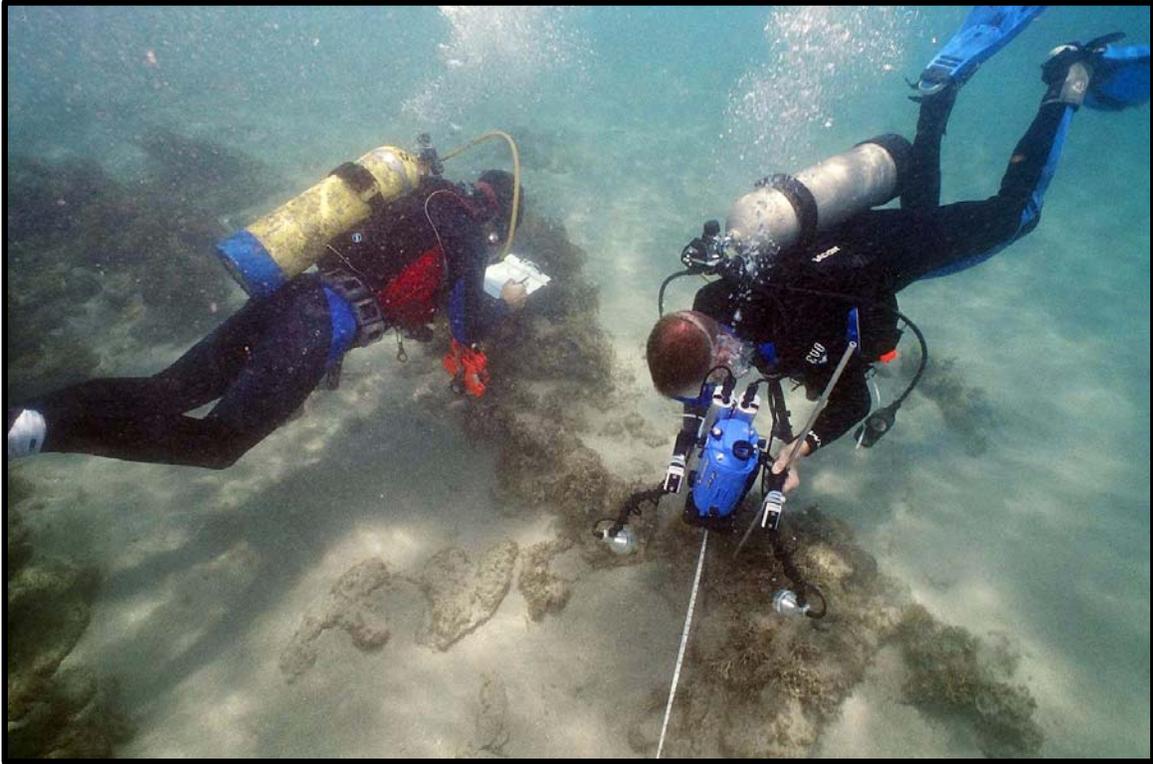
Photo 11 - Scattered exposed hard bottom along Survey Line R-43.

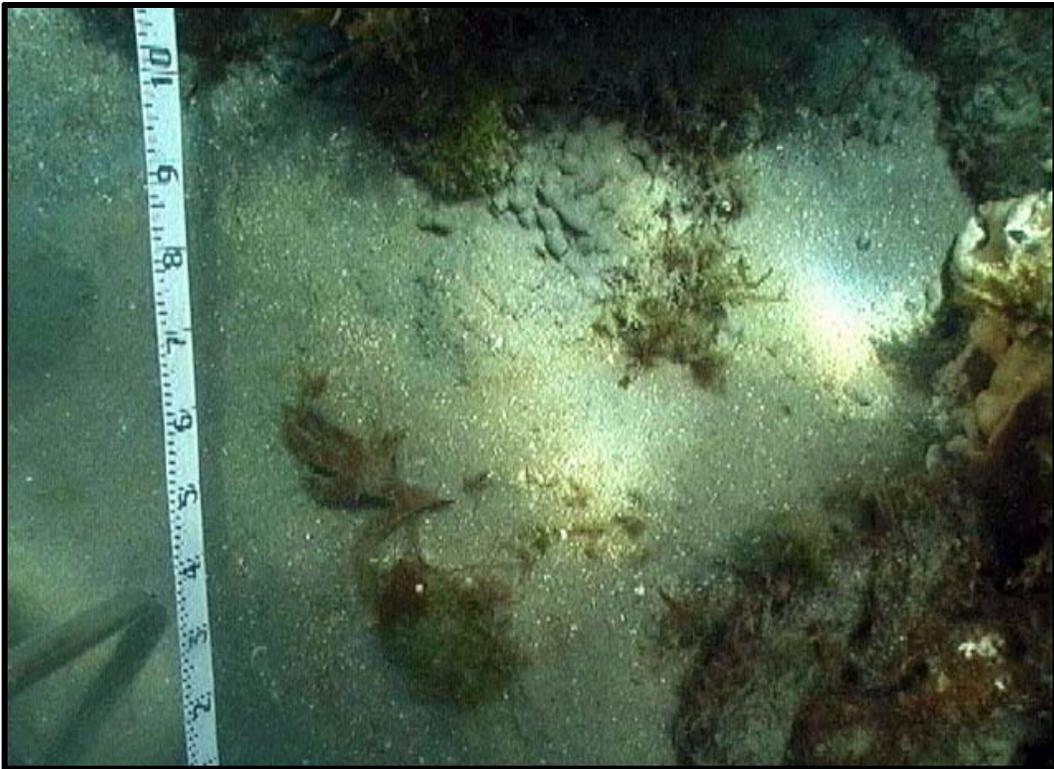
Photo 14 - Shell hash bottom with scattered macroalgae along Survey Line R-53.

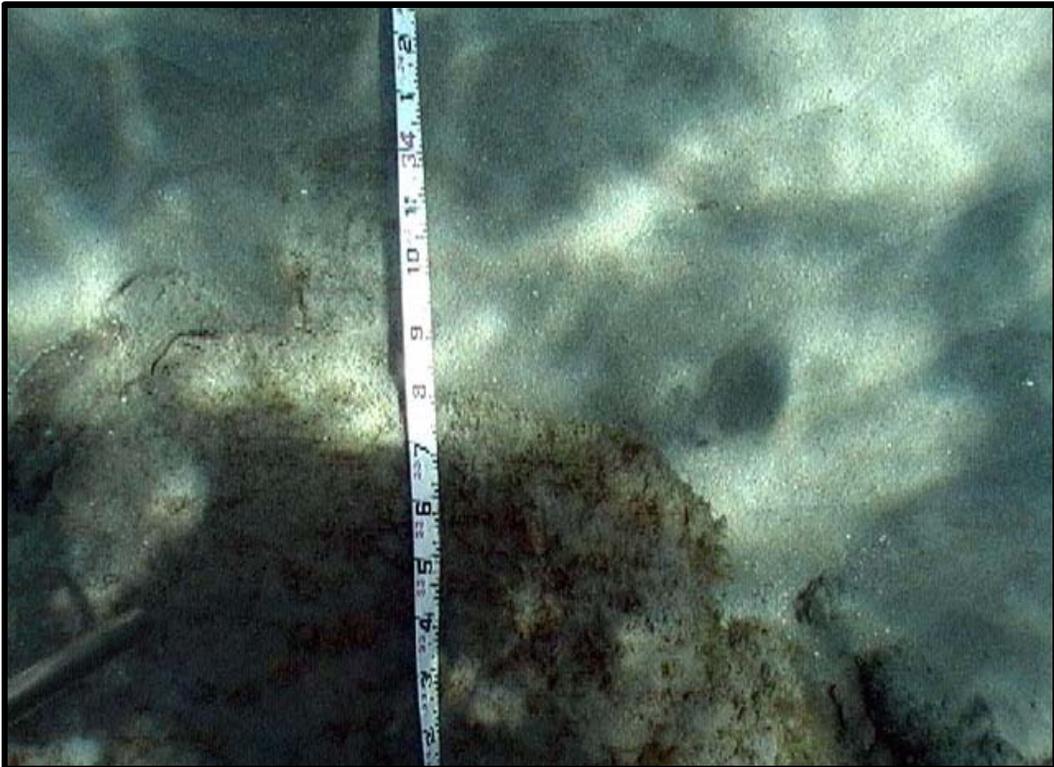
Photo 16 - Sand bottom with scattered exposed hard bottom along Survey Line R-54.

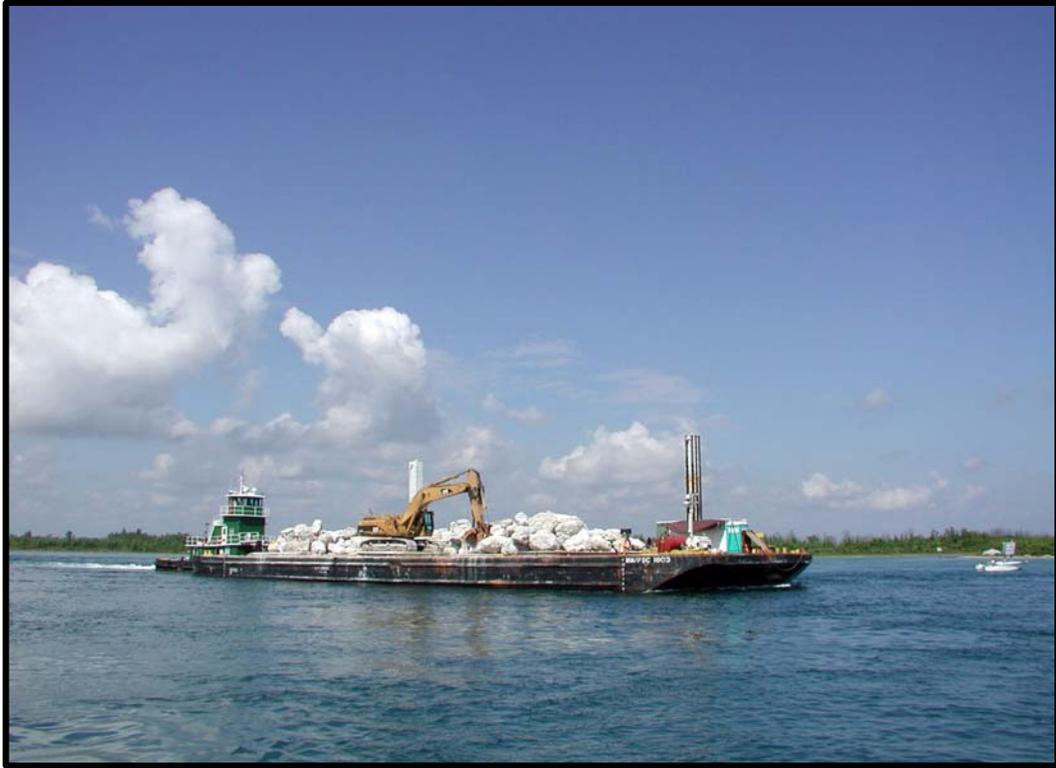
Photo 17 - Deployment of mitigation reef off Fort Pierce, Florida.

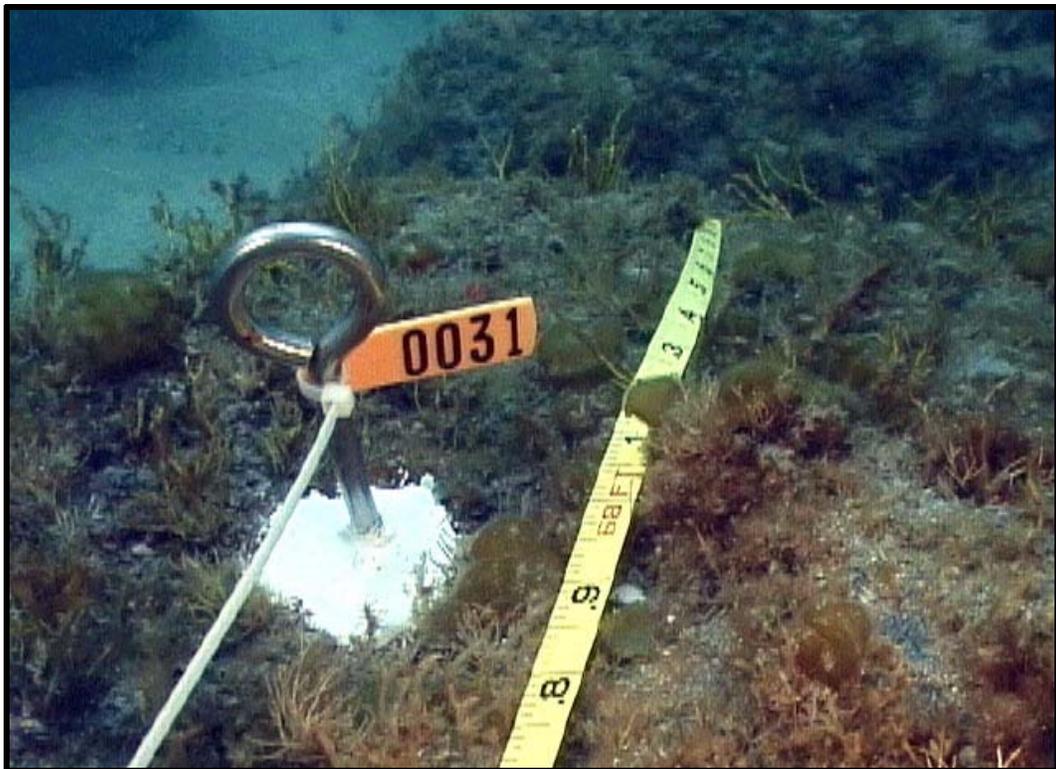
Photo 18 - Quantitative Transect MT-1 on mitigation reef with dense algal cover.

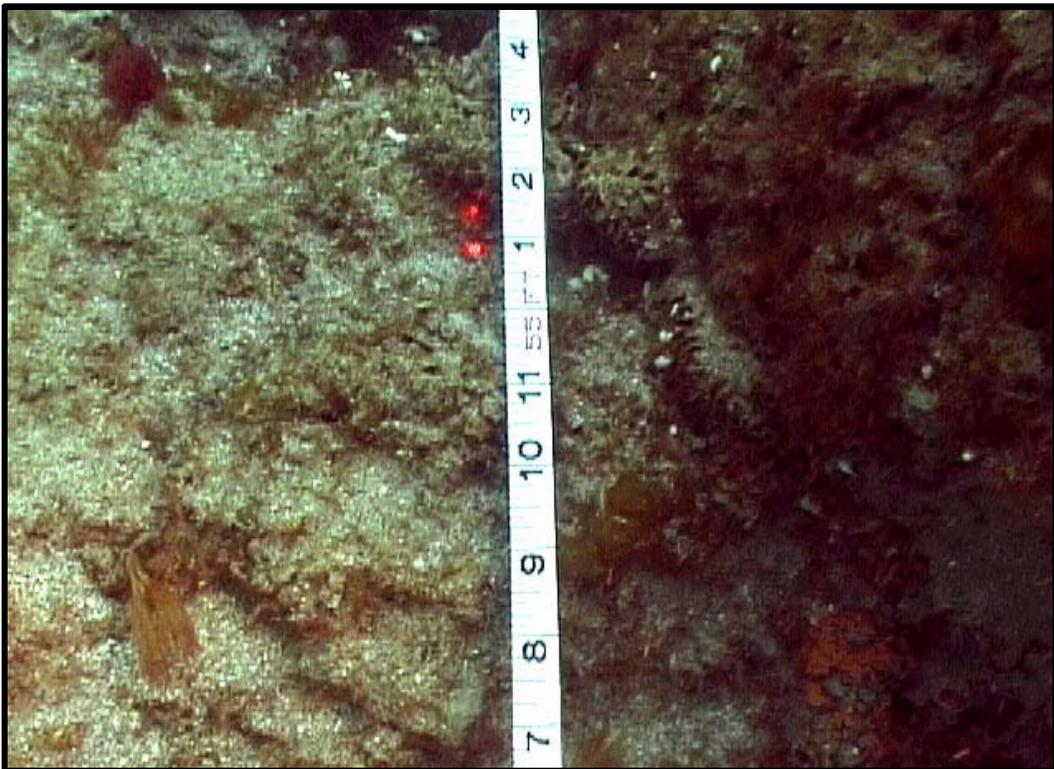
Photo 20 - Quantitative Transect MT-2 on mitigation reef with dense algal cover and sabellarid worms (*Phragmatapoma lapidosa*).
